# **Moraga Storm Drain Master Plan**

## **July 2015**

# TECHNICAL MEMORANDUM

## TOWN OF MORAGA STORM DRAINAGE CONDITION ASSESSMENT

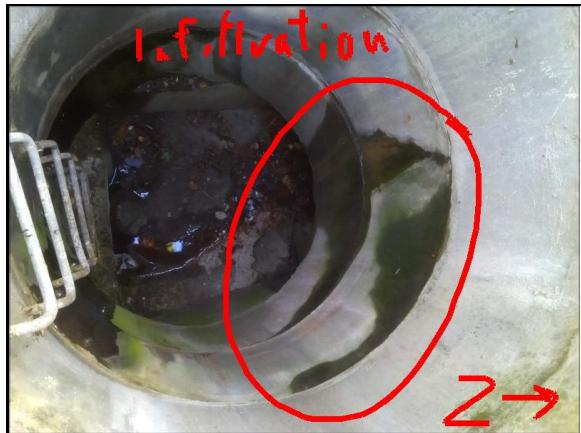
## Catch Basin Z1\_NODE\_0042

Water infiltration staining.

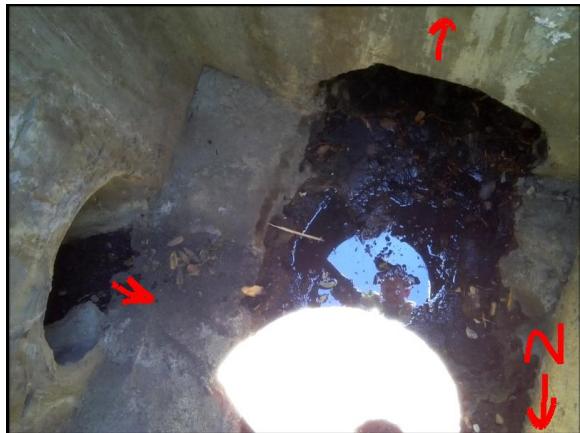
**SDFA 11 - Joseph Dr and Bollinger Canyon Rd*****Manhole Z5\_NODE\_0126***

View of inlet and outlet.

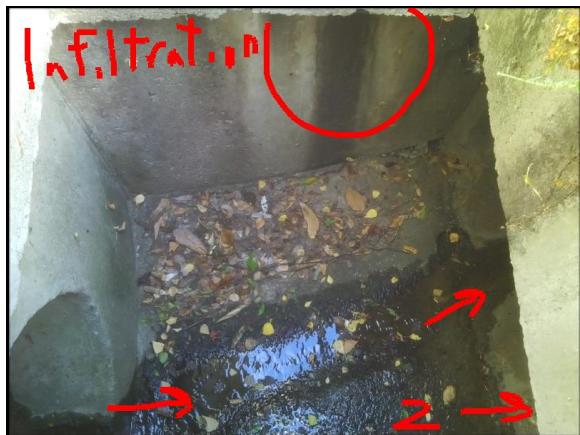
## Catch Basin Z7\_NODE\_0158

Down view of structure. Water infiltration staining.

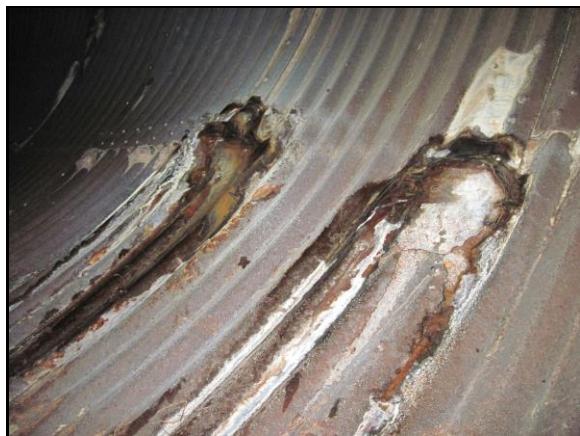
Downstream 3' Infiltration (1)

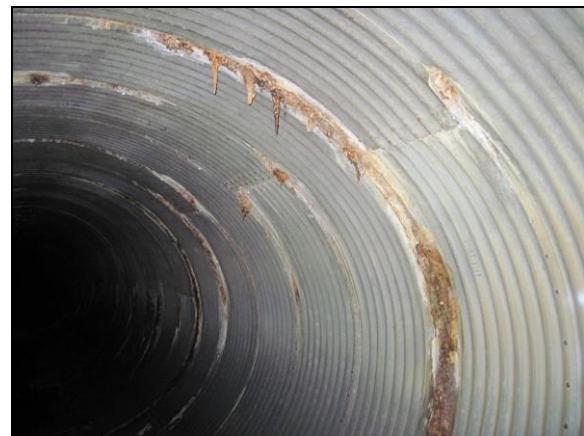
Downstream 5' Encrustation

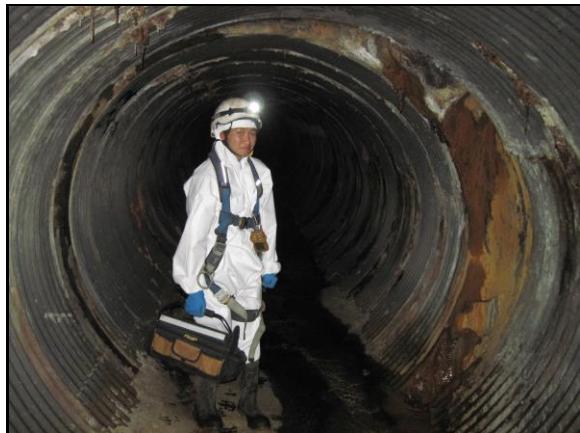
Downstream 77' Defective Pipe Size Change (1)

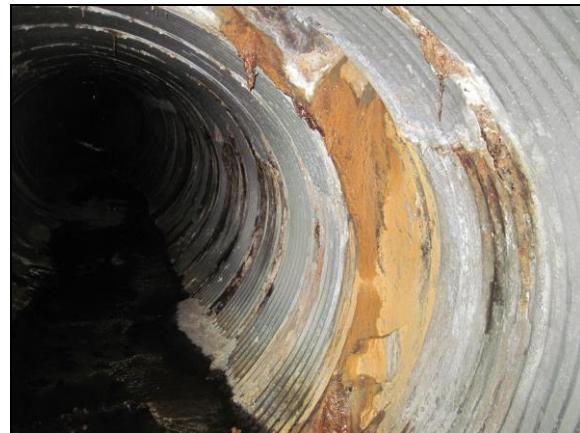
Downstream 77' Defective Pipe Size Change (2)

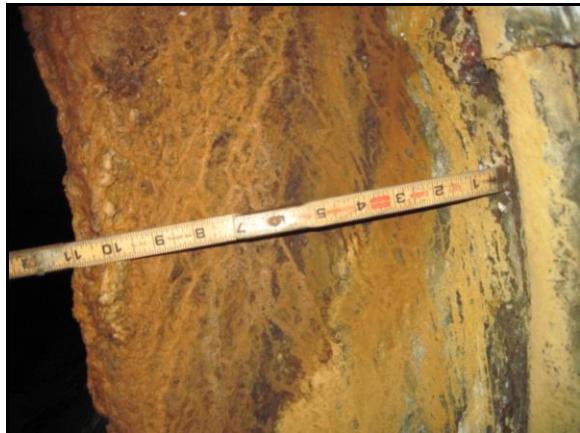
Downstream 77' Defective Pipe Size Change (3)

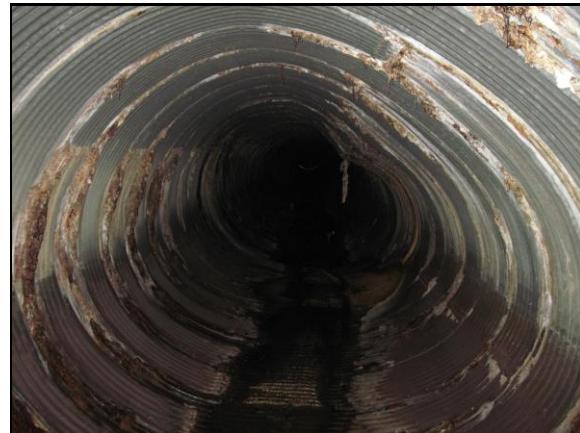
Downstream 186' Deformed (IMG\_2636)

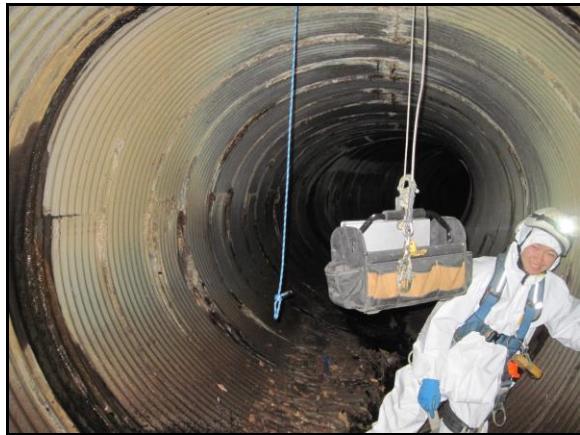
Upstream 2' Infiltration

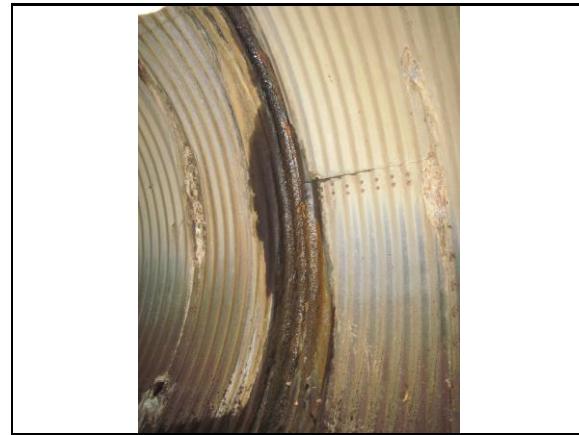
Upstream 2' Infiltration (2)

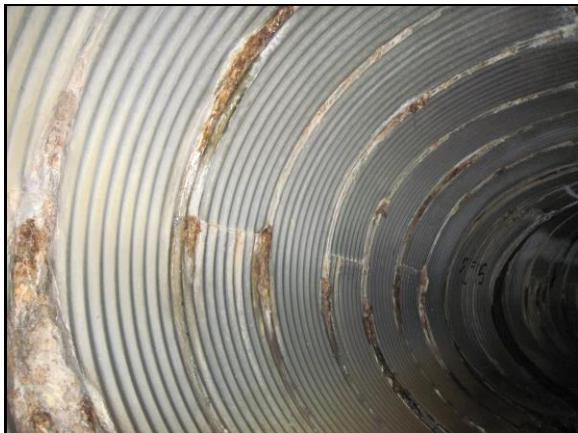
Upstream 10' Infiltration

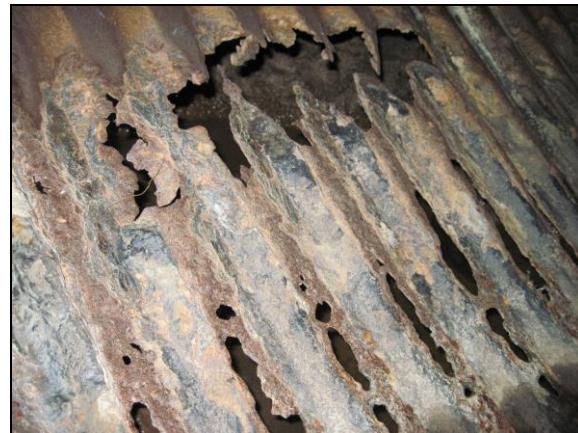
Upstream 15' Hole Void Visible

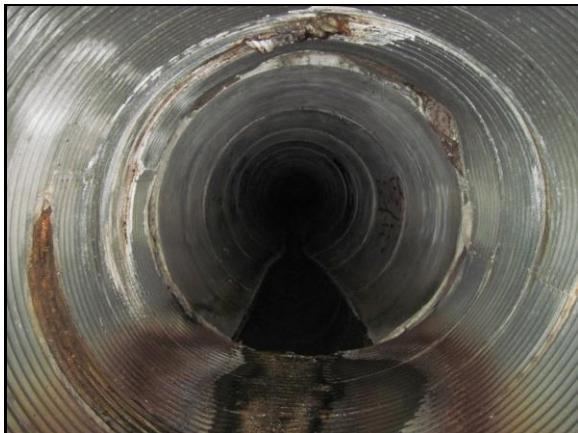
Upstream 46' Defective Pipe Material Change (4)

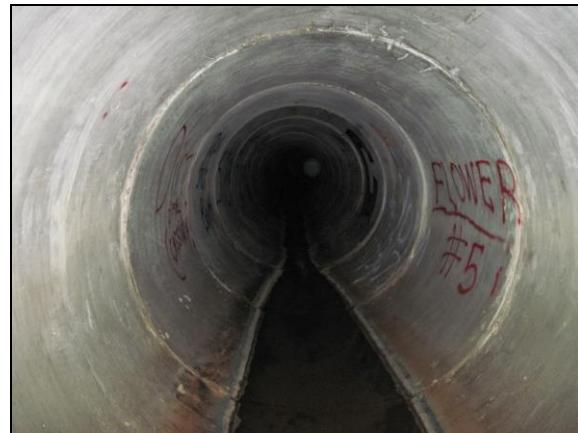
Upstream 55' Longitudinal Cracks at Joint (1)

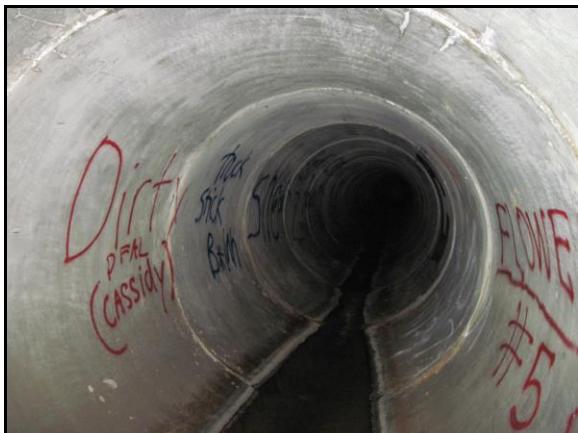
Upstream 55' Longitudinal Cracks at Joint (2)

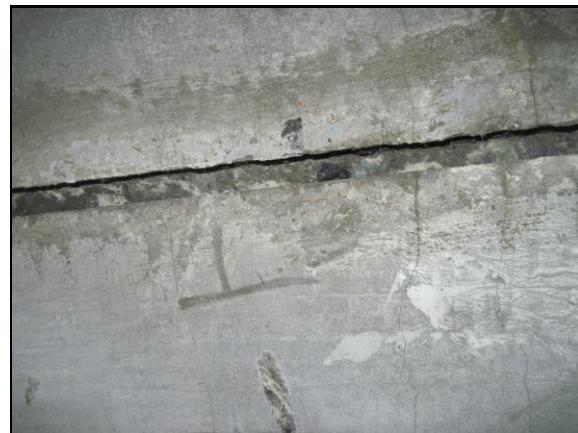
Upstream 65' Missing Mortar (1)

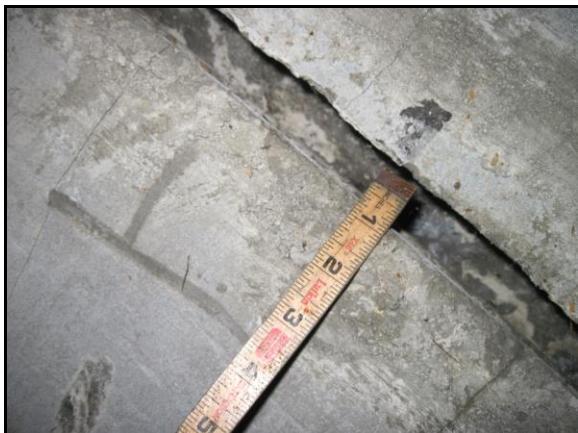
Upstream 65' Missing Mortar (2)

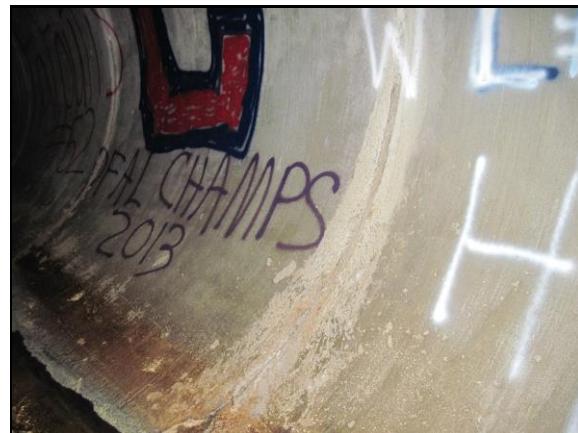
Upstream 73' Infiltration Stains

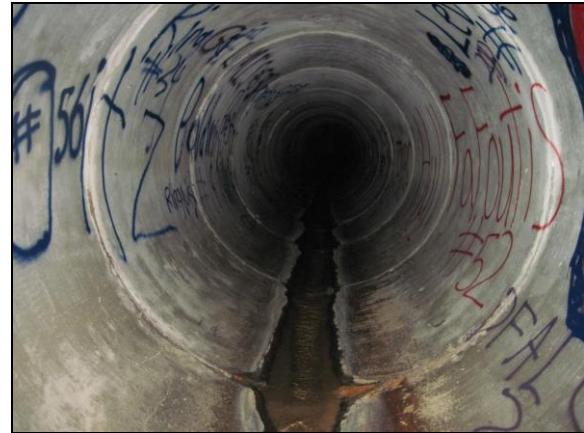
Upstream 81' Longitudinal Cracks, Staining (3)

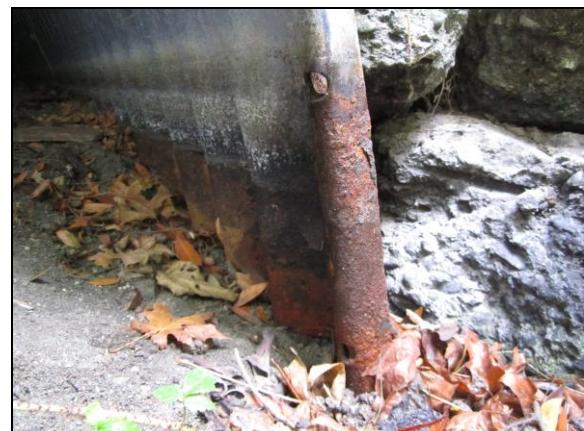
Corrosion on pipe wall.

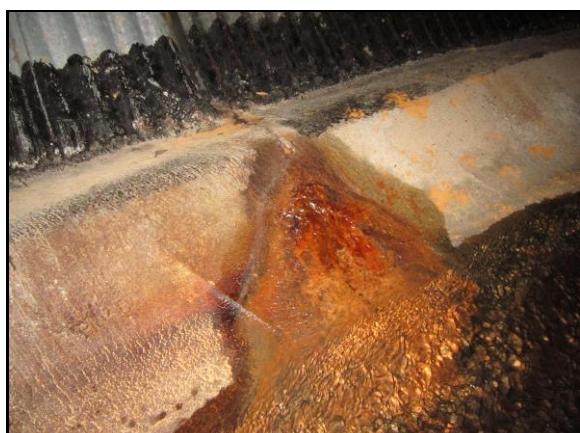
Infiltration staining.

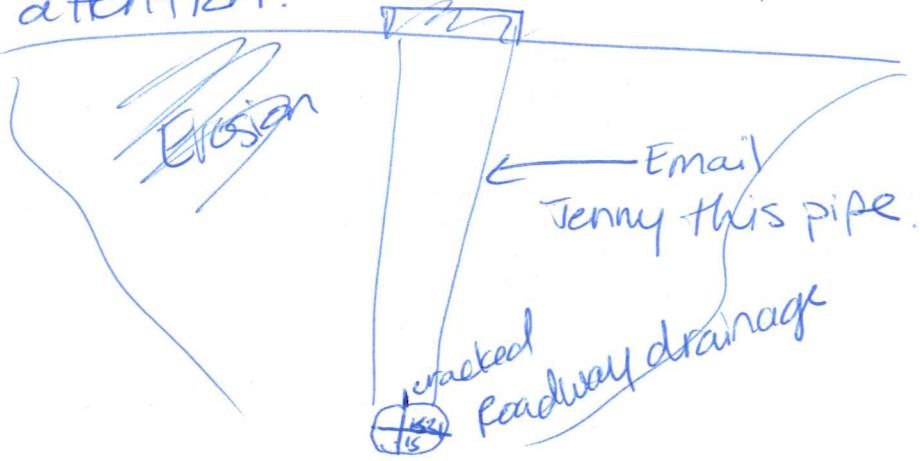
**SKETCH:** is creek covered. RCP needs replacing & CMP needs attention. 2024

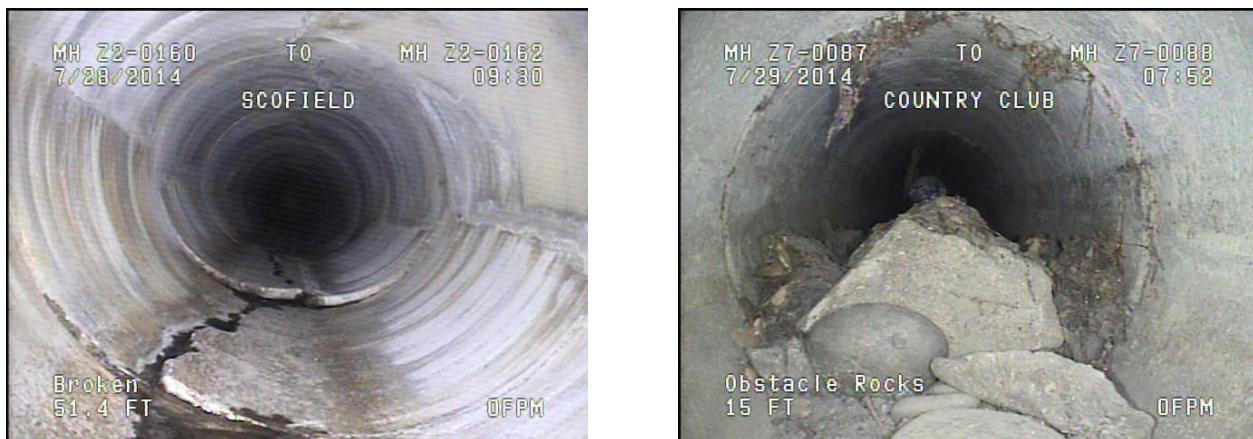
Figure 2: Pipe Impairment Examples: Broken Pipe (left) Pipe Debris (right)

An example of a light severity defect is longitudinal cracking in a reinforced concrete pipe (RCP) that does not show signs of infiltration or weakened structure. An example of a severe defect is a hole in a pipe that is allowing soil, roots, or sediment. Any defect that limits the conveyance capacity of a pipe is considered Heavy to Severe. In some instances, sediment or debris might be considered a Heavy or Severe defect if it is thought that the limit in capacity may result in flooding. The locations of the street repairs and the storm drain impairments are shown in Figure 1. Figure 2 shows examples of debris and broken pipe defects.
