2021 – 2023 Storm Drain Repairs Project

Basis of Design Report

Town Council Meeting - November 9, 2022

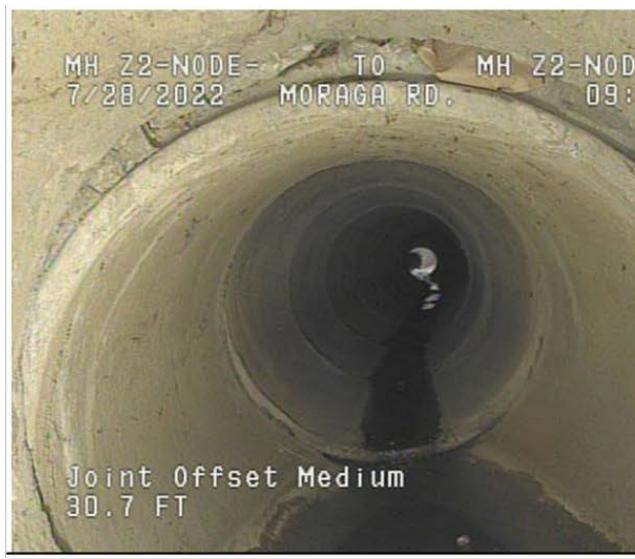
Grade 3 – Medium Joint Offset

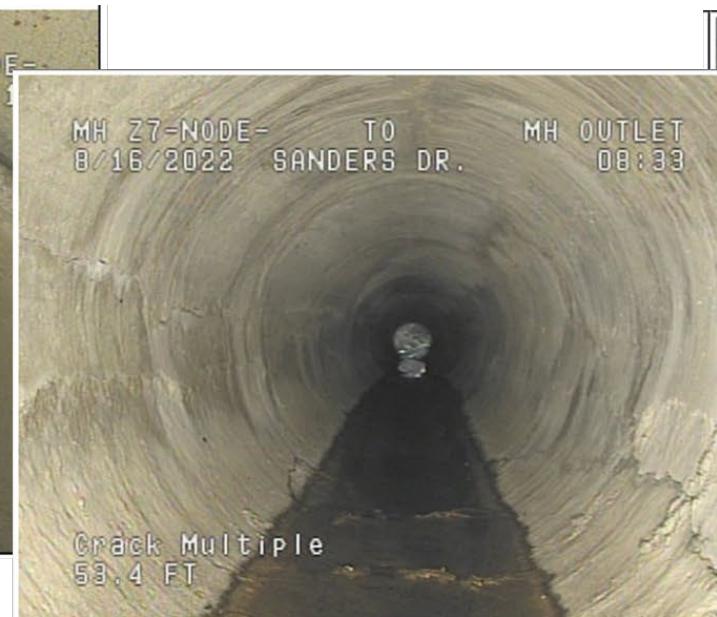
Grade 4 – Severe Cracking

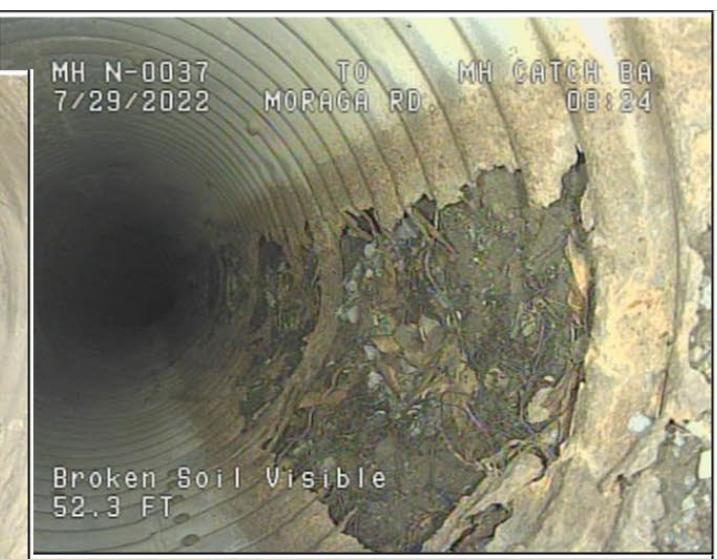
Grade 5 – Broken Hole with Visible Soil

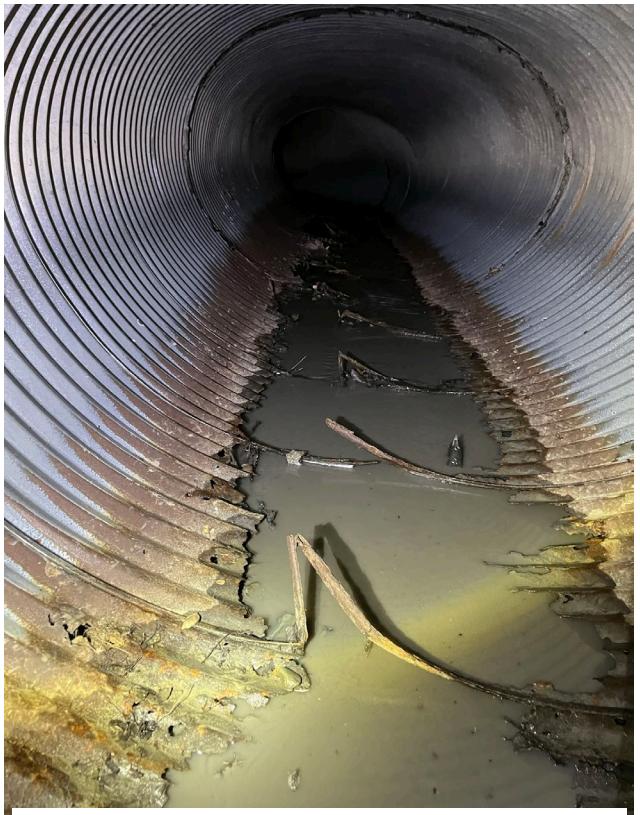
BEFORE: ERODED BOTTOM
