## Final Memorandum

**Date:** April 14, 2014  
**To:** Edric Kwan, Public Works Director/Town Engineer - Town of Moraga  
**From:** Grant Wilcox/Kazuya Tsurushita/Sonia Leung - WRECO  
**Subject:** Laguna Creek Hydraulic Study Project

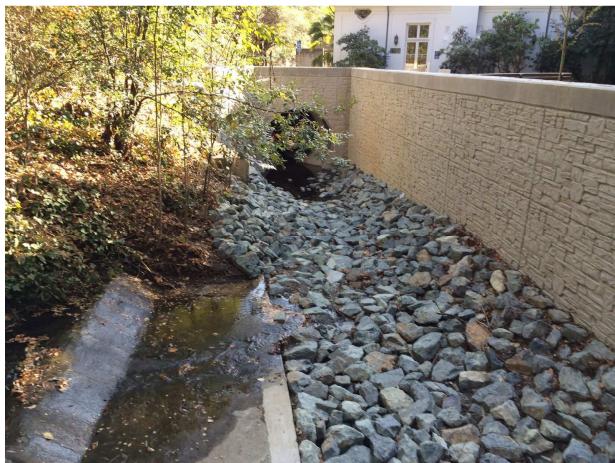
About 50 ft upstream of the existing 8-ft diameter CMP culvert, Laguna Creek flows through a sharp 90 degree turn and converges with Donald Drive Tributary; see Photo 1. This sharp turn is caused by the relocation of the channel in the 1930's; Laguna Creek used to run where the Pavilion is now located and the turn angle was more moderate. Immediately upstream of the confluence, the Central Contra Costa Sanitary District (CCCSD) installed a concrete spillway apron to protect an existing 18-in sewer line; see Photo 2. This sewer line is nearly parallel to the existing culvert, and it flows from northwest to southeast. The inlet face of the existing CMP culvert was repaired during the construction project 2013; see Figure 3. About 110 ft downstream from the CMP culvert's inlet face, the top of the CMP is exposed; see Photo 3. These photos were taken on December 19, 2013 during WRECO's site visit.

**Photo 1. Upstream of Existing 8-ft CMP Culvert**

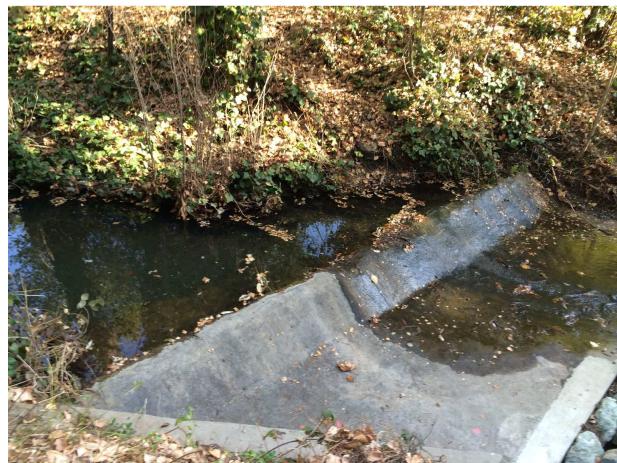
**Photo 2. Concrete Spillway Apron**

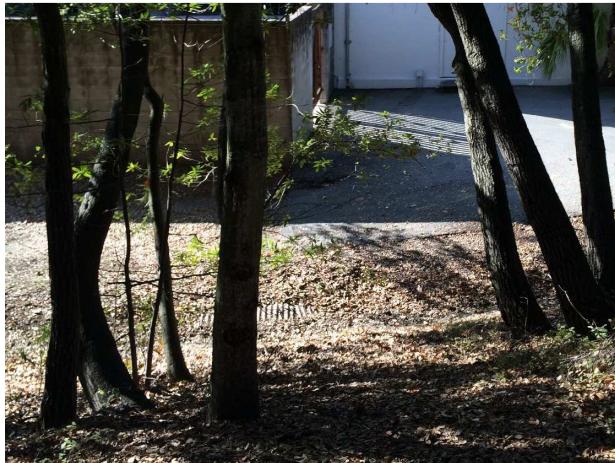
**Photo 3. Exposed Existing CMP**

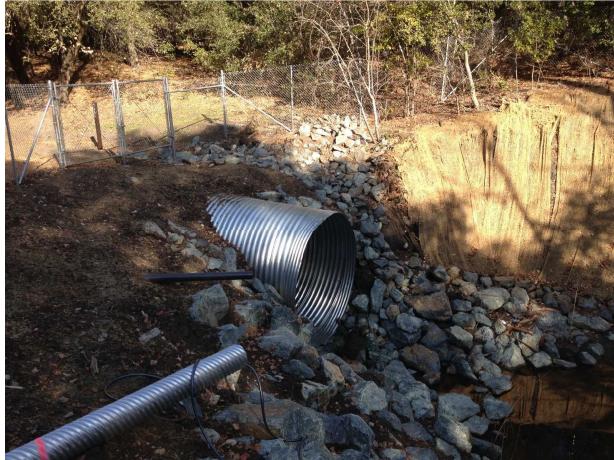
Before the construction project in 2013, the retaining wall on the downstream side of the existing 8-ft CMP culvert fell into the creek after the storm events in 2005. The outfall from the culvert was causing a scouring problem to the downstream and the broken concrete pieces from the failed headwall and wing walls were left in the stream. The construction project in 2013 repaired the scoured channel by providing the 1-ton rock slope protection (RSP) at the outlet face of the 8-ft CMP culvert (see Photo 4) to prevent further erosion caused by the outflows from the existing 8-ft CMP culvert. The RSP was also installed at the damaged channel slope to provide additional channel protection (see Photo 5). The wing walls left in the stream were removed and replaced by the RSP cross vane (see Photo 6).

**Photo 4. Downstream Face of the Existing 8-ft CMP Culvert**

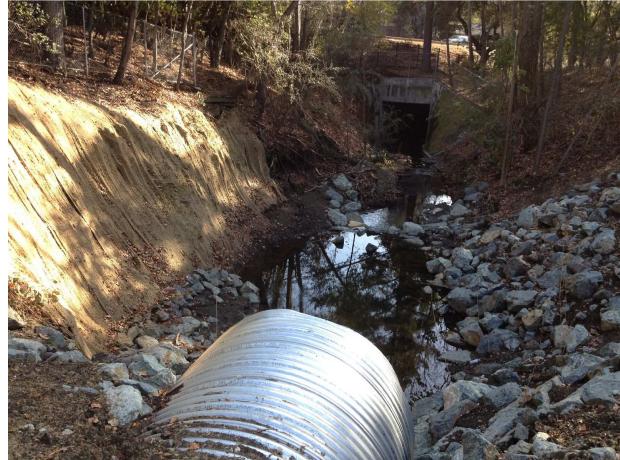
**Photo 5. Laguna Creek Looking Downstream from the Existing 8-ft CMP Culvert**

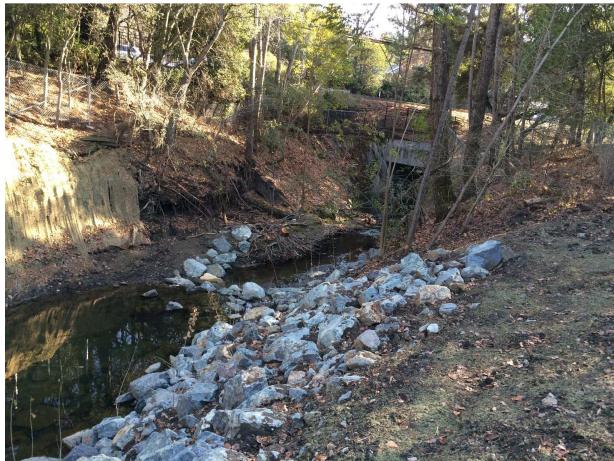
**Photo 6. RSP Cross Vane**
