A Existing Traffic Conditions Memorandum

MEMORANDUM

SUBJECT: Moraga Road – Existing Traffic Conditions

P# 13130-000

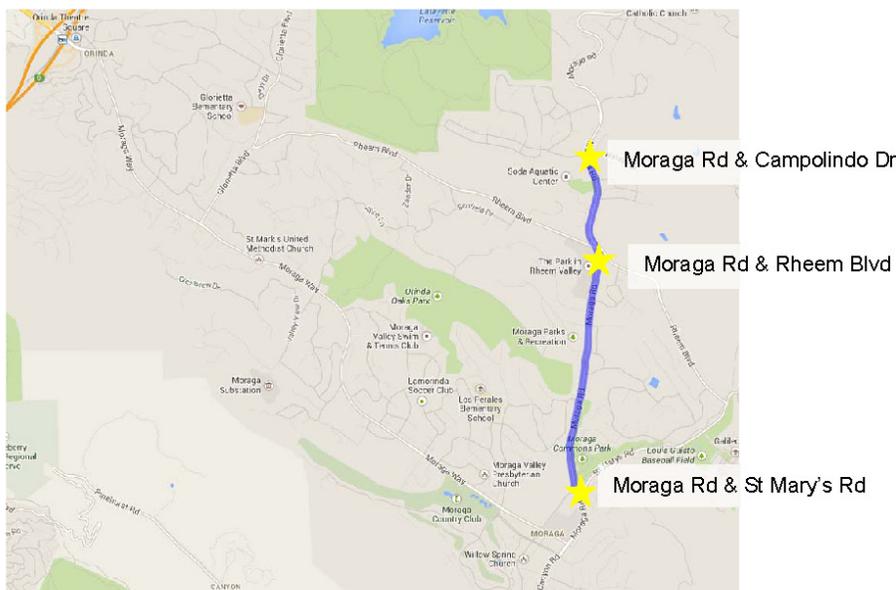
Figure 1: Site Map with Study Intersections

The Town of Moraga is located just south of Highway 24 in Contra Costa County. Moraga Road is a popular route for residents of Moraga traveling to Lafayette or accessing Highway 24. Moraga Road is mostly four lanes through the Town of Moraga. This study will focus on the portion of Moraga Road between Campolindo Drive and St. Mary's Road. Additionally, the intersections at Campolindo Drive, Rheem Blvd and St. Mary's Rd will be evaluated for level-of-service. Figure 1 shows the general locations of the roadway segment as well as each study intersection.

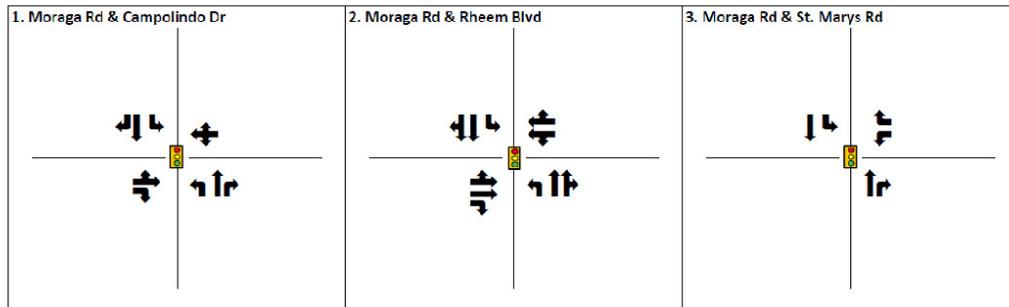
Figure 2: Existing Lane Geometry at Study Intersections

Figure 2 shows the existing intersection lane geometry at each intersection. Figure 3 shows the AM and PM Peak hour turning movements at each intersection. Counts at Campolindo Dr and St. Mary’s Rd were conducted on September 4th, 2013. Counts at Rheem Blvd were conducted on April 17, 2012.

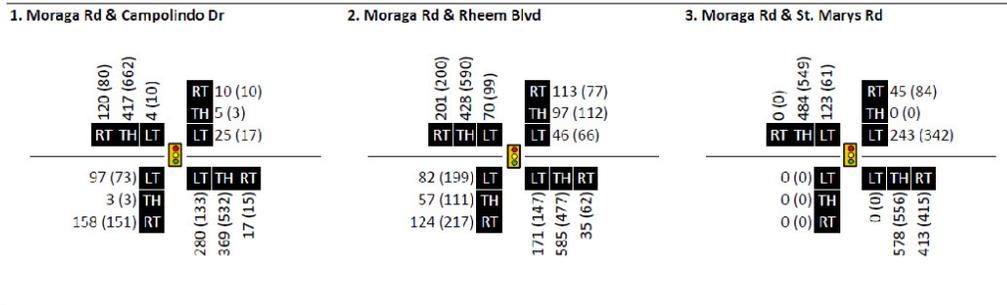
Figure 3: Existing AM and PM Peak Hour Turning Movements at Study Intersections

Notes: xx(yy) represents AM (PM) Peak Hour

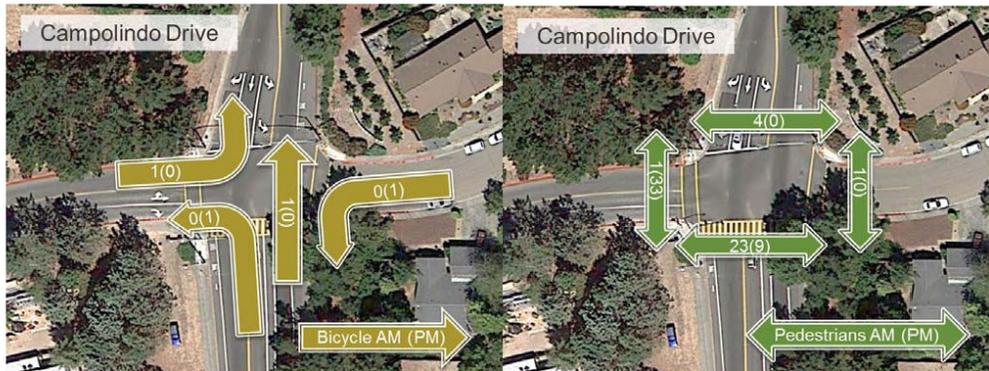
Figure 4: Existing AM and PM Peak Hour Bicycle and Pedestrian Volumes at Campolindo Drive

Figure 4 shows the bicycle and pedestrian flows for the intersection of Moraga Road and Campolindo Drive. Figure 5 Shows the bicycle and pedestrian flows for the intersection of Moraga Road and St. Mary’s Road. Counts at Campolindo Dr and St. Mary’s Rd were conducted on September 4th, 2013. Bicycle and pedestrian counts were not collected for Rheem Boulevard.

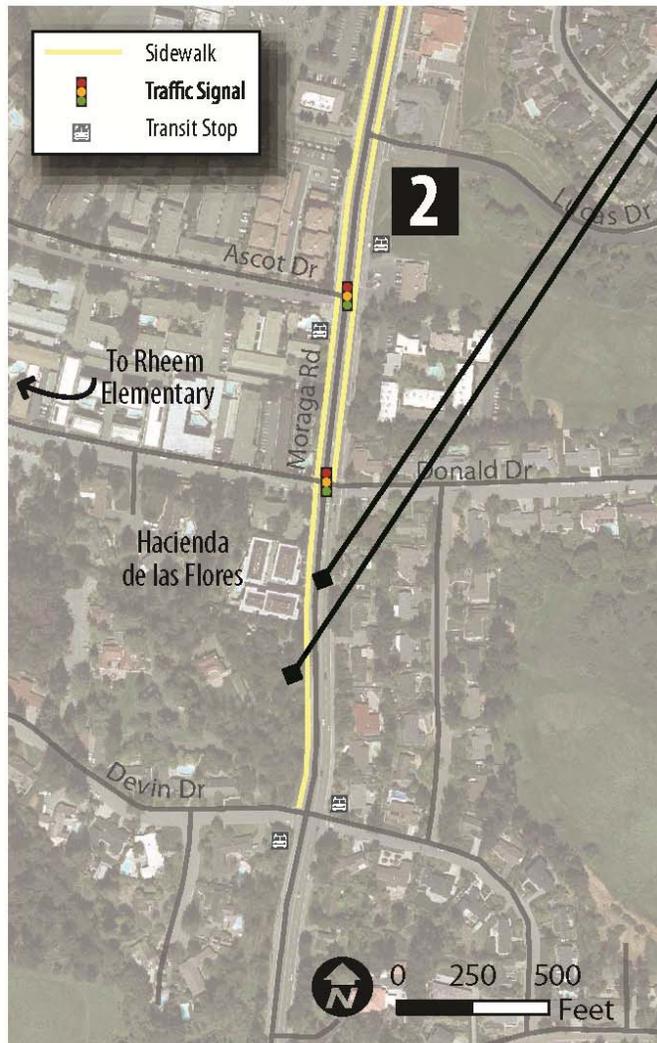
Figure B-9: Community Walking Route – Tour Stop 2: Ascot Drive to Devin Drive

Specific Locations

- No good way to cross road south of Donald Dr
- Entry to Hacienda poorly defined, poor signage

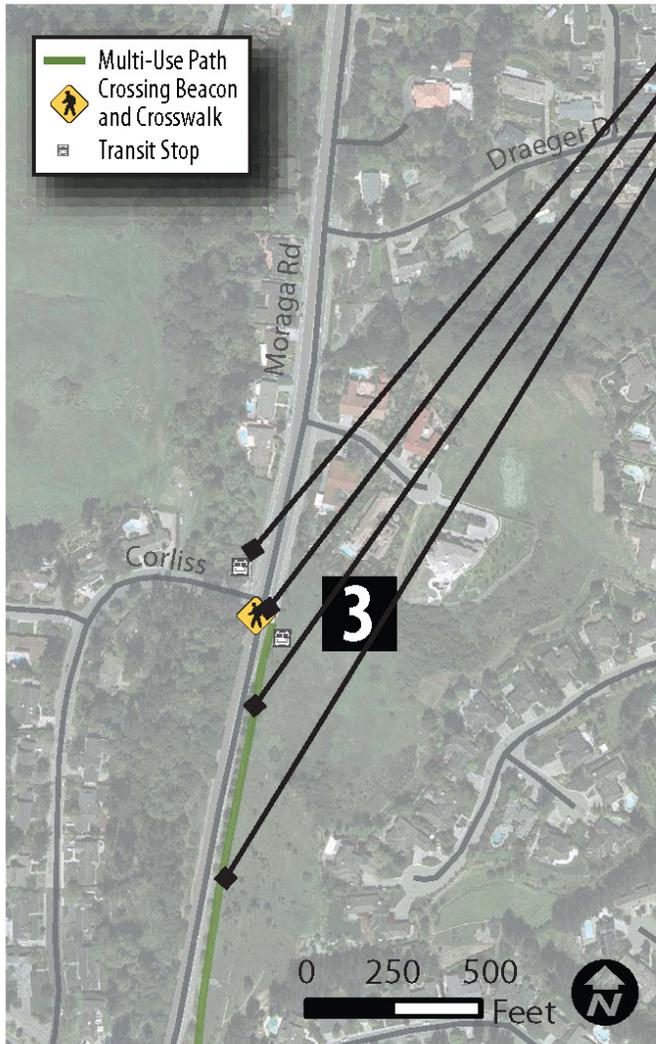
Figure B-10: Community Walking Route – Tour Stop 3: Corliss Drive

Specific Locations

- Bus stop complicates movements
- Need pedestrian signalhead so pedestrians know it's OK to cross
- Shrubs block bike path here
- Lots of cars driving 50 mph

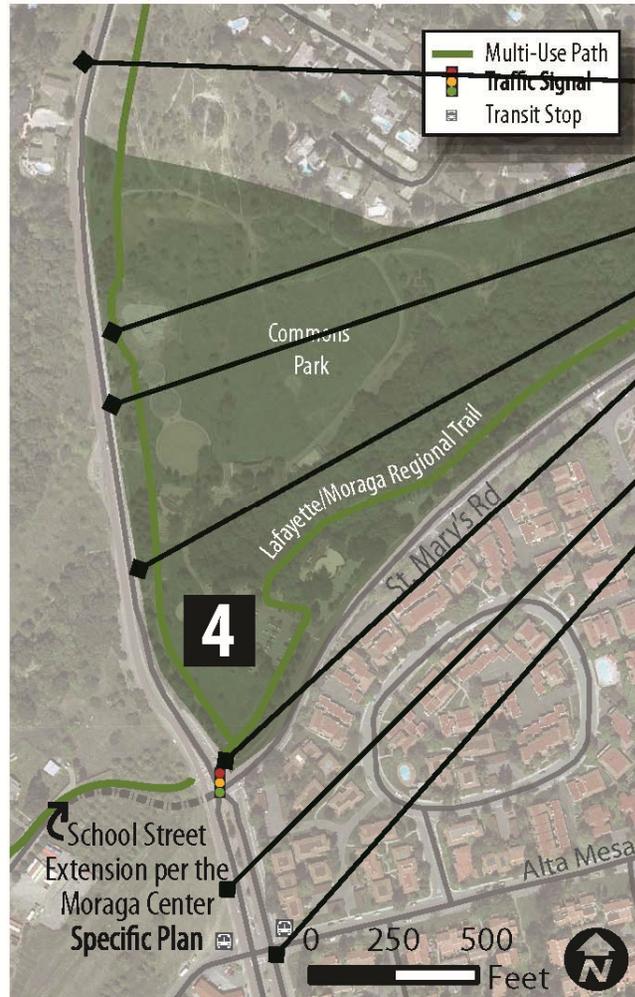
Figure B-11: Community Walking Route – Tour Stop 4: St. Mary's Road

Specific Locations

- Northbound on Moraga Rd past skatepark, people pass on the right as cars wait to turn left into cul-de-sac for three houses. Passing cars sometimes go off road and get stuck in the gutter

- Roadside lamp does nothing for traffic safety and only encourages skate park use after hours
- People illegally park outside new parking lot. Car tires kick-up gravel into bike lane, causing bikes to enter the vehicular lane

- Left turn into and out of parking lot feels dangerous
- Add benches and lookout at creek crossing
- Add a crosswalk on south side of the St. Mary's Street intersection

- Moraga Garden Club installed and maintains the landscaping at intersection
- Bike detection needed at the traffic signal
- Gateway opportunity at St. Mary's Road: connect the park, library, and shopping

- The overflow parking south of St. Mary's Road is located on private property
- From Alta Mesa, it is very difficult to make a left or go straight
- The crosswalk at Alta Mesa crosses two lanes of traffic in each direction; it can be hard for a motorist in the far lane to see a crossing pedestrian
