Livable Moraga Road Study and Design

Existing Conditions Summary Report

May 7, 2014

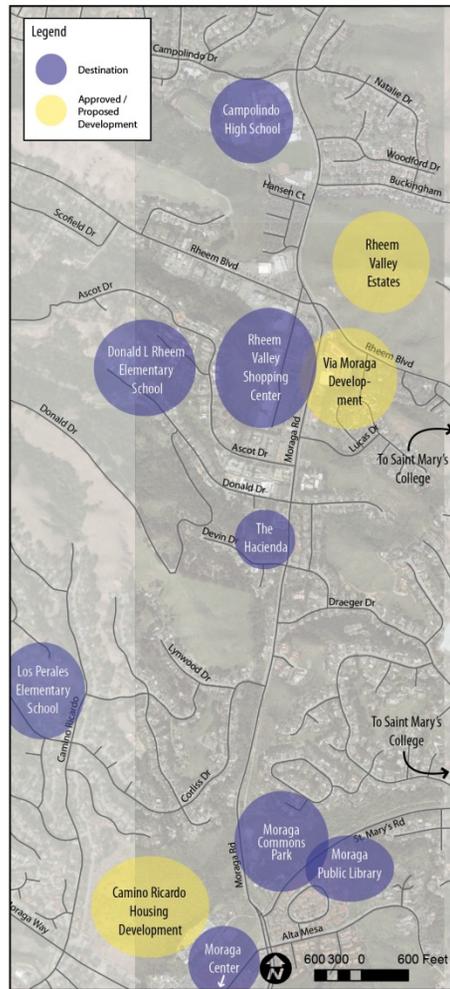
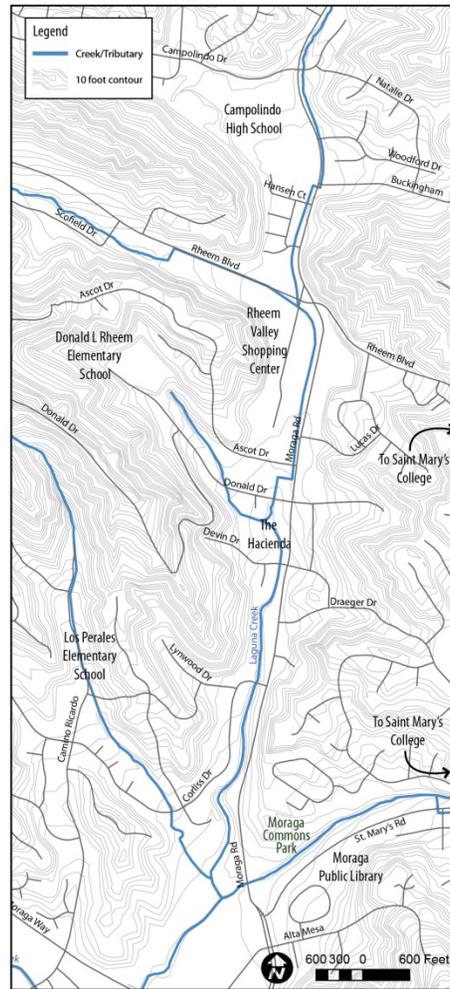
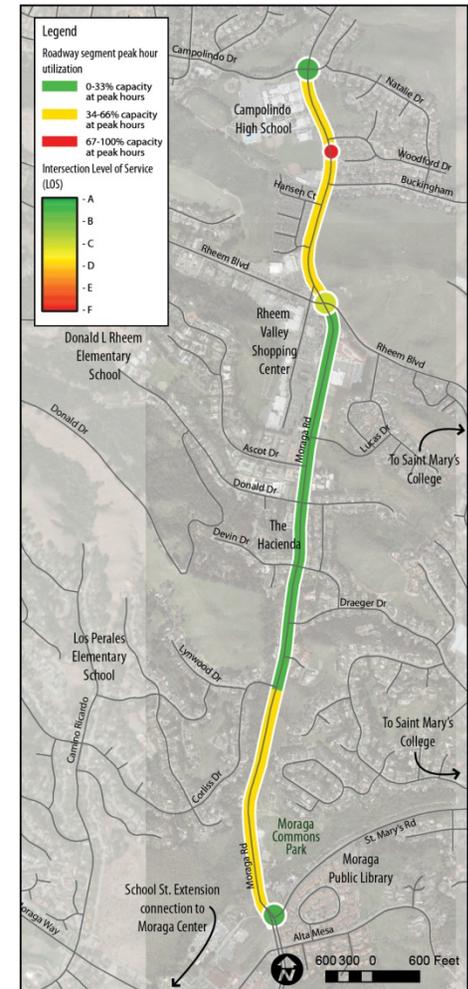
Figure 2-1: Key Destinations, Hydrology and Topography, and Traffic

Destinations

Hydrology + Topography

Traffic

Improving access to destinations along the Study Corridor is a key objective of the Livable Moraga Road project. Moraga Road runs through the center of the Town of Moraga and is bordered by single-family residential, open space, commercial, office, and institutional land uses. Many of the key destinations within the Study Corridor—Rheem Shopping Center, Campolindo High School, Donald L. Rheem and Los Perales elementary schools, and Hacienda de las Flores, which serves as a community center and event space—are located on the west side of Moraga Road (see **Figure 2-1**).

Road Tributary, northwest of the Moraga Road/.St. Mary's Drive intersection. The creek exists in an open channel, except where it is piped under roadways and developed areas (e.g., Rheem Valley Shopping Center). The creek is a hidden asset within the Study Corridor, creating opportunities for habitat viewing and interpretation. It also creates a constraint in some areas where riparian habitat exists very close to the road edge. Topography is also a constraint in some areas where there are steep upslopes or downslopes close to the roadway.

Moraga Road is the major north-south arterial road within the Town of Moraga. It has sections of two-lane as well as four-lane roadway. DKS Associates prepared an Existing Traffic Conditions Memorandum for the Study Corridor in December 2013 to better understand existing and future conditions within the Study Corridor (see **Appendix A** for the full Memorandum). Key findings are summarized below.

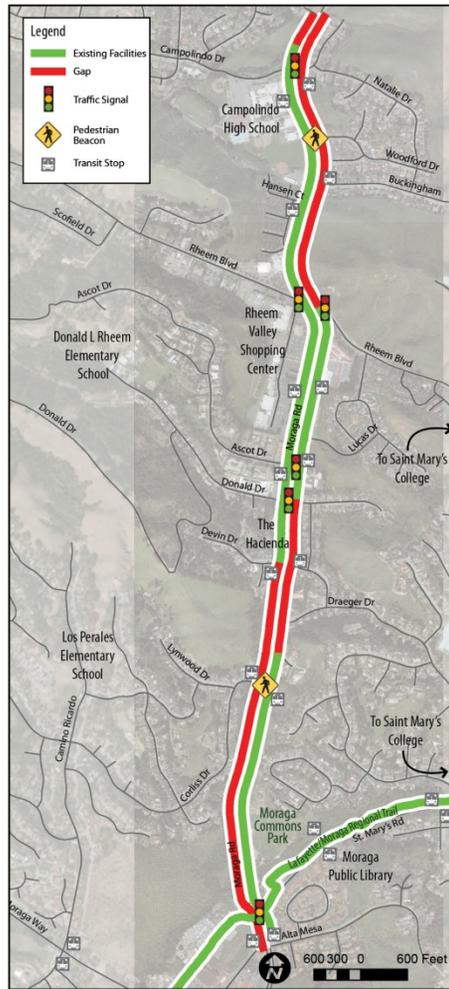
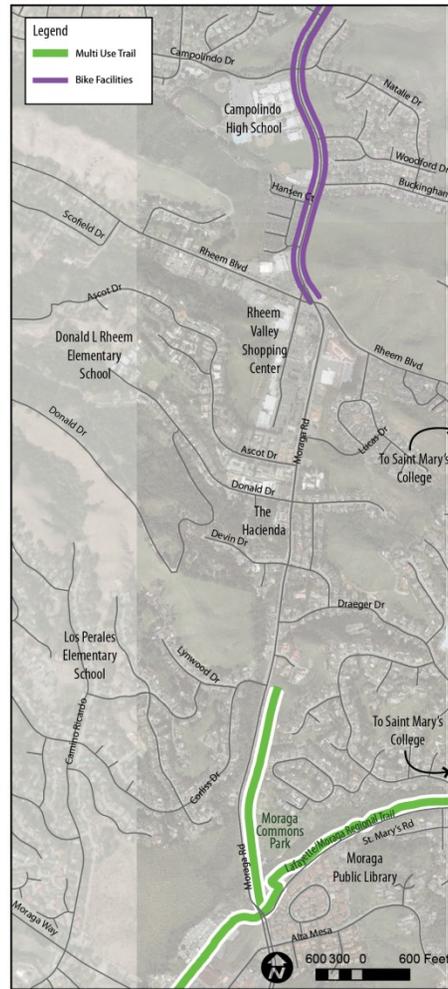
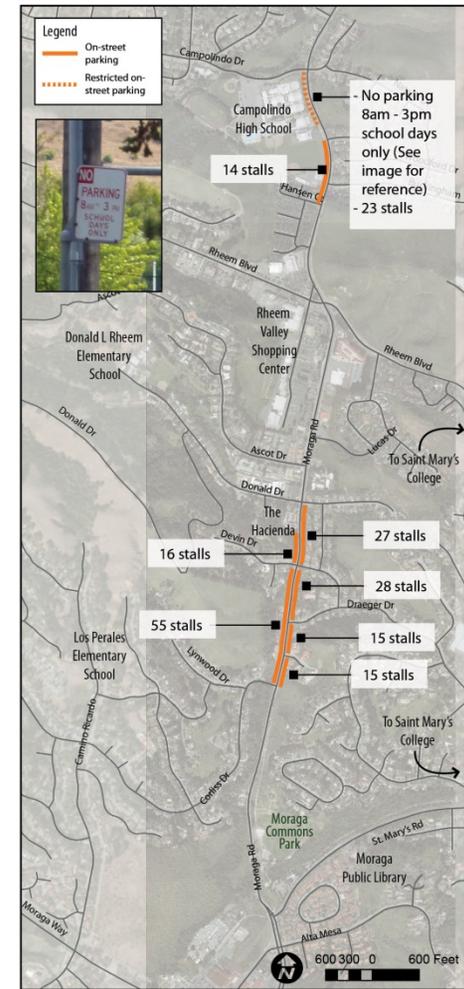
Figure 2-2: Pedestrian and Bicycle Facilities and On-Street Parking

Pedestrian Facilities

Trail + Bicycle Facilities

On-street Parking

Pedestrian facilities along the Study Corridor include sidewalks, the Moraga Spur Trail, and roadway crossings. **Figure 2-2** shows where pedestrian facilities exist (shown with green lines) and where there are gaps in the pedestrian network (shown with red lines). The sidewalk network on Moraga Road is inconsistent; some segments have narrow sidewalks and some segments do not have any designated sidewalks at all. During field observations, the consultant team observed pedestrians using the roadway shoulder for travel. Marked pedestrian crosswalks spanning Moraga Road are located at the following intersections: Campolindo Drive, Woodford Drive, Rheem Boulevard, Lucas Drive, Ascot Drive, Donald Drive, Corliss Drive, and St. Mary's Road.

Bikeways along the Study Corridor include bike lane segments and the Moraga Spur Trail (see **Figure 2-2**). Moraga Road has on-street bike lanes on both sides of the roadway from the Town Limits to Rheem Boulevard. Along the high school frontage, however, the bike lane also serves as a student drop off/pick up and parking aisle. Striped shoulders exist between Rheem Boulevard and St. Mary's Road. Parking is allowed in the shoulder between Donald Drive and Corliss Drive. Between Corliss Drive and St. Mary's Road, the Moraga Spur Trail (Class I Bike Path) parallels the east side of the roadway.

On-street parking is allowed in select areas along the Study Corridor (see **Figure 2-2**). Along the high school frontage north of Woodford Drive, parking is allowed on weekdays after 3:00 PM and before 8:00 AM and on weekends. Unrestricted parking is allowed along the high school frontage south of Woodford Drive, and between Donald Drive and Corliss Drive.

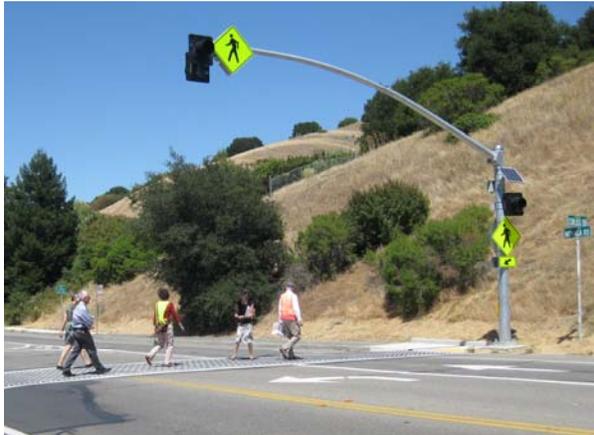
Figure 2-3 presents the site visit notes. The project team discussed various site conditions, including congestion near Campolindo High School during student pick-up and drop-off times, Rheem Valley Shopping Center access, previous planning efforts involving reconfiguration of the Rheem Boulevard intersection, and user behavior observed along the corridor (e.g., bicycling on sidewalks).

The project team traveled the site in July 2013 to observe conditions, issues, and opportunities

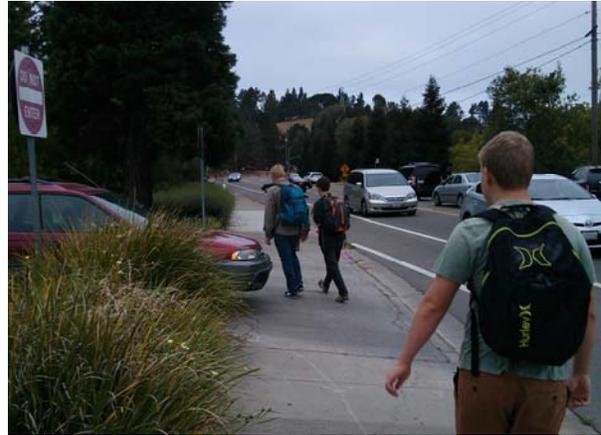
The consultant team conducted AM and PM school bell time observations on Wednesday, September 11th along Moraga Road near Campolindo High School and Donald L. Rheem Elementary School. The consultants observed pedestrian, bike, and vehicular activity, including school access and pickup and discharge activity, at each school and the nearest signalized intersections.

The project team observed morning and afternoon activity near Campolindo High School and Donald L. Rheem Elementary School

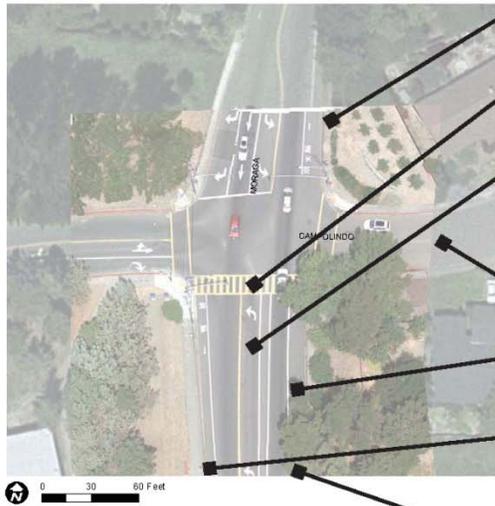
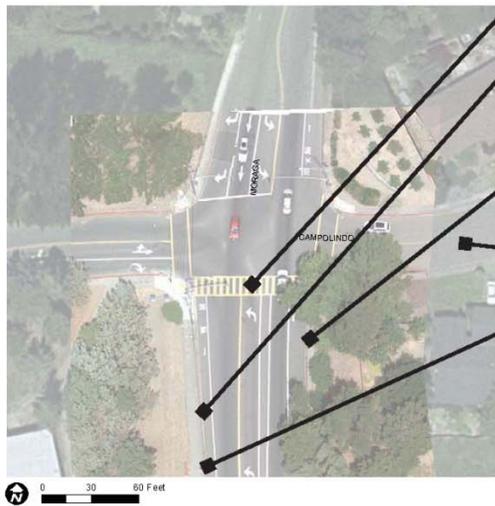
Figure 2-4: AM (top image) and PM (bottom image) School Bell Time Observations – Moraga Road and Campolindo Drive

Moraga Rd. at Campolindo Dr. (AM)

- There is no sidewalk on the east side of Moraga Road north of Campolindo Drive.
- Pedestrian wait time after activating push button varied from 1 minute 12 seconds to 15 seconds.
- Heavy northbound traffic flows. Some northbound motorists turning left onto Campolindo Drive must wait for a second traffic signal cycle to pass through the intersection.
- Parents observed dropping off students on the north and south sides of Campolindo Drive, east of Moraga Road.
- Some parents use the northbound bus stop as a student drop off. Students then cross at the crosswalk.
- Parents traveling south observed dropping off students south of the bus stop. Students access school on informal paths that lead up slope.
- There is no sidewalk on the east side of Moraga Road south of the bus stop.

Moraga Rd. at Campolindo Dr. (PM)

- Approximately 25 students observed using crosswalk.
- Approximately 15 students observed boarding the #6 bus southbound. Approximately 20 students observed boarding the #603 bus southbound.
- Eight students observed boarding the #6 bus northbound.
- Parents observed picking up students on the north and south sides of Campolindo Drive, east of Moraga Road.
- Parents observed picking up students south of the bus stop on the west side of the street. (Parking is not allowed on school days between 8am and 3pm.)

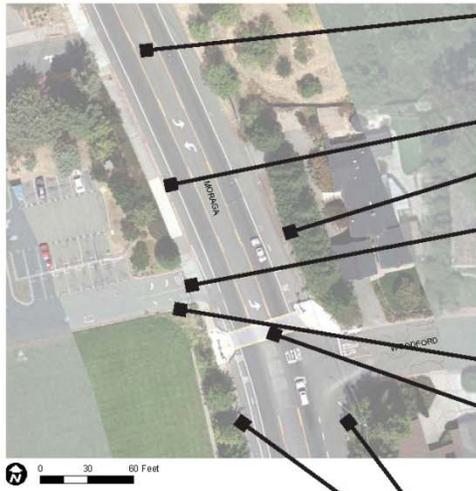
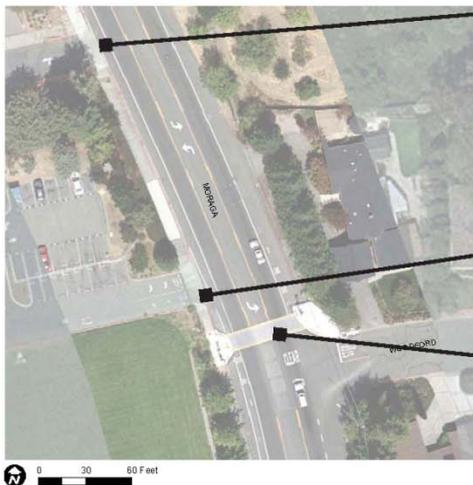
Figure 2-5: AM (top image) and PM (bottom image) School Bell Time Observations – Moraga Road and Woodford Drive

Moraga Rd. at Woodford (AM)

- Northbound motorists turning left into the school driveway back up in the center turn lane and across the crosswalk, blocking traffic turning left out of the school driveway.

- Drivers pull over to drop off students, blocking street.
- Drivers pull over after the crosswalk to drop off students.
- Visibility is poor for drivers pulling out of the driveway due to the curve of the street and vegetation. Drivers pull into the sidewalk and/or bike lane to get a better view of oncoming traffic.

- Students walk along the driveway.
- The crossing beacon is responsive to the push button. The rate at which motorists yield to pedestrians/bicyclists in the crosswalk is high. Most students activate the beacon before crossing. Partial curb extension on west side improves visibility of pedestrians and discourages drivers from blocking the crosswalk.

- Northbound bicyclists ride wrong way in the sidewalk and use the bike lane.

Moraga Rd. at Woodford (PM)

- Southbound motorists turning right into the school driveway back up along Moraga Road, parking in the parking lane. One motorist was observed straddling the crosswalk for half an hour. This blocked both the crosswalk and, partially, the southbound through lane on Moraga Road, forcing southbound through traffic to maneuver into the middle turn lane where northbound motorists were waiting to turn left into the driveway.
- Motorists turning right onto Moraga Road often move quickly to enter a gap in traffic, some without looking to the right to check for pedestrians and bicyclists in the crosswalk.
- Almost all students activated the crossing beacon to cross. Most, but not all, motorists yielded to pedestrians in the crosswalk.

- Near Woodford Drive during the morning bell time, northbound motorists turning left into the school driveway back up in the center turn lane and across the crosswalk, blocking traffic turning left out of the school driveway

- Near Woodford Drive during the afternoon bell time, southbound motorists turning right into the school driveway back up along Moraga Road, forcing southbound through traffic to maneuver into the middle turn lane where northbound motorists wait to turn left into the driveway

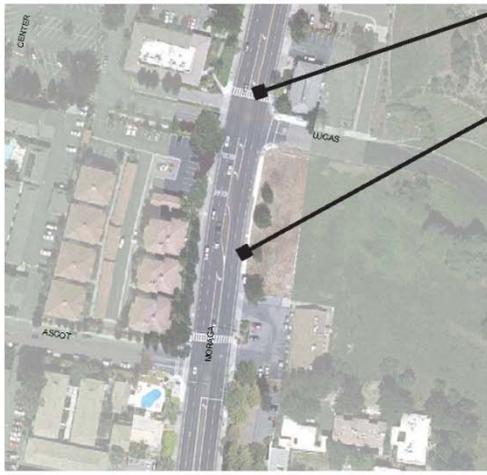
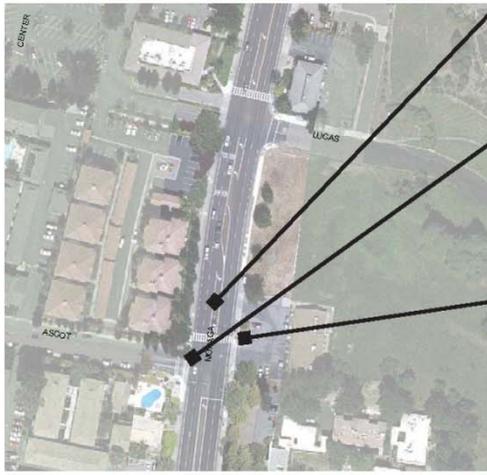
Figure 2-6: AM (top image) and PM (bottom image) School Bell Time Observations – Moraga Road between Lucas Drive and Ascot Road

Moraga Rd. between Lucas Dr. and Ascot Rd. (AM)

Mostly recreational walkers in the morning. No pedestrians observed crossing at the uncontrolled crosswalk north of Lucas Drive.

Many school-age bicyclists traveled north on Moraga Road, likely headed toward the high school. Eleven northbound bicyclists were observed, of which nine were youth. Most used the bike lane, but three bicyclists traveled northbound on the west sidewalk of Moraga Road. Many seemed to have entered Moraga Road from Ascot Road.

Moraga Rd. between Lucas Dr. and Ascot Rd. (PM)

It is unclear that the elementary school drop-off and pick-up periods affected traffic volumes. No discernible change in traffic volume and no marked shift in the number/age of passengers in vehicles.

A handful of parents with small children in the afternoon, all walking north on the east sidewalk, and most of whom turned left onto Ascot Road. No pedestrians observed crossing at the uncontrolled crosswalk north of Lucas Drive. One pedestrian crossed at mid-block.

One leg of the intersection at Ascot Road is the driveway to the 7-11. Pedestrians walking along the west side of Moraga Road have a pedestrian signal to cross this entrance.

- Many school-aged bicyclists observed traveling north during the morning bell time; most used the shoulder, but some used the west side sidewalk
- It is unclear whether the elementary school drop-off and pick-up periods affect traffic volumes

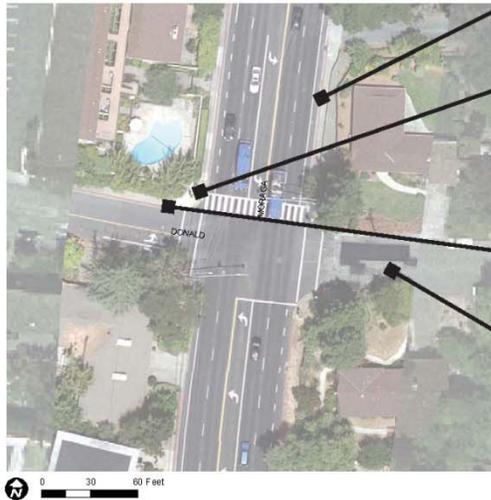
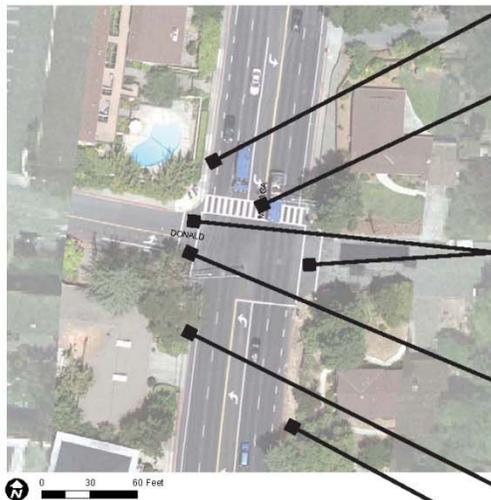
Figure 2-7: AM (top image) and PM (bottom image) School Bell Time Observations – Moraga Road and Donald Road

Moraga Rd. at Donald Rd. (AM)

- Eleven school-age bicyclists observed riding north in the shoulder.
- Signals include pedestrian push buttons. The southeast corner of the intersection does not include a sidewalk or curb ramp. The signal posts and a utility box at the back of sidewalk on the northwest corner of the intersection create a tight clearance, which is difficult to navigate with stroller.
- Donald Drive west of Moraga Road includes a sidewalk on the north side only.
- Donald Drive east of Moraga Road is not a through street, allows onstreet parking and does not include sidewalks.

Moraga Rd. at Donald Rd. (PM)

- Some parents with school-aged children observed walking east on Donald Drive then north on Moraga Road.
- School-age children were observed running in the crosswalk across Moraga Road. Eight pedestrians used the crosswalk during observation period. Short, six second wait time between push button activation and pedestrian crossing phase.
- 25% of pedestrians crossing Donald Drive did not activate the push button. Six pedestrians observed using the western crosswalk and three pedestrians observed using the eastern crosswalk.
- Eastbound cars turning onto Moraga Road (north- and southbound) observed blocking the crosswalk. Sightlines are limited due to vegetation and grade.
- There are sidewalk gaps on the west side of Moraga Road.
- There is no sidewalk south of Donald Drive on Moraga Road. Pedestrians walk and jog in northbound bike lane.

- 11 school-aged bicyclists observed traveling north in the shoulder during the morning bell time
- Sidewalk obstructions (e.g., signal poles, utility boxes) limit the usable portion of the sidewalk in some locations
- Drivers encroach into the western crosswalk
- Sightlines on Donald Drive are limited due to vegetation and grade
