# School Bell Time Observations

# Campolindo High School Cross Country Team Survey Results

# Walking Tour Notes

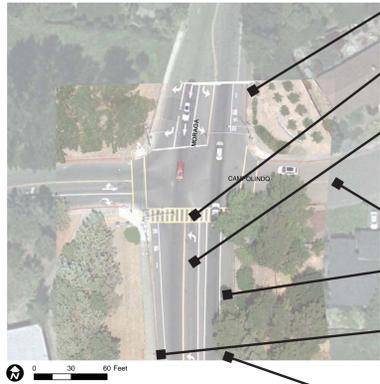
## Moraga Rd. at Campolindo Dr. (AM)

- There is no sidewalk on the east side of Moraga Road north of Campolindo Drive.
- Pedestrian wait time after activating push button varied from 1 minute 12 seconds to 15 seconds.
- Heavy northbound traffic flows. Some northbound motorists turning left onto Campolindo Drive must wait for a second traffic signal cycle to pass through the intersection.
- Parents observed dropping off students on the north and south sides of Campolindo Drive, east of Moraga Road.
- Some parents use the northbound bus stop as a student drop off. Students then cross at the crosswalk.
- Parents traveling south observed dropping off students south of the bus stop. Students access school on informal paths that lead up slope.
- There is no sidewalk on the east side of Moraga Road south of the bus stop.

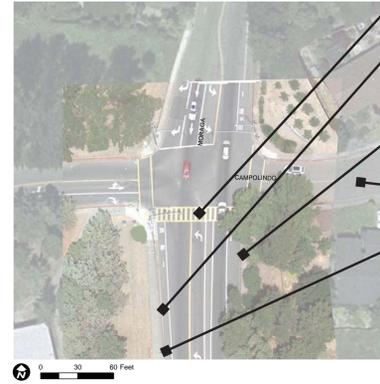
## Moraga Rd. at Campolindo Dr. (PM)

- Approximately 25 students observed using crosswalk.
- Approximately 15 students observed boarding the #6 bus southbound. Approximately 20 students observed boarding the #603 bus southbound.
- Eight students observed boarding the #6 bus northbound.
- Parents observed picking up students on the north and south sides of Campolindo Drive, east of Moraga Road.
- Parents observed picking up students south of the bus stop on the west side of the street. (Parking is not allowed on school days between 8am and 3pm.)

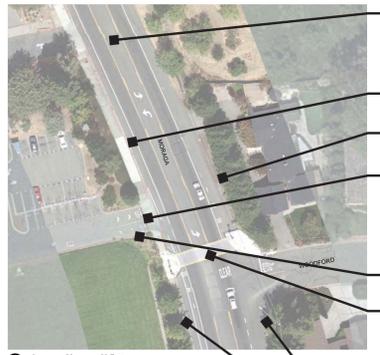
## Moraga Rd. at Woodford (AM)

- Northbound motorists turning left into the school driveway back up in the center turn lane and across the crosswalk, blocking traffic turning left out of the school driveway.

- Drivers pull over to drop off students, blocking street.
- Drivers pull over after the crosswalk to drop off students.
- Visibility is poor for drivers pulling out of the driveway due to the curve of the street and vegetation. Drivers pull into the sidewalk and/or bike lane to get a better view of oncoming traffic.

- Students walk along the driveway.
- The crossing beacon is responsive to the push button. The rate at which motorists yield to pedestrians/bicyclists in the crosswalk is high. Most students activate the beacon before crossing. Partial curb extension on west side improves visibility of pedestrians and discourages drivers from blocking the crosswalk.

- Northbound bicyclists ride wrong way in the sidewalk and use the bike lane.

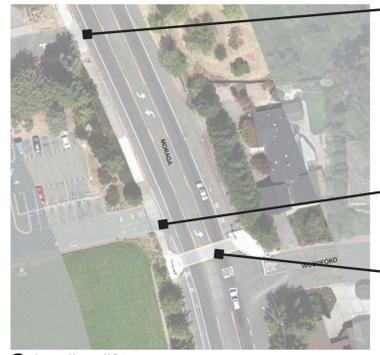
## Moraga Rd. at Woodford (PM)

- Southbound motorists turning right into the school driveway back up along Moraga Road, parking in the parking lane. One motorist was observed straddling the crosswalk for half an hour. This blocked both the crosswalk and, partially, the southbound through lane on Moraga Road, forcing southbound through traffic to maneuver into the middle turn lane where northbound motorists were waiting to turn left into the driveway.
- Motorists turning right onto Moraga Road often move quickly to enter a gap in traffic, some without looking to the right to check for pedestrians and bicyclists in the crosswalk.
- Almost all students activated the crossing beacon to cross. Most, but not all, motorists yielded to pedestrians in the crosswalk.

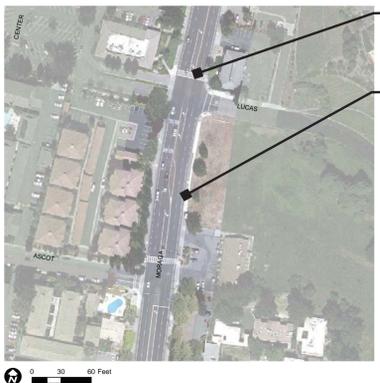
## Moraga Rd. between Lucas Dr. and Ascot Rd. (AM)

- Mostly recreational walkers in the morning. No pedestrians observed crossing at the uncontrolled crosswalk north of Lucas Drive.
- Many school-age bicyclists traveled north on Moraga Road, likely headed toward the high school. Eleven northbound bicyclists were observed, of which nine were youth. Most used the bike lane, but three bicyclists traveled northbound on the west sidewalk of Moraga Road. Many seemed to have entered Moraga Road from Ascot Road.

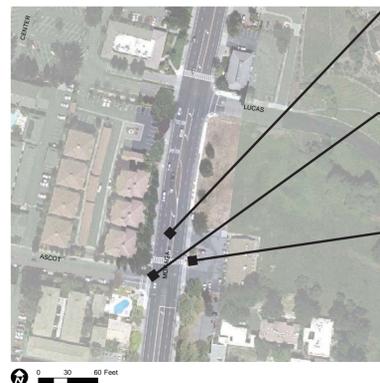
## Moraga Rd. between Lucas Dr. and Ascot Rd. (PM)

- It is unclear that the elementary school drop-off and pick-up periods affected traffic volumes. No discernible change in traffic volume and no marked shift in the number/age of passengers in vehicles.
- A handful of parents with small children in the afternoon, all walking north on the east sidewalk, and most of whom turned left onto Ascot Road. No pedestrians observed crossing at the uncontrolled crosswalk north of Lucas Drive. One pedestrian crossed at mid-block.
- One leg of the intersection at Ascot Road is the driveway to the 7-11. Pedestrians walking along the west side of Moraga Road have a pedestrian signal to cross this entrance.

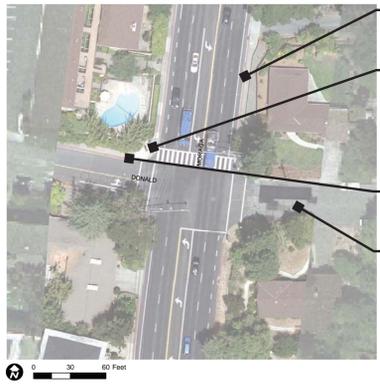
## Moraga Rd. at Donald Rd. (AM)

- Eleven school-age bicyclists observed riding north in the shoulder.
- Signals include pedestrian push buttons. The southeast corner of the intersection does not include a sidewalk or curb ramp. The signal posts and a utility box at the back of sidewalk on the northwest corner of the intersection create a tight clearance, which is difficult to navigate with stroller.
- Donald Drive west of Moraga Road includes a sidewalk on the north side only.
- Donald Drive east of Moraga Road is not a through street, allows onstreet parking and does not include sidewalks.

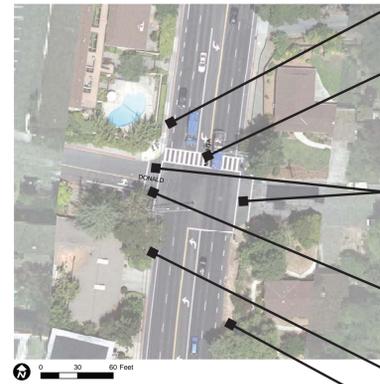
## Moraga Rd. at Donald Rd. (PM)

- Some parents with school-aged children observed walking east on Donald Drive then north on Moraga Road.
- School-age children were observed running in the crosswalk across Moraga Road. Eight pedestrians used the crosswalk during observation period. Short, six second wait time between push button activation and pedestrian crossing phase.
- 25% of pedestrians crossing Donald Drive did not activate the push button. Six pedestrians observed using the western crosswalk and three pedestrians observed using the eastern crosswalk.
- Eastbound cars turning onto Moraga Road (north- and southbound) observed blocking the crosswalk. Sightlines are limited due to vegetation and grade.
- There are sidewalk gaps on the west side of Moraga Road.
- There is no sidewalk south of Donald Drive on Moraga Road. Pedestrians walk and jog in northbound bike lane.

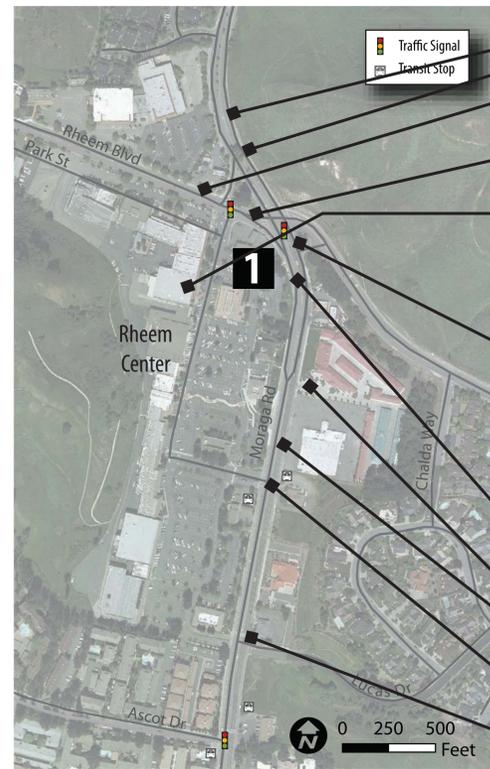
## Tour Stop 1: Rheem Center

- Traffic backs up from Campolindo to Rheem
- Trees in the median block motorist sight lines of pedestrians and cyclists
- More queue space is needed on Rheem for left turns onto Moraga Rd

- Lights too fast for all of the lights at the 2 intersections here. A 4-way pedestrian crossing could help
- Could streamline and consolidate into just one main intersection with wider turn lanes and more pedestrian friendly path

- The post office is a destination, but it's hard to get to
- No audible signal at crosswalk
- Walking routes through the Moraga Road/Rheem Boulevard intersection are circuitous

- Hard to watch for cars and pedestrians in the unrestricted right turn lanes
- Can't get from Nation's to Rheem Boulevard/Moraga Road crossing without jaywalking

- Driving southbound on Moraga Road, after Rheem Boulevard, the right jog in road is too sharp for 35 mph
- Consider placing a concrete urn at the north end of the traffic island on Moraga Road as a gateway feature

- Consider that people walking to the Rheem Center from the new Via Moraga housing development (Bowling Alley site) may jay-walk
- Replace two-way turn lane with landscape median and turn pockets

- Consider a crosswalk between the bus stops; people take the bus to shop but then walk out of direction or jay-walk to get to the other side of the street to catch the bus home

- Northbound buses block traffic
- Consider lighting and yield teeth (a line of white triangular pavement markings) at the crosswalk at Lucas Drive to improve visibility of the crossing

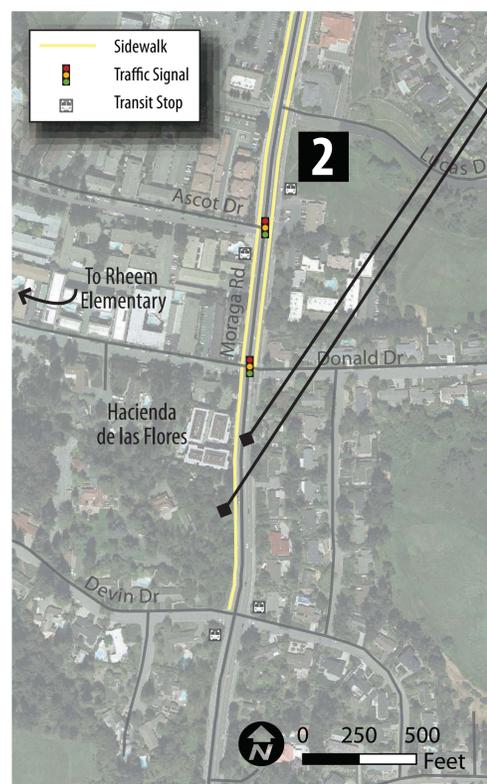
## Tour Stop 2: Ascot Drive to Devin Drive

- No good way to cross road south of Donald Dr
- Entry to Hacienda poorly defined, poor signage

- Enhance amenities for transit stops
- No street lighting; very dark at night
- Increase bus service. Free bus service would be ideal
- Elementary schools have bus service; the high school has one bus
- Cars park on shoulder
- Cars turning into and backing out of driveways can block traffic
- Driving - don't need more stop lights, existing turn lanes (left) are sufficient

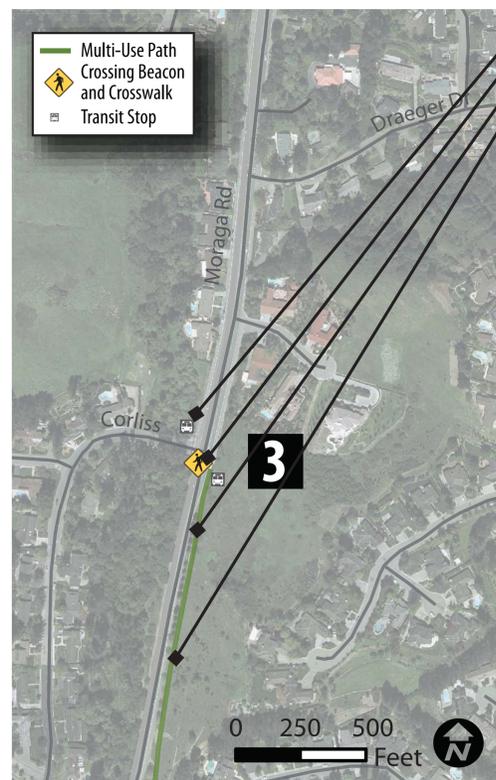
## Tour Stop 3: Corliss Drive

- Bus stop complicates movements
- Need pedestrian signalhead so pedestrians know it's OK to cross
- Shrubs block bike path here
- Lots of cars driving 50 mph

- Put utility lines underground
- Inconsistent crosswalk treatments along Moraga Road
- Cracks in the pavement
- Kids ride the wrong way and wear dark clothes
- Northbound sightlines are not great due to hill

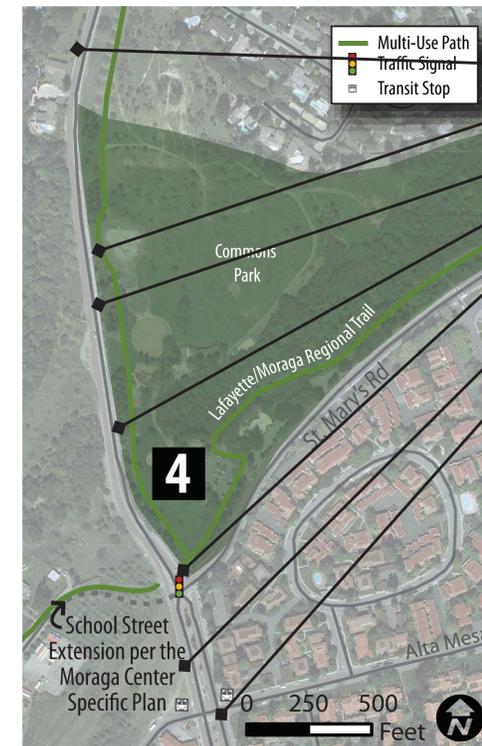
## Tour Stop 4: St. Mary's Road

- Northbound on Moraga Rd past skatepark, people pass on the right as cars wait to turn left into cul-de-sac for three houses. Passing cars sometimes go off road and get stuck in the gutter

- Roadside lamp does nothing for traffic safety and only encourages skate park use after hours
- People illegally park outside new parking lot. Car tires kick-up gravel into bike lane, causing bikes to enter the vehicular lane

- The overflow parking south of St. Mary's Road is located on private property
- From Alta Mesa, it is very difficult to make a left or go straight
- The crosswalk at Alta Mesa crosses two lanes of traffic in each direction; it can be hard for a motorist in the far lane to see a crossing pedestrian

- Left turn into and out of parking lot feels dangerous
- Add benches and lookout at creek crossing
- Add a crosswalk on south side of the St. Mary's Street intersection

- Consider undergrounding the power lines to make room for improvements
- Reach out to Mom's Council at Church, middle schools, high schools
- Improve routes kids take to get to schools in this area
- Benches, water fountains, bike racks, and restrooms would encourage more pedestrian use
- More foot traffic to Moraga Center is good for business
- A better bike connection to get to the shopping center is needed
- No sidewalk or bike lanes
- Traffic is worst near Miramonte and Campolindo
- Need overflow parking for Commons Park
- With the new parking lot, fewer people park on the street where they would open doors near traffic--good improvement
- Traffic flow functions well in this area
- There is a year-round Farmers Market from 9am-1pm Sundays at the Moraga Center.
- Opportunity to get more public input on the project?
