# 2019 Addendum to the Storm Drain Master Plan

## Town Moraga

November 2019

# FINAL Storm Drain Operations & Maintenance Plan

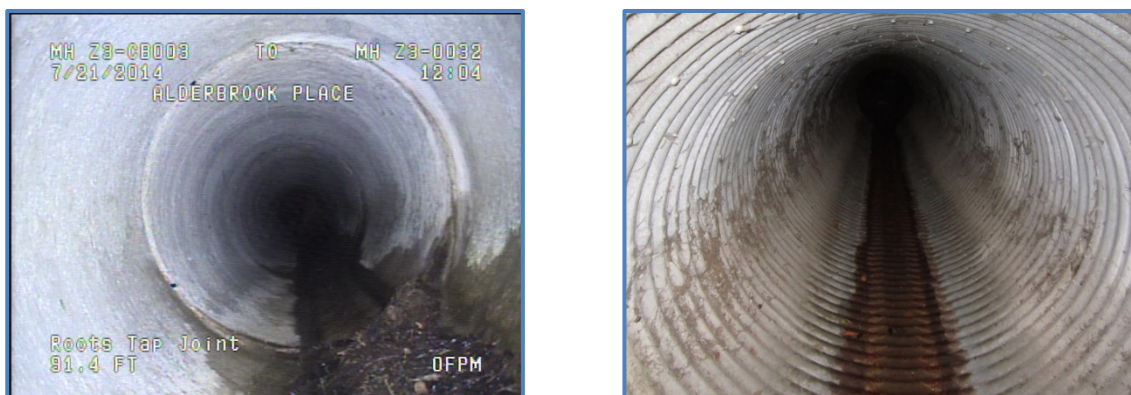
Figure 2-1. Typical Public Storm Drain Pipes – RCP (left) and CMP (right)

Pipes are installed under public roads to convey the runoff generated from the roads and surrounding properties to the creek systems. The town has roughly 1,092 pipes mapped that cover a length of 20.8 miles. The majority of the pipes, roughly 88%, are made of reinforced concrete pipe (RCP), then about 7% of corrugated metal pipe (CMP), with a handful of plastic pipes made of polyvinyl chloride (PVC) or high-density polyethylene (HDPE) material. The pipe diameters start as low as 10 inches and get bigger as the drainage area increases and the pipes get closer to the creek systems where they eventually discharge. Figure 2-1 below shows typical RCP and CMP pipes in the Town of Moraga.

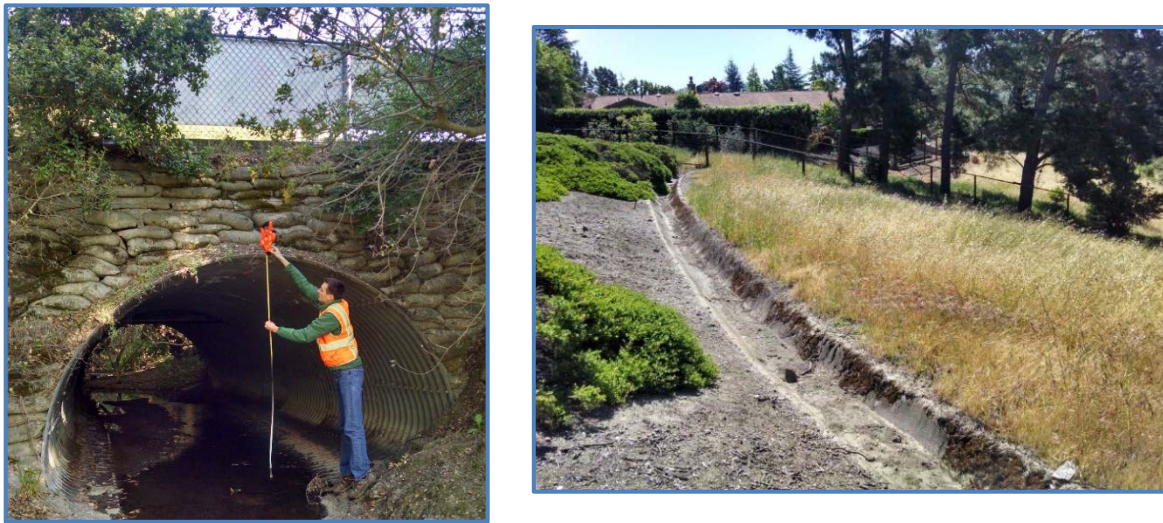
**Figure 2-3. Creek Culvert (left) and Concrete Lined Ditch (right)**

When a roadway crosses a stream or creek, a culvert is constructed to convey the creek or stream under the roadway. These culverts should be designed to convey the 100-year storm event. The newly collected GIS data shows 46 culverts in the Town, of which 23 cross under private roadways and are maintained by the private property owners or through a Homeowner Association (HOA). Figure 2-3 shows a typical creek culvert.

There are two types of ditches in the Town of Moraga - concrete or asphalt-lined v-ditches and earthen or vegetated ditches. The majority of the ditches throughout the Town are located on private property or hillside slopes and were constructed by developers to develop the land. There are also ditches along the roadside that convey water under private driveways. The Town maintains ditches that are shown in Figure 2-2 which are classified as M-Ditches. There is approximately 2,100 linear feet of M-Ditches that are maintained by the Town. Many of the ditches throughout the Town are not mapped in the Town's GIS due to access issues. A typical concrete lined ditch is shown in Figure 2-3.

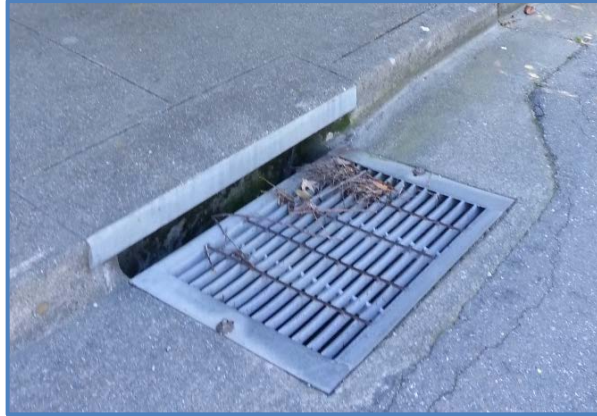
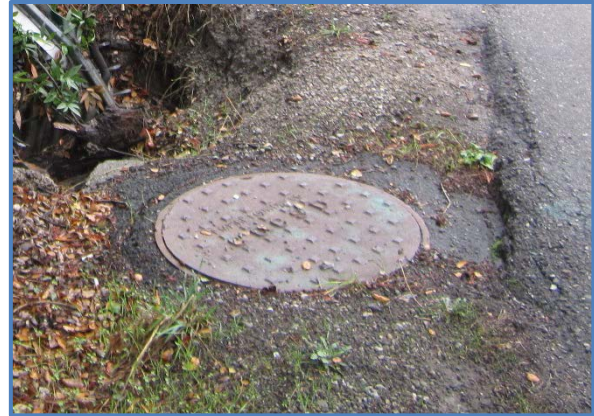
**Figure 2-4. Storm Drain Inlet (left) Storm Drain Manhole (right)**

A manhole is constructed to connect two pipes at a bend in a pipe or at a location to provide access to the pipe system for cleaning and maintenance. A manhole has a solid lid that can be removed to inspect or clean the pipes. Figure 2-5 (right) shows a typical manhole in the Town.

Storm drain inlets allow surface runoff to enter into the underground storm drain pipes. Storm drain inlets are typically located on a curb at the low point in a street to collect the runoff that flows by gravity to the inlet. The Town has approximately 754 publicly-owned storm drain inlets. Figure 2-4 (left) shows a typical inlet on the left.

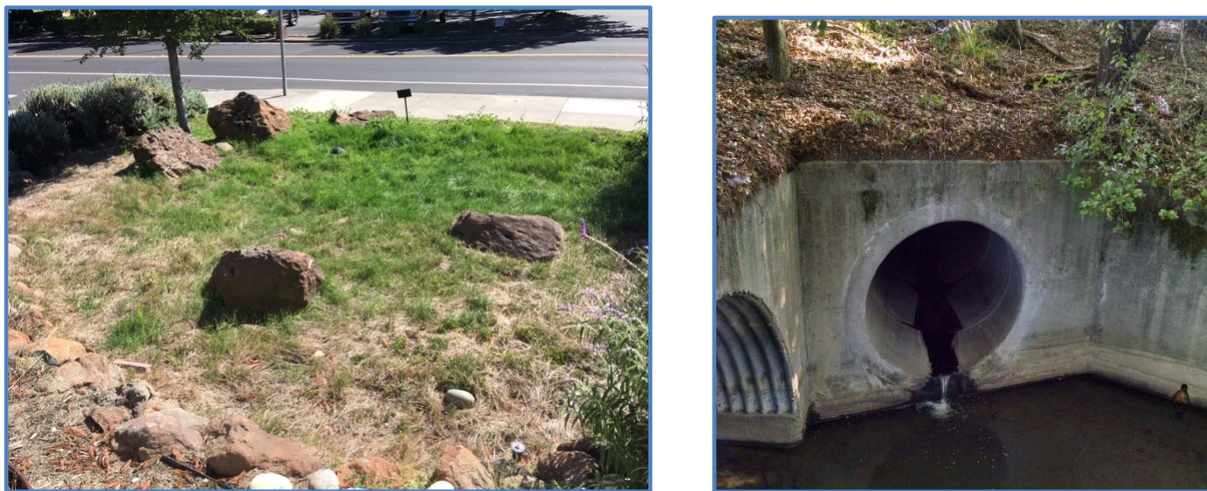
**Figure 2-5. Bioretention Basin (left) Storm Drain Outfall (right)**

A bioretention basin is designed to detain and infiltrate runoff through a soil media to remove the pollutants. It is known as a low impact development (LID) that is required under the Municipal Regional Permit (MRP). Bioretention basins are typically required of private new and redevelopment projects. The Town has two bioretention basins - one at the Corp Yard and the other near Commons Park. Figure 2-5 shows one of the Town's bioretention basins.

An outfall is where a pipe, culvert, or ditch that discharges storm water into a receiving water body. In the Town of Moraga, there are approximately 245 mapped outfalls where Stormwater enters into a creek or stream. Of the 245 mapped outfalls, approximately 114 outfalls that are located in public right-of-way or public property. The rest of the outfalls are located on private property. Figure 2-5 shows an outfall pipe in the Town.

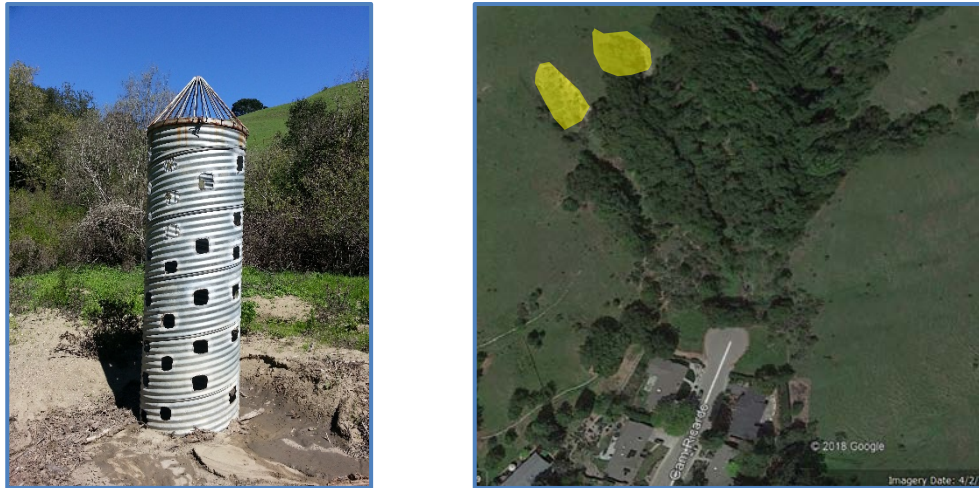
**Figure 3-1. Missouri Riser Structure (left) Active Landslide Areas in Yellow (right)**

A sedimentation basin is designed to hold back water to allow sediment to settle out rather than being conveyed downstream. The Town has a sedimentation basin at the end of El Camino Ricardo Street that is controlled by a structure called a "Missouri Riser" that detains runoff from the hillside and allows sediment to settle out. Figure 3-1 shows the Missouri Riser structure and the sediment basin.

There is a sedimentation basin controlled by a Missouri Riser structure (Figure 3-1) located at the end of El Camino Ricardo Street. Each year, the basin fills up with sediment that is deposited when the runoff is held back by the Missouri Riser, which is the purpose of the basin and riser. The removal of the sediment can cost the Town up to \$15,000 per year. The source of the sediment has been identified as active landslides on the steep hillslopes above the sedimentation basin. In order to reduce the amount of sediment that needs to be removed each year, Schaaf & Wheeler researched materials and developed a conceptual project to stabilize the hillside by installing geotextile products and replanting vegetation to hold the soil in place. When costing out this project, it was determined that to properly stabilize the steep hillside, the project would cost upwards of \$800,000. Since the maintenance of this basin over the course of ten years is significantly less than the project cost, the annual cleaning fee has been included into the annual operations and maintenance budget for the Town in Table 6-1.

Town staff has requested that the sedimentation basin design and the excavation of the sediments be optimized to potentially reduce the annual maintenance budget required. So instead of a construction project, N05 is a study to value engineer the sedimentation basin and optimize the excavation of the sediments. This study is estimated to cost around \$20,000 and is included in the list of projects in Table 5-1 as a high priority project. If the study determines that a construction project could improve the function of the sedimentation basin and reduce the annual maintenance cost, the Town staff may elect to use the money set aside for maintenance to construct improvements to the basin.

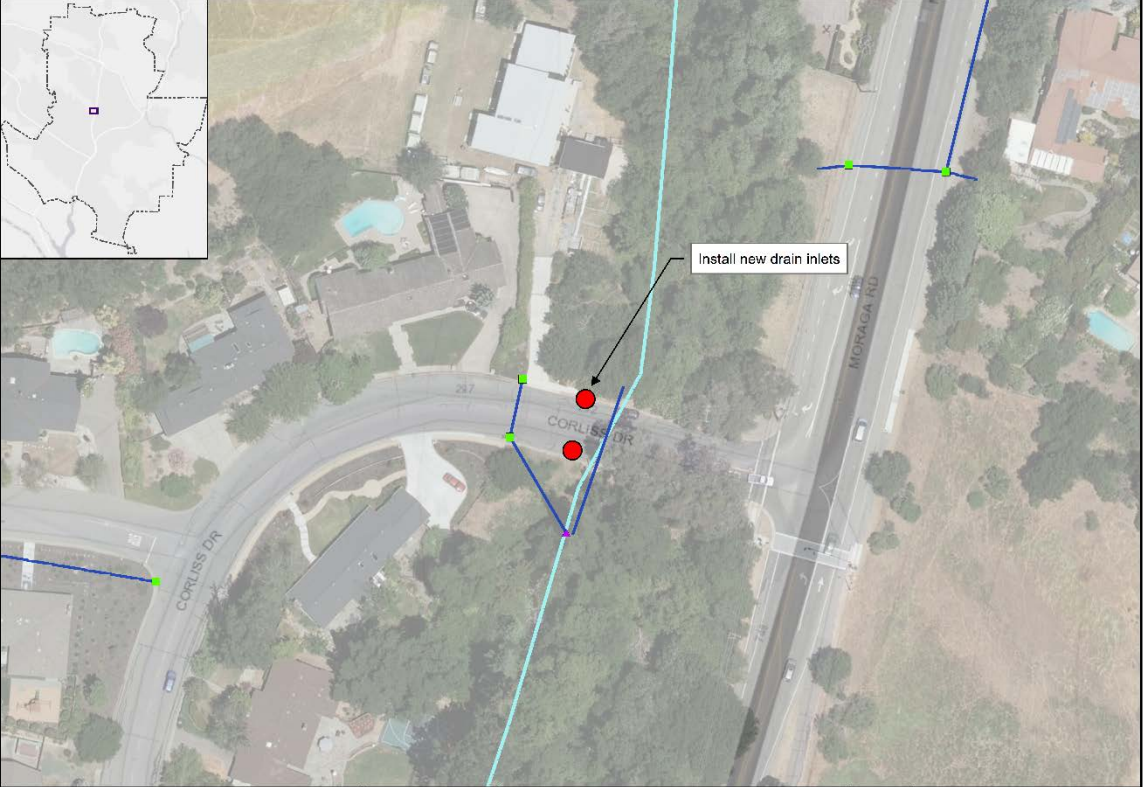
| <p><b>Project Description:</b> Install two additional storm drain inlets on Corliss drive and two new outlets to the creek to prevent surface ponding on Corliss Drive. The existing two storm drain inlets are not sufficient to drain the street.</p> | | | | | | | | | | | | | | |

A project to mitigate nuisance flooding caused by storm drain inlets and pipes clogging on Corliss Drive near the crossing of Laguna Creek was identified in the 2015 SDMP. This project was categorized as a pipe maintenance project in the 2015 SDMP, but further investigation by Town staff has identified the need to install additional catch basins to allow roadway runoff to enter into the drain inlets and drain to Laguna Creek. Schaaf & Wheeler worked with Town staff to develop a conceptual design and cost estimate for this project.
