# Moraga Storm Drain Master Plan

**Town of Moraga**

**July 2015**

**Schaaf & Wheeler**  
CONSULTING CIVIL ENGINEERS

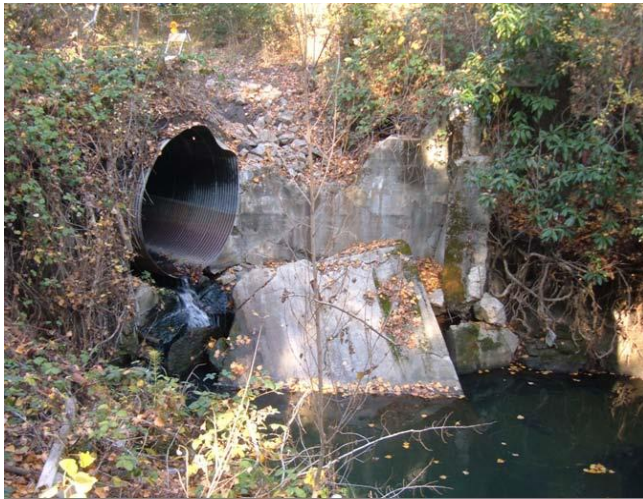
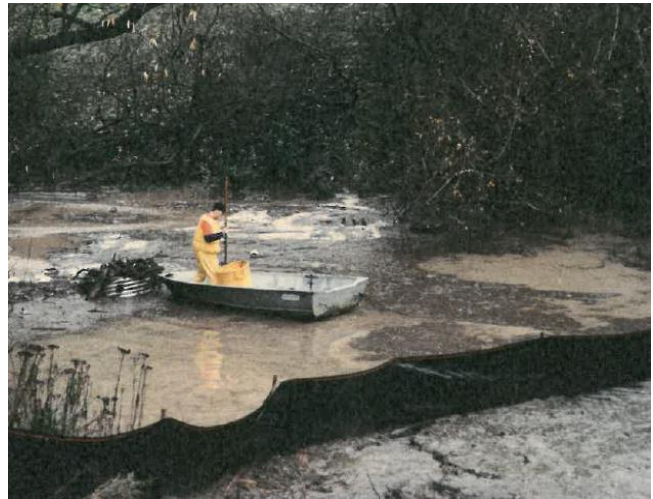
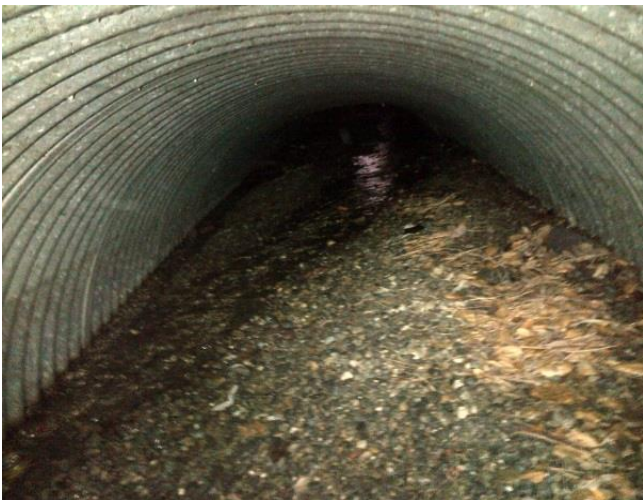
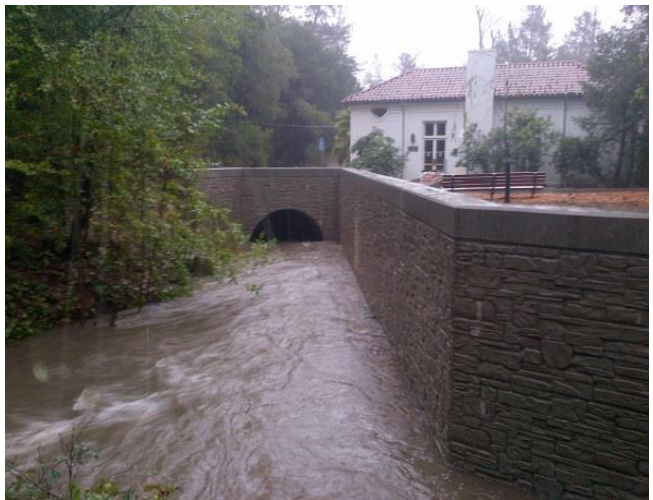
**Figure 1-2: High Flow Events in Moraga – Hacienda Culvert (top left) Missouri Riser (top right) St Mary's Road Culvert with Sediment (bottom left) Hacienda Culvert Headwall (bottom right)**
