Subject: Review and Accept the 2019 Addendum to the Storm Drain Master Plan

2019 Addendum to the Storm Drain Master Plan

Town Moraga

FINAL Storm Drain Operations & Maintenance Plan

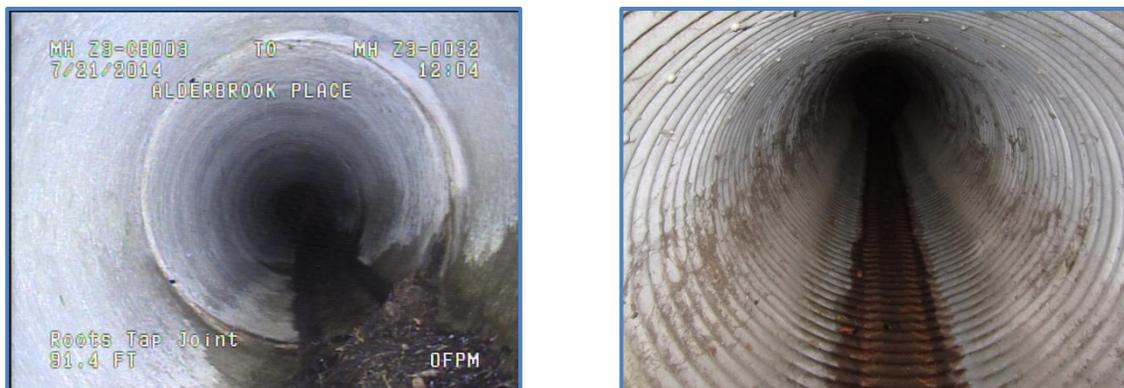
Figure 2-1. Typical Public Storm Drain Pipes – RCP (left) and CMP (right)

Pipes are installed under public roads to convey the runoff generated from the roads and surrounding properties to the creek systems. The town has roughly 1,092 pipes mapped that cover a length of 20.8 miles. The majority of the pipes, roughly 88%, are made of reinforced concrete pipe (RCP), then about 7% of corrugated metal pipe (CMP), with a handful of plastic pipes made of polyvinyl chloride (PVC) or high-density polyethylene (HDPE) material. The pipe diameters start as low as 10 inches and get bigger as the drainage area increases and the pipes get closer to the creek systems where they eventually discharge. Figure 2-1 below shows typical RCP and CMP pipes in the Town of Moraga.

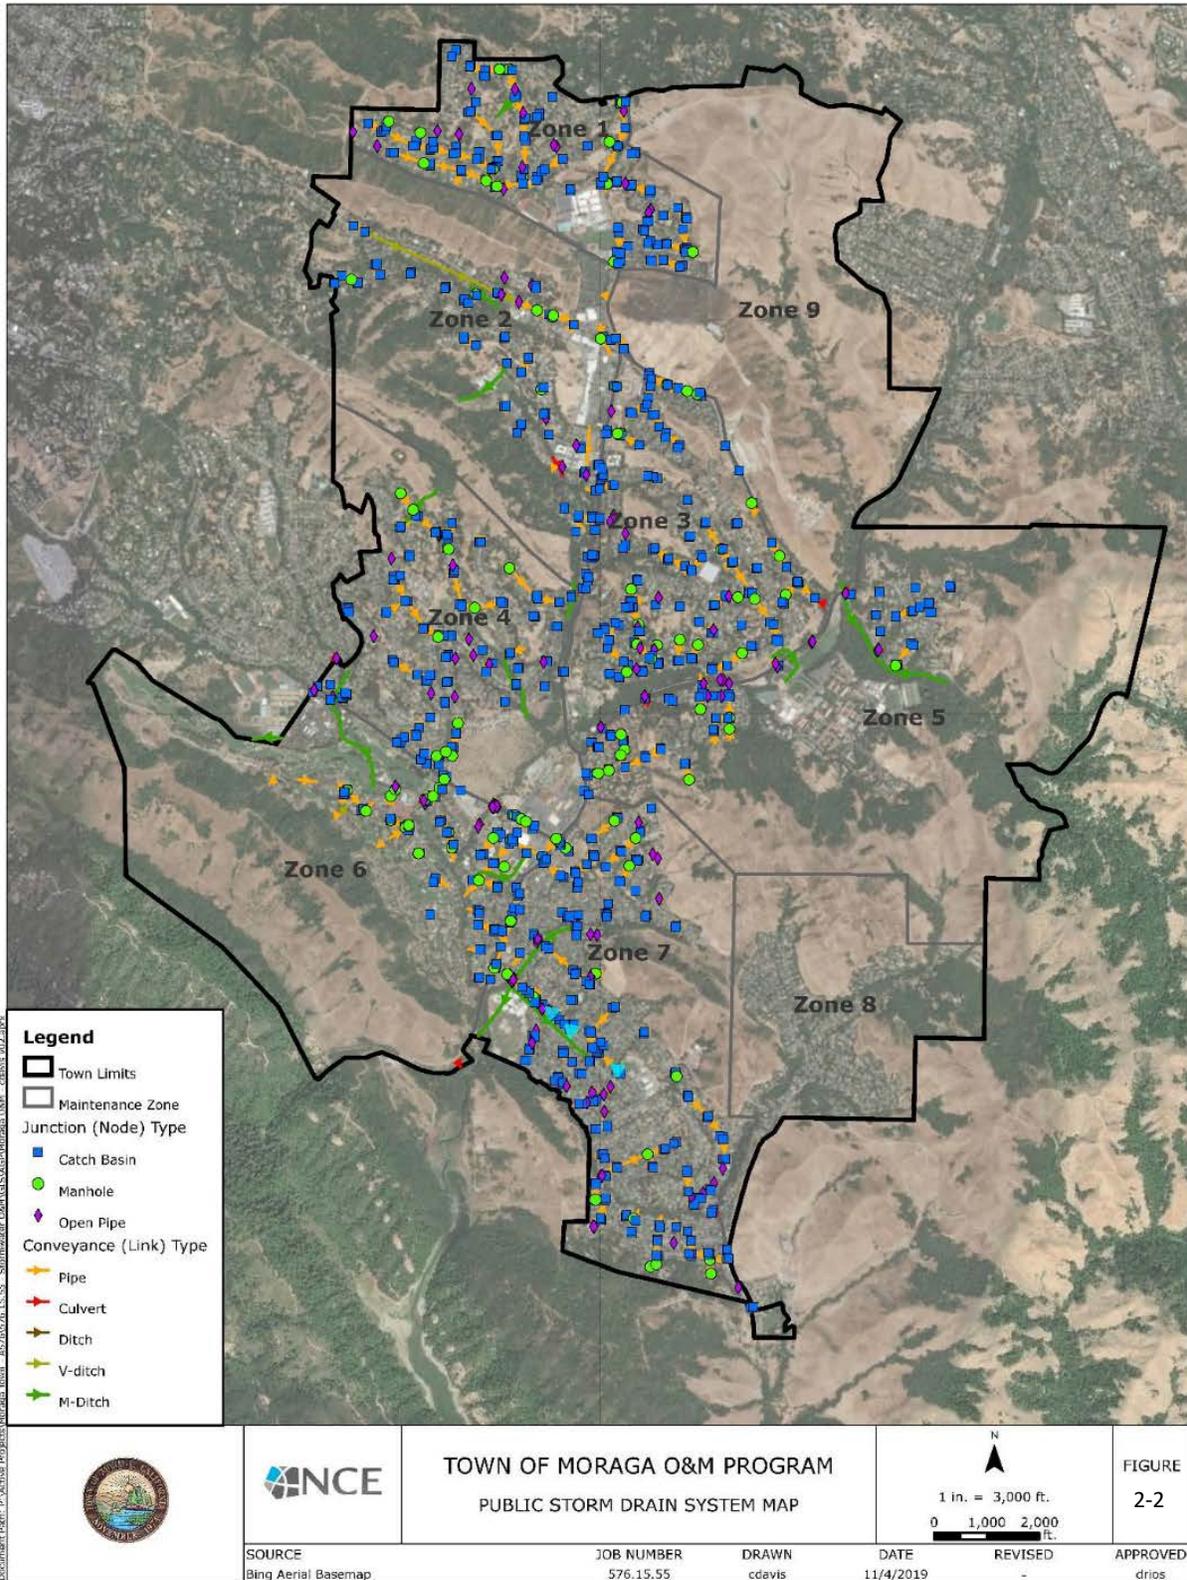
Figure 2-2. Public Storm Drain Infrastructure

The majority of the storm drain infrastructure throughout the Town of Moraga was installed in the 1960s under the jurisdiction of Contra Costa County and 1970s after the Town incorporated. Figure 2-2 depicts the Town's public storm drain infrastructure that was mapped during the 2019 summer field mapping project. Over 29 miles of storm drain infrastructure data was collected during the fieldwork of which 21 miles are Town owned. The various types of infrastructure are further described in the following sections.

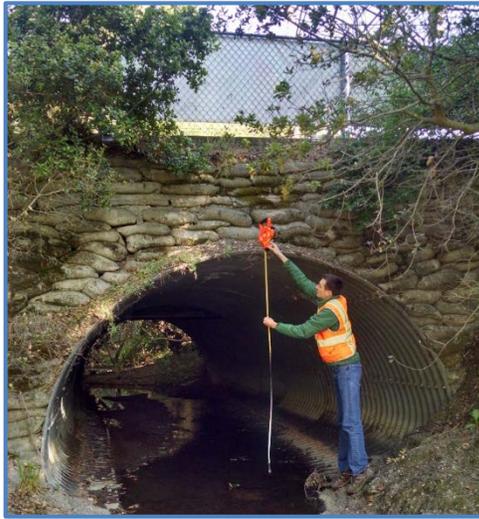
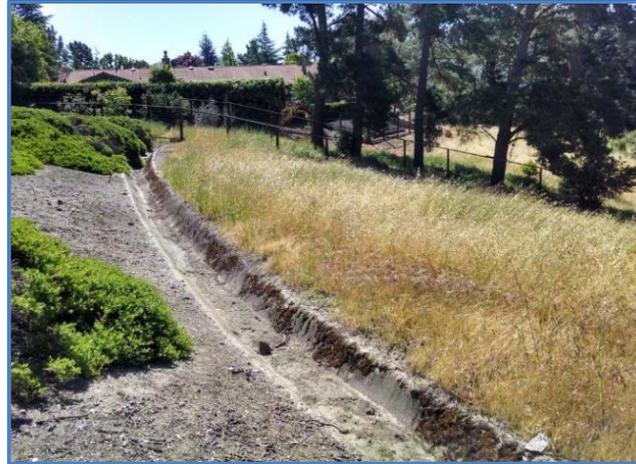
Figure 2-3. Creek Culvert (left) and Concrete Lined Ditch (right)

When a roadway crosses a stream or creek, a culvert is constructed to convey the creek or stream under the roadway. These culverts should be designed to convey the 100-year storm event. The newly collected GIS data shows 46 culverts in the Town, of which 23 cross under private roadways and are maintained by the private property owners or through a Homeowner Association (HOA). Figure 2-3 shows a typical creek culvert.

There are two types of ditches in the Town of Moraga - concrete or asphalt-lined v-ditches and earthen or vegetated ditches. The majority of the ditches throughout the Town are located on private property or hillside slopes and were constructed by developers to develop the land. There are also ditches along the roadside that convey water under private driveways. The Town maintains ditches that are shown in Figure 2-2 which are classified as M-Ditches. There is approximately 2,100 linear feet of M-Ditches that are maintained by the Town. Many of the ditches throughout the Town are not mapped in the Town's GIS due to access issues. A typical concrete lined ditch is shown in Figure 2-3.

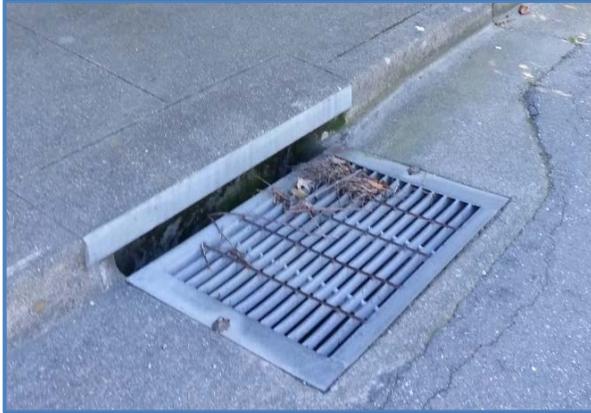
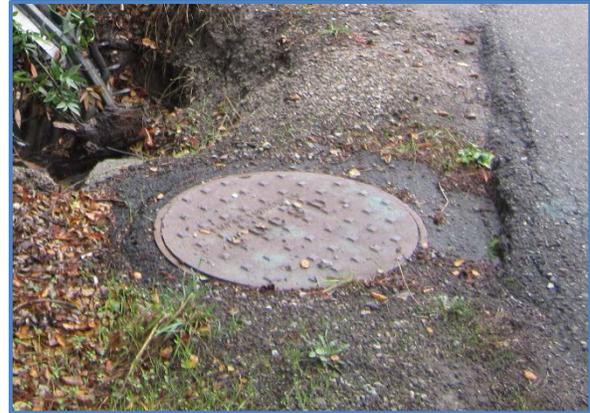
Figure 2-4. Storm Drain Inlet (left) Storm Drain Manhole (right)

A manhole is constructed to connect two pipes at a bend in a pipe or at a location to provide access to the pipe system for cleaning and maintenance. A manhole has a solid lid that can be removed to inspect or clean the pipes. Figure 2-5 (right) shows a typical manhole in the Town.

Storm drain inlets allow surface runoff to enter into the underground storm drain pipes. Storm drain inlets are typically located on a curb at the low point in a street to collect the runoff that flows by gravity to the inlet. The Town has approximately 754 publicly-owned storm drain inlets. Figure 2-4 (left) shows a typical inlet on the left.

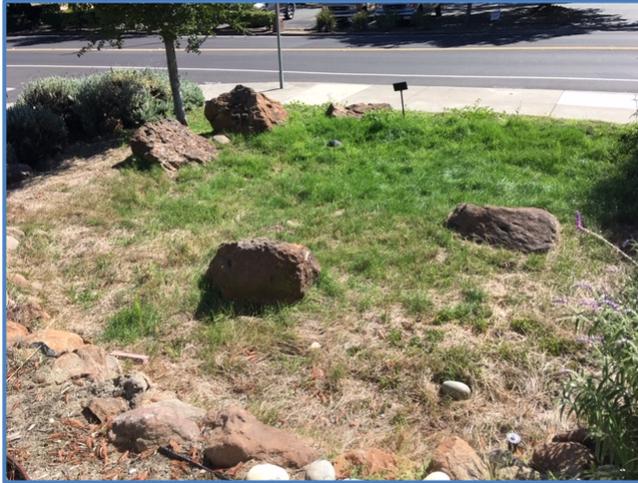
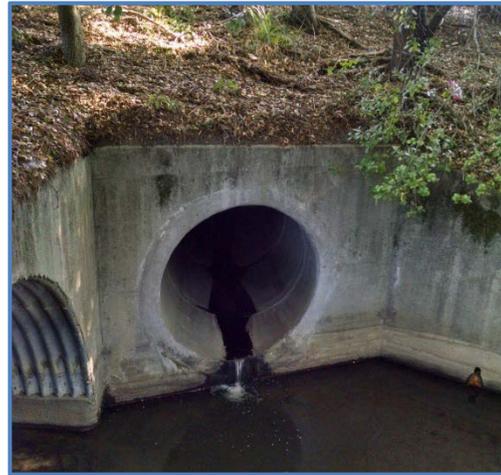
Figure 2-5. Bioretention Basin (left) Storm Drain Outfall (right)

A bioretention basin is designed to detain and infiltrate runoff through a soil media to remove the pollutants. It is known as a low impact development (LID) that is required under the Municipal Regional Permit (MRP). Bioretention basins are typically required of private new and redevelopment projects. The Town has two bioretention basins - one at the Corp Yard and the other near Commons Park. Figure 2-5 shows one of the Town's bioretention basins.

An outfall is where a pipe, culvert, or ditch that discharges storm water into a receiving water body. In the Town of Moraga, there are approximately 245 mapped outfalls where Stormwater enters into a creek or stream. Of the 245 mapped outfalls, approximately 114 outfalls that are located in public right-of-way or public property. The rest of the outfalls are located on private property. Figure 2-5 shows an outfall pipe in the Town.

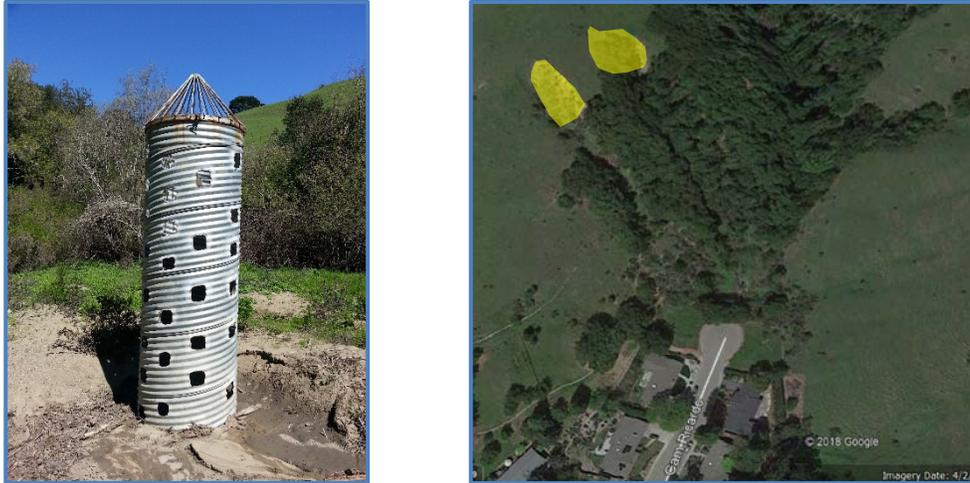
Figure 3-1. Missouri Riser Structure (left) Active Landslide Areas in Yellow (right)

A sedimentation basin is designed to hold back water to allow sediment to settle out rather than being conveyed downstream. The Town has a sedimentation basin at the end of El Camino Ricardo Street that is controlled by a structure called a "Missouri Riser" that detains runoff from the hillside and allows sediment to settle out. Figure 3-1 shows the Missouri Riser structure and the sediment basin.

There is a sedimentation basin controlled by a Missouri Riser structure (Figure 3-1) located at the end of El Camino Ricardo Street. Each year, the basin fills up with sediment that is deposited when the runoff is held back by the Missouri Riser, which is the purpose of the basin and riser. The removal of the sediment can cost the Town up to \$15,000 per year. The source of the sediment has been identified as active landslides on the steep hillslopes above the sedimentation basin. In order to reduce the amount of sediment that needs to be removed each year, Schaaf & Wheeler researched materials and developed a conceptual project to stabilize the hillside by installing geotextile products and replanting vegetation to hold the soil in place. When costing out this project, it was determined that to properly stabilize the steep hillside, the project would cost upwards of \$800,000. Since the maintenance of this basin over the course of ten years is significantly less than the project cost, the annual cleaning fee has been included into the annual operations and maintenance budget for the Town in Table 6-1.

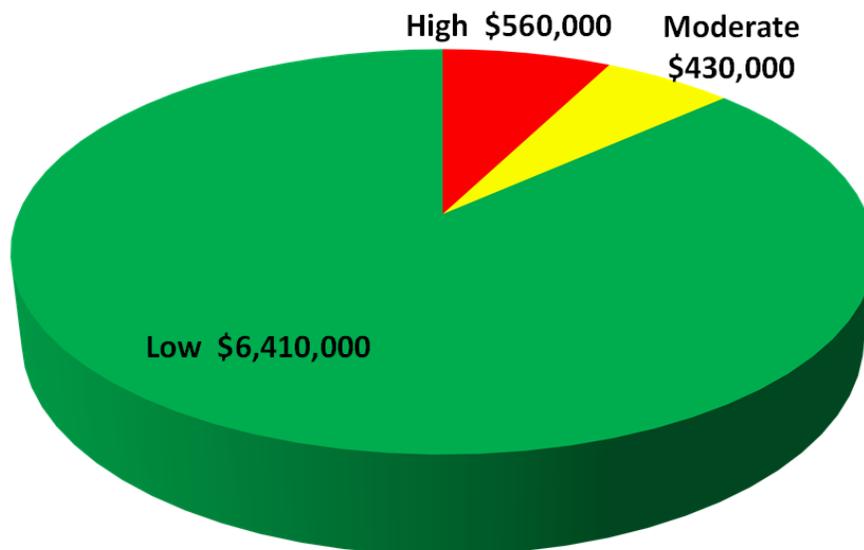
Figure 5-1. 10-yr Storm Drain \$7.4M CIP Breakdown into Priorities

Table 5-1 through 5-3 present the Town's ten-year storm drain CIP in the high, moderate, and low priorities. The high and moderate priority projects in Tables 5-1 and 5-2 are listed in recommended order of completion. The overall CIP is estimated to cost the Town \$7,400,000 and consists of \$560,000 in high priority projects, \$430,000 in moderate priority projects, and \$6,410,000 in low priority projects. Figure 5-1 shows a breakdown of the CIP costs into priorities and Figure 5-2 shows the priorities on a map.

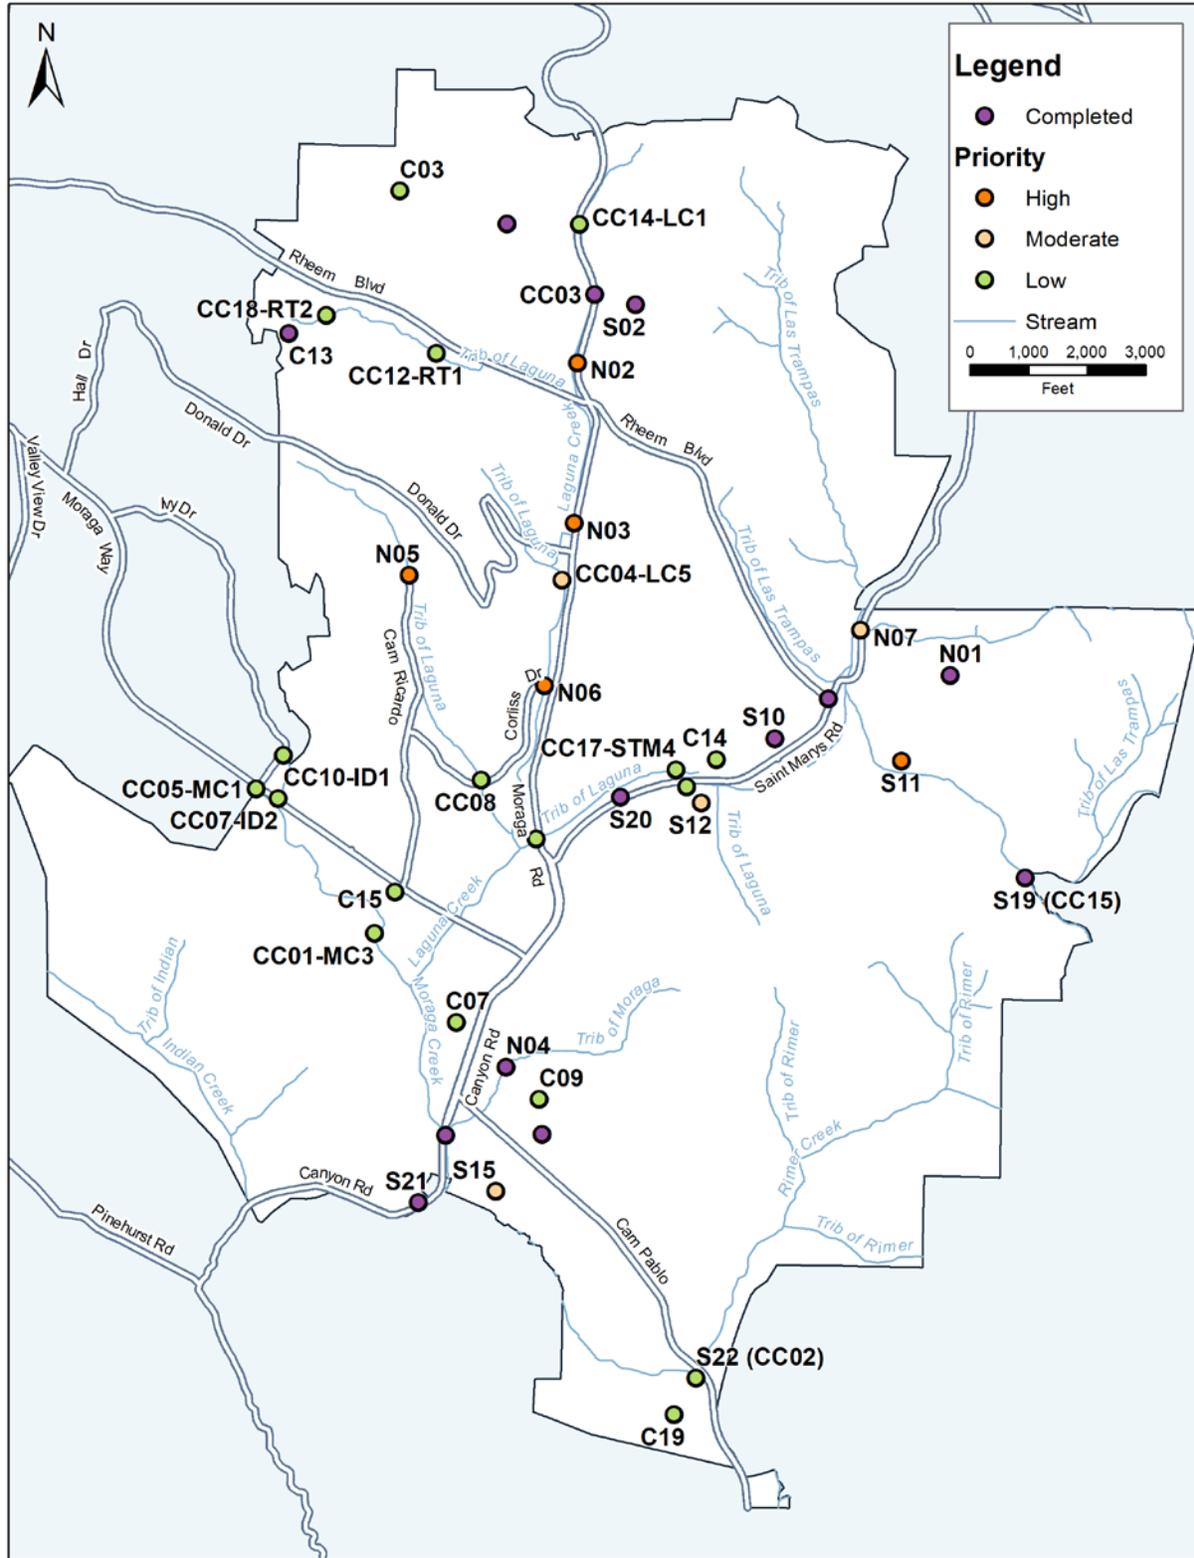
Figure 5-2. Ten Year Storm Drain Prioritized CIP

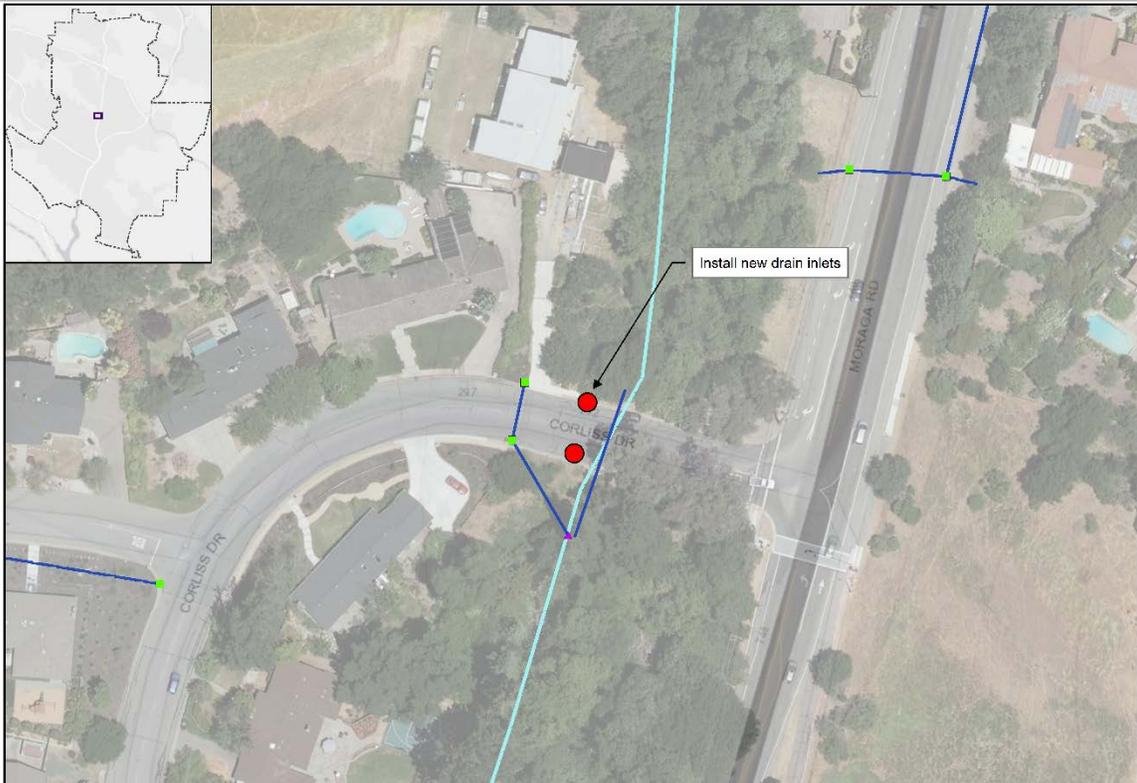
A. Project ID: N06	B. Project Name: Corliss Dr Drain Inlets
C. Project Location: Adjacent to 299 Corliss Drive near the corner of Corliss Drive and Moraga Road	
D. Priority: High (Nuisance)	
<p>Project Description: Install two additional storm drain inlets on Corliss drive and two new outlets to the creek to prevent surface ponding on Corliss Drive. The existing two storm drain inlets are not sufficient to drain the street.</p>

<p>Project: Corliss Drive Drain Inlets (N06)</p>	<p>Priority: High</p>	<p>Priority ■ High ■ Moderate ■ Low</p>	<p>Stream Ditch Pipe, Culvert</p>	<p>Inlet Manhole Outfall</p>	<p>N </p>	<p>Schaaf & Wheeler CONSULTING CIVIL ENGINEERS 0 20 40 80 Feet</p>
--	---------------------------	---	---	--	----------------	---

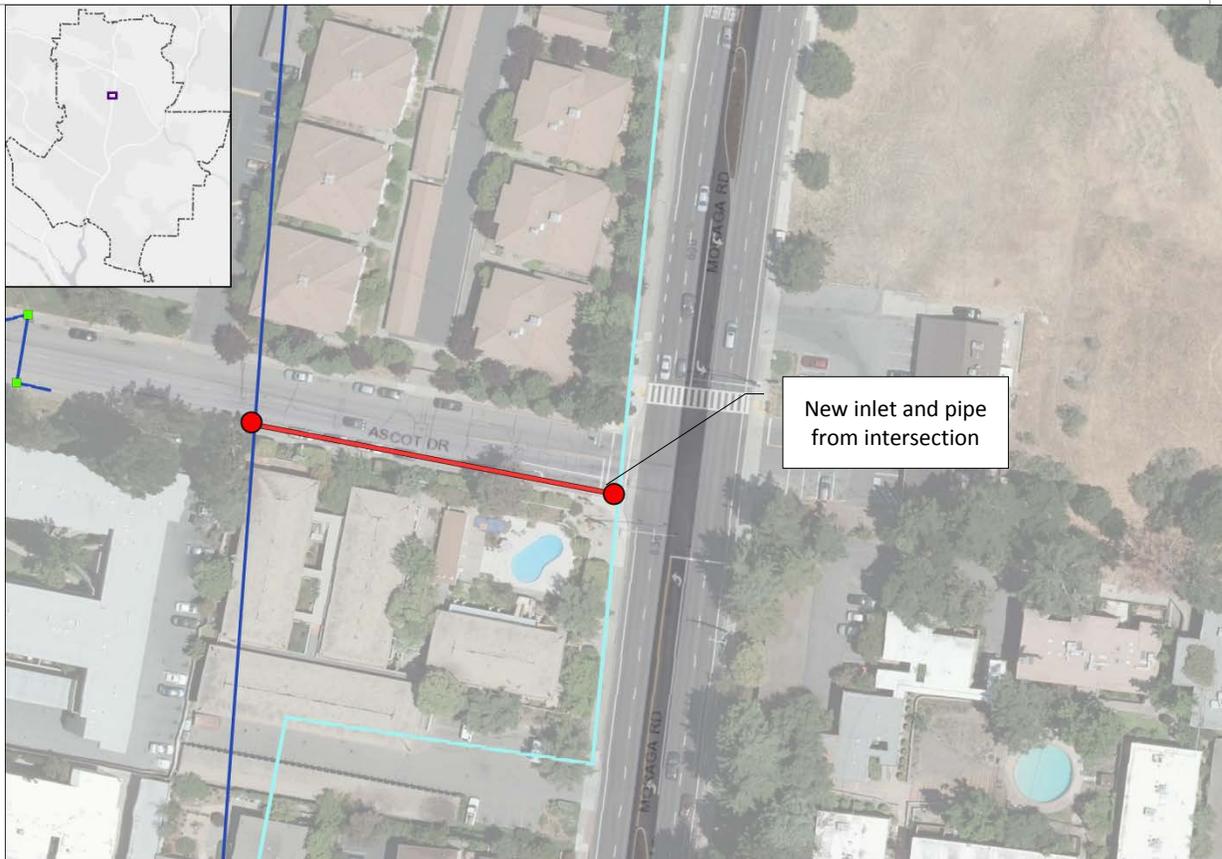
Length	Diameter	Material	Number of New Storm Drain Inlets
250	24"	Concrete	2

<p>Project: Ascot and Moraga Drain Inlet (N03)</p>	<p>Priority: High</p>	<p>Priority</p> <ul style="list-style-type: none"> — High — Moderate — Low 	<ul style="list-style-type: none"> — Stream — Ditch — Pipe, Culvert 	<ul style="list-style-type: none"> ■ Inlet ● Manhole ▲ Outfall 	<p>N</p>	<p>Schaaf & WHEELER CONSULTING CIVIL ENGINEER</p> <p>0 20 40 80 Feet</p>
---	----------------------------------	--	---	---	----------	---

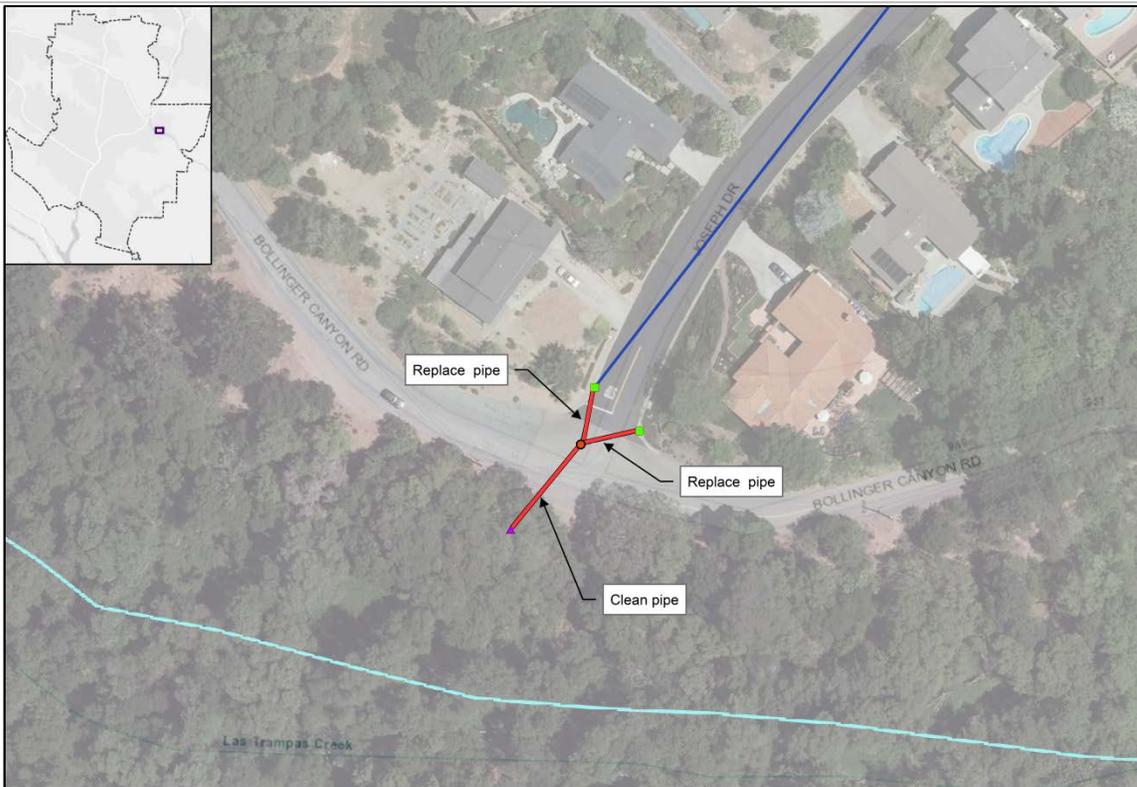
Pipe ID	Length	Diameter	VANDA Rating	Improved Material	Project Type
Z5_LINK_0098	40	18"	4	Concrete	Replace
Z5_LINK_0099	44	18"	2	Concrete	Replace
Z5_LINK_0155	55	15"	3	n/a	Clean

Project: Bollinger Clean/Replace (S11)	Priority: High	Priority — High — Moderate — Low	— Stream — Ditch — Pipe, Culvert	■ Inlet ● Manhole ▲ Outfall	N Schaaf & Wheeler CONSULTING CIVIL ENGINEERS 0 20 40 80 Feet
---	-------------------	--	--	---	---

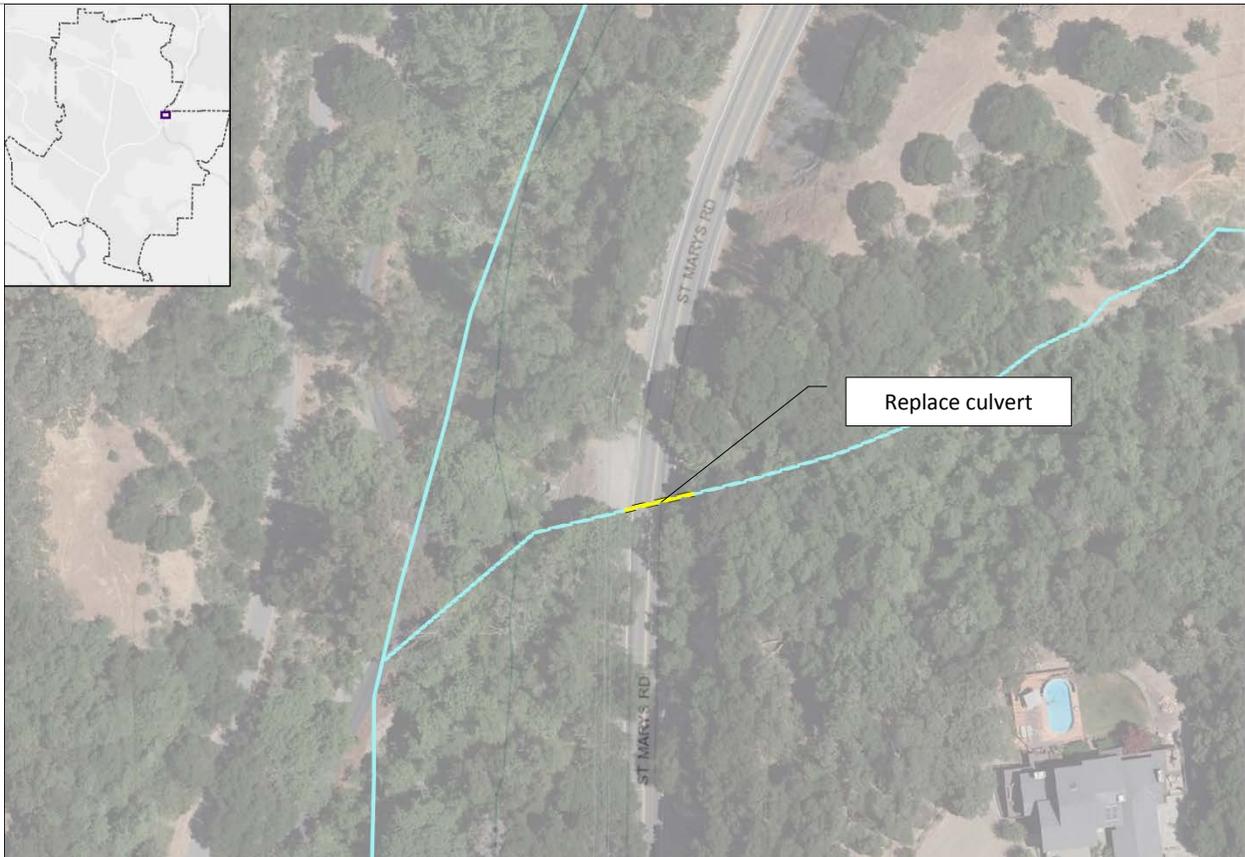
Culvert ID	Length	Existing Size	Improved Size	Improved Material
LTC2	40	54" x 32"	60" x 36"	Concrete

<p>Project: St. Mary's Rd Culvert Replacement (N07)</p>	<p>Priority: Moderate</p>	<p>Priority</p> <ul style="list-style-type: none"> — High — Moderate — Low 	<ul style="list-style-type: none"> — Stream — Ditch — Pipe, Culvert 	<ul style="list-style-type: none"> ■ Inlet ● Manhole ▲ Outfall 	<p>N</p>	<p>Schaaf & Wheeler CONSULTING CIVIL ENGINEERS</p>
---	-------------------------------	--	--	--	----------	---

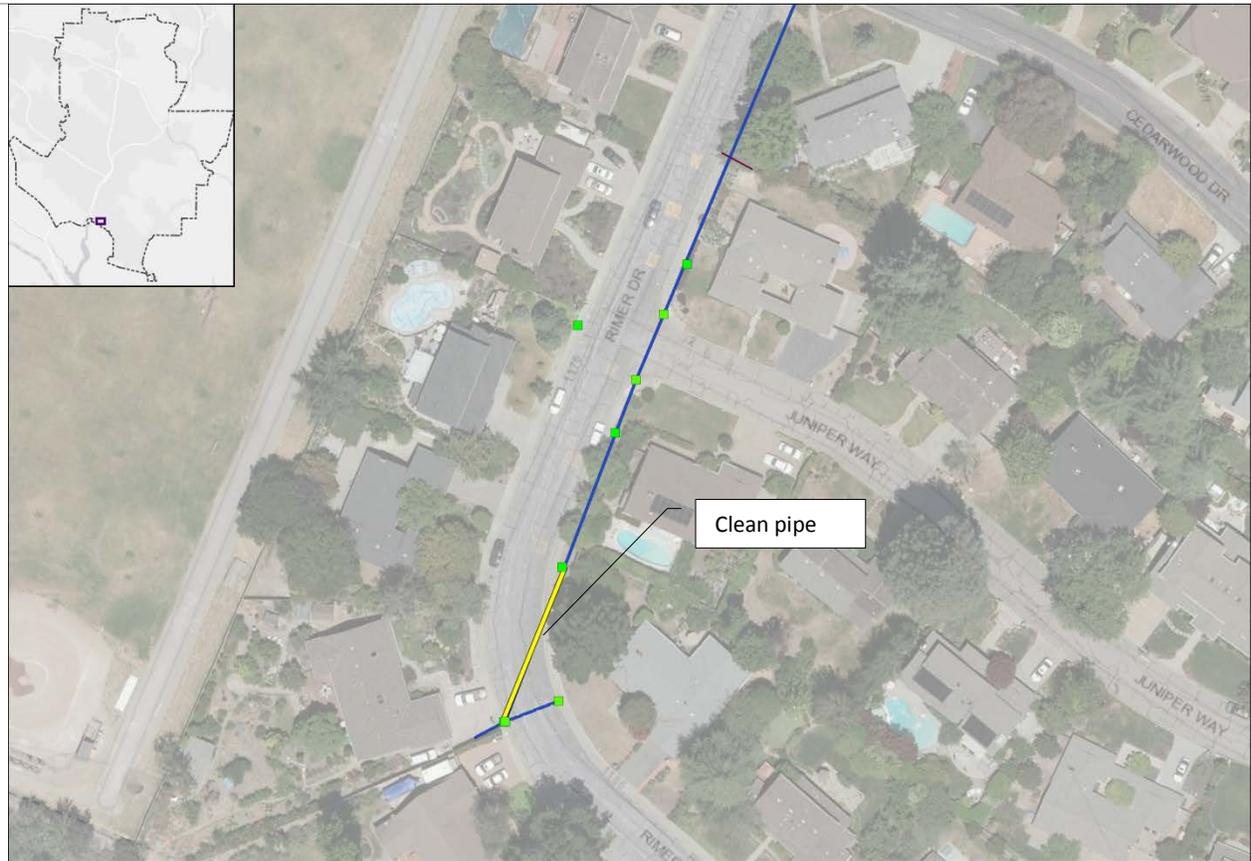
Pipe ID	Length	Diameter	VANDA Rating	Improved Material	Project Type
ZL-201907170730	106	18"	3	n/a	Clean

<p>Project: Rimer Drive Cleaning (S15)</p>	<p>Priority: Moderate</p>	<p>Priority</p> <ul style="list-style-type: none"> — High — Moderate — Low 	<ul style="list-style-type: none"> — Stream — Ditch — Pipe, Culvert 	<ul style="list-style-type: none"> ■ Inlet ● Manhole ▲ Outfall 	<p>N</p>	<p>Schaaf & Wheeler CONSULTING CIVIL ENGINEERS</p> <p>0 20 40 80 Feet</p>
---	--------------------------------------	--	---	--	----------	--

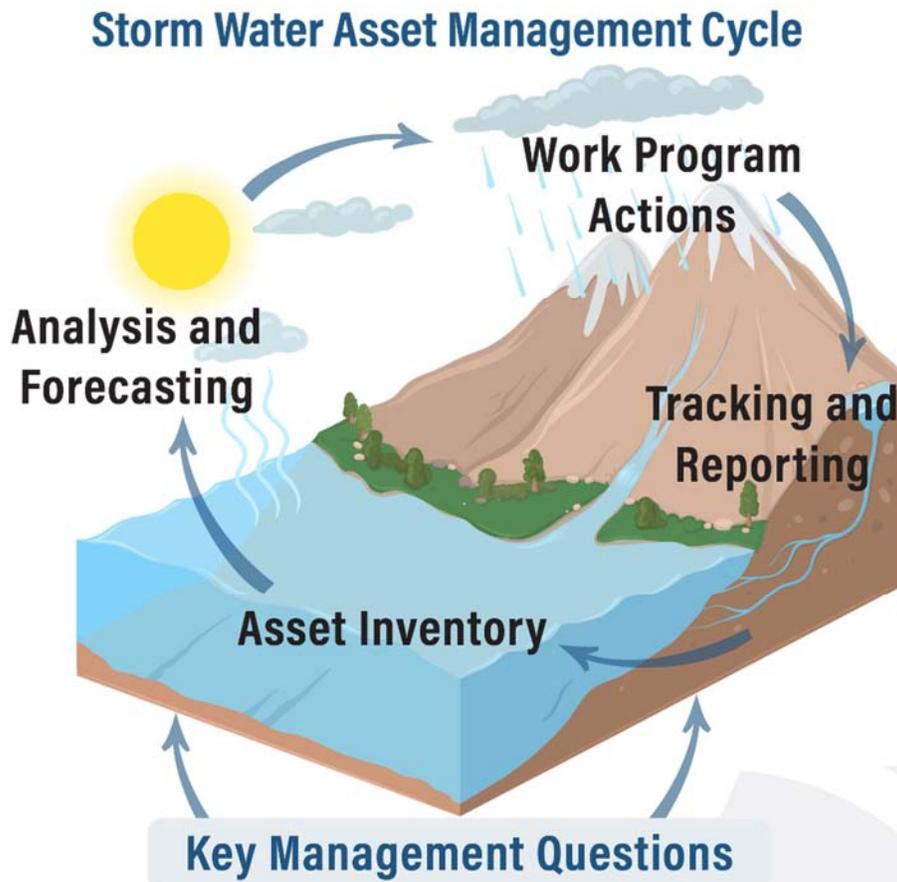
Storm Water Asset Management is an iterative and evolving process that provides a comprehensive means of cost effectively operating, maintaining, and investing in storm drain systems. The diagram below presents the cycle and relationship between the various elements of Storm Water Asset Management. For the Town of Moraga (Town) the storm drain Operations & Maintenance (O&M) Program is effectively the Town's Storm Water Asset Management Program. As the Town continues to implement enhancements to the Program, new information will be gathered through ongoing visual and Closed-Circuit Television (CCTV) inspections, annual and recurring maintenance and repairs, and the implementation of capital improvement program (CIP) projects. The components of the O&M Program will change overtime and this O&M Plan should be revisited and updated every few years to reflect the most current information.

Figure 1. Storm Water Asset Management Cycle

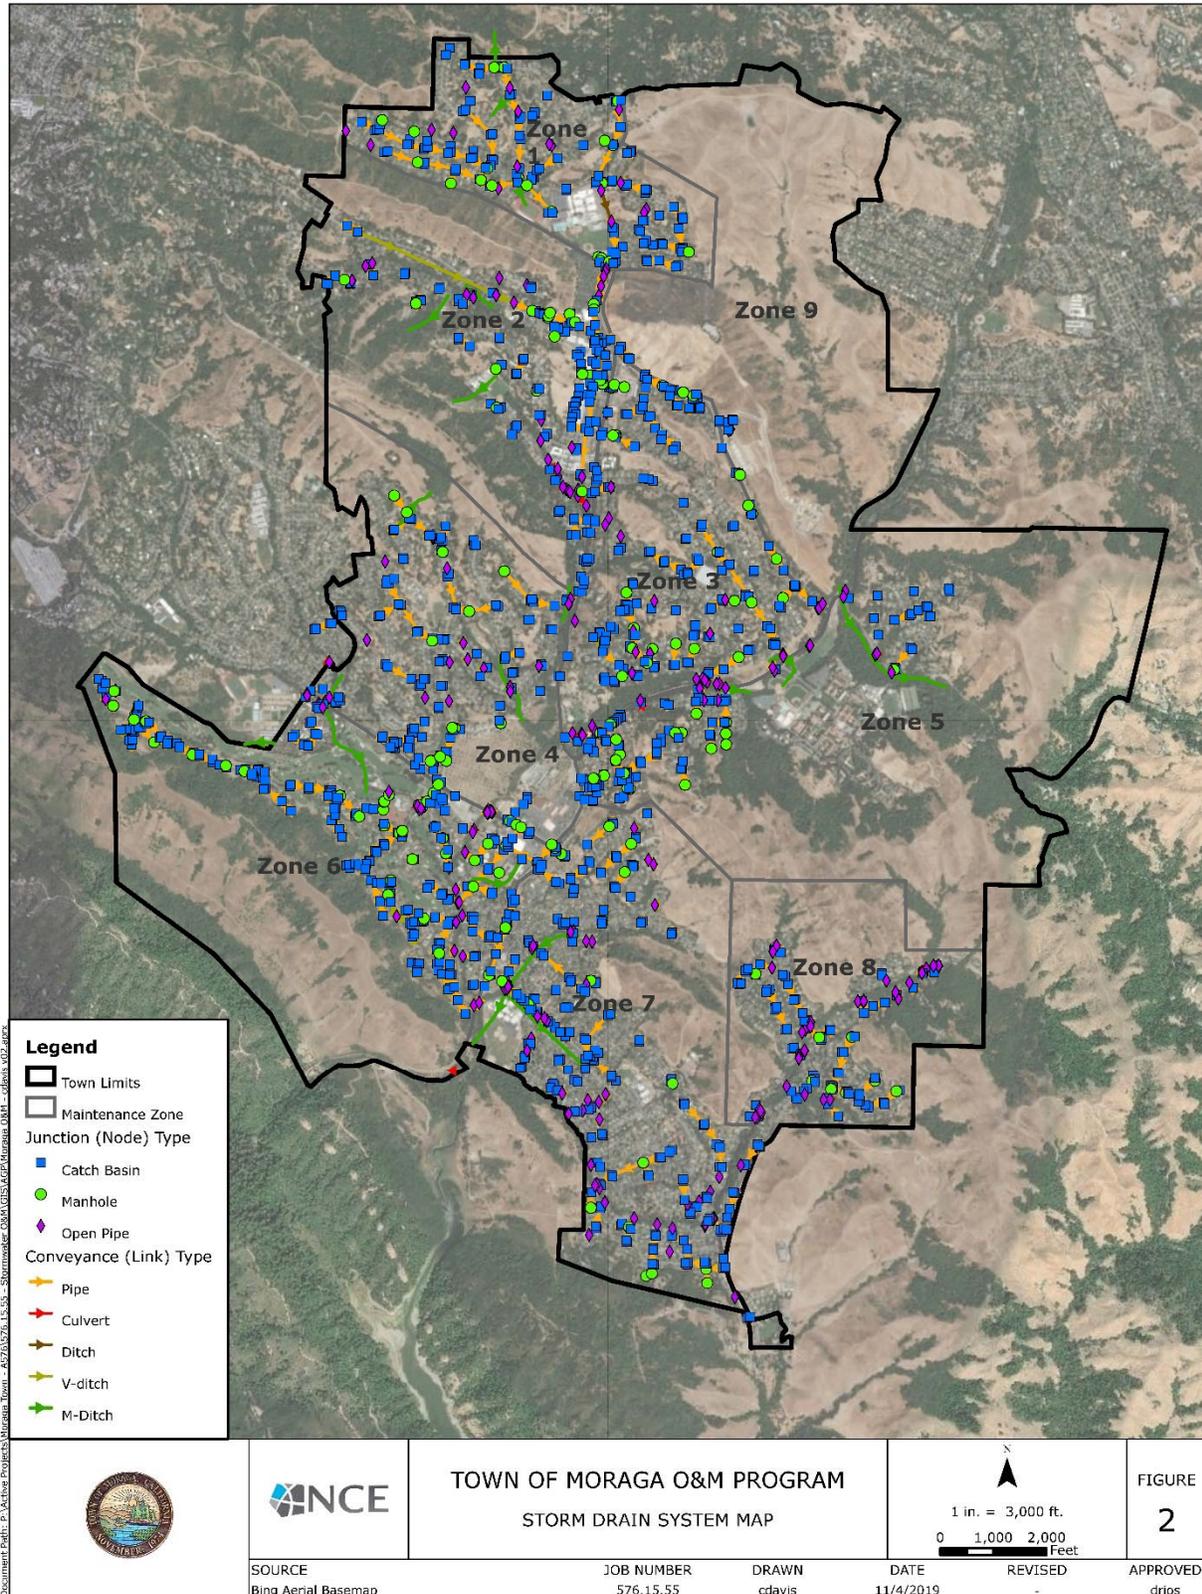
Two summary tables are presented below that provide the count and length of the various storm drain feature types within the asset inventory. **Table 1** presents the summary statistics for the entire asset inventory. There is a total of 1,630 junctions (nodes) and 1,731 conveyances (links) with approximately 29 miles of storm drain pipes and culverts. **Figure 2** below presents the public and private storm drain system map.

Figure 2: Storm Drain System Map

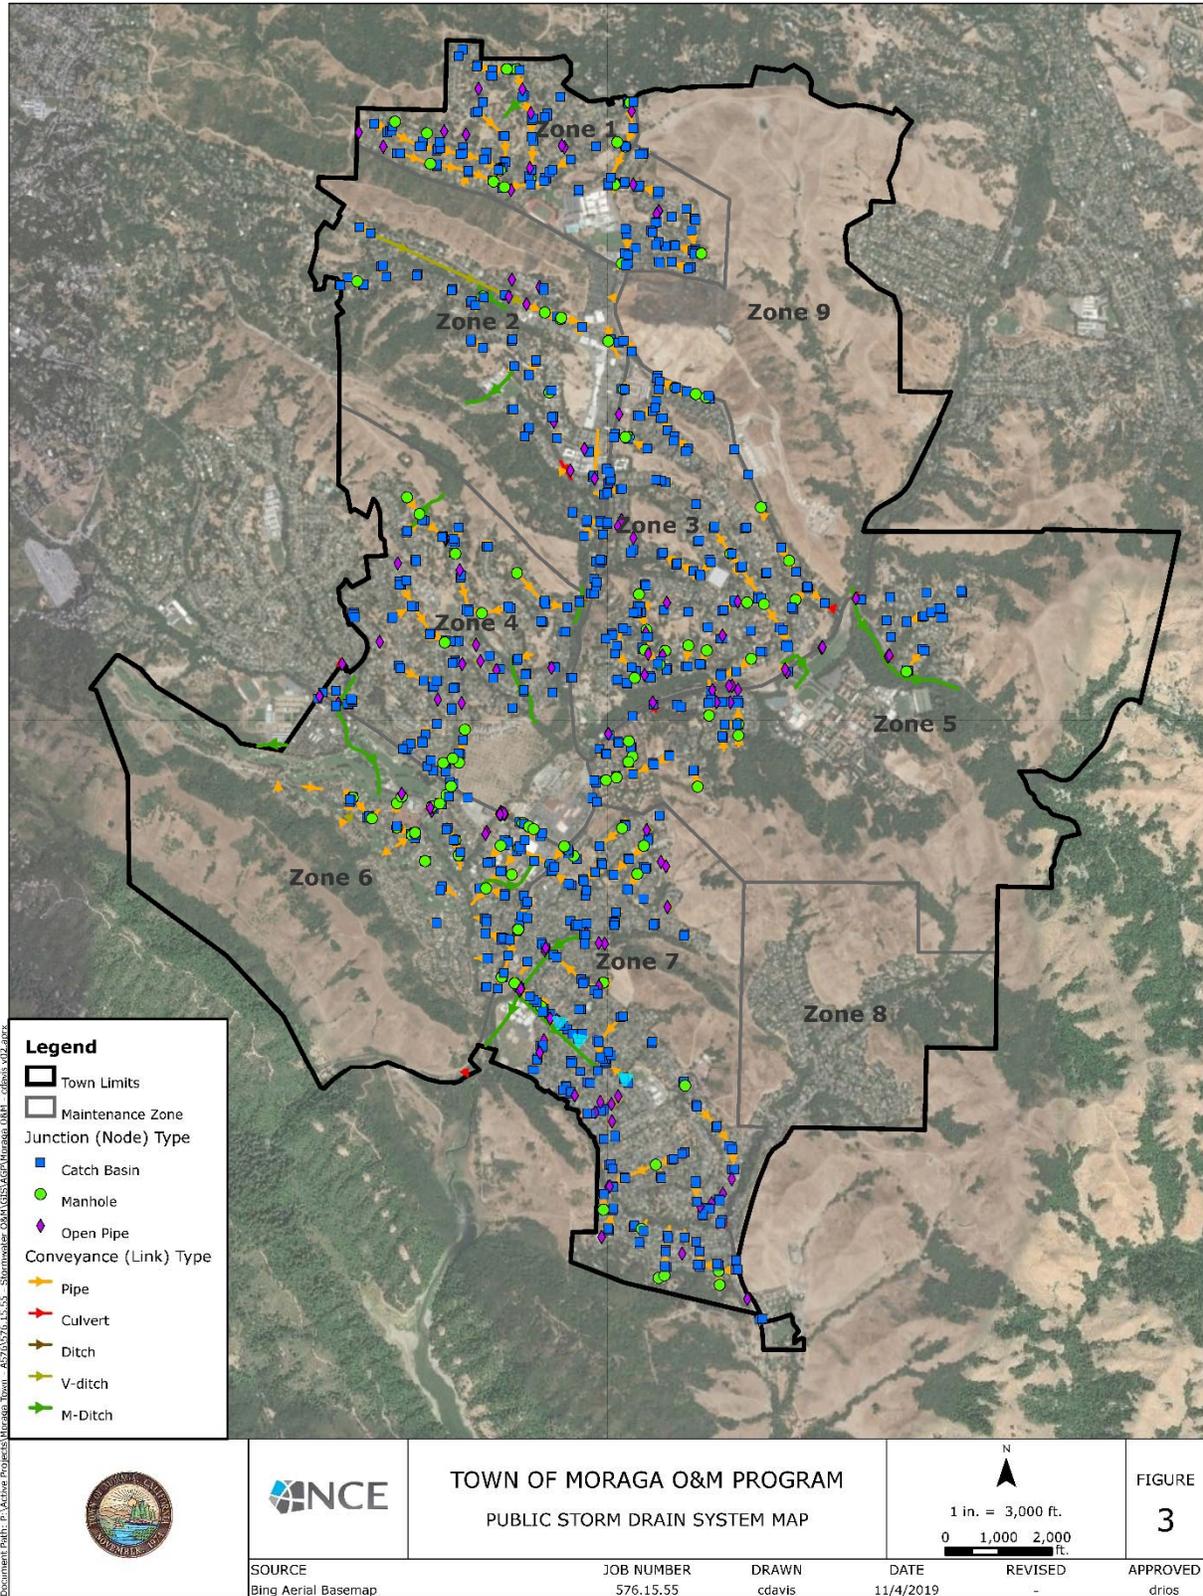
The public only asset inventory summary statistics are presented in **Table 2** below. These assets represent the storm drain assets that the Town is responsible for maintaining. There is a total of 974 junctions (nodes) and 1,161 conveyances (links) with approximately 21 miles of storm drain pipes and culverts. **Figure 3** below presents the public storm drain system map.

Figure 3: Public Storm Drain System Map
