Subject: Review and Accept the 2019 Addendum to the Storm Drain Master Plan

2019 Addendum to the Storm Drain Master Plan

Town Moraga

FINAL Storm Drain Operations & Maintenance Plan

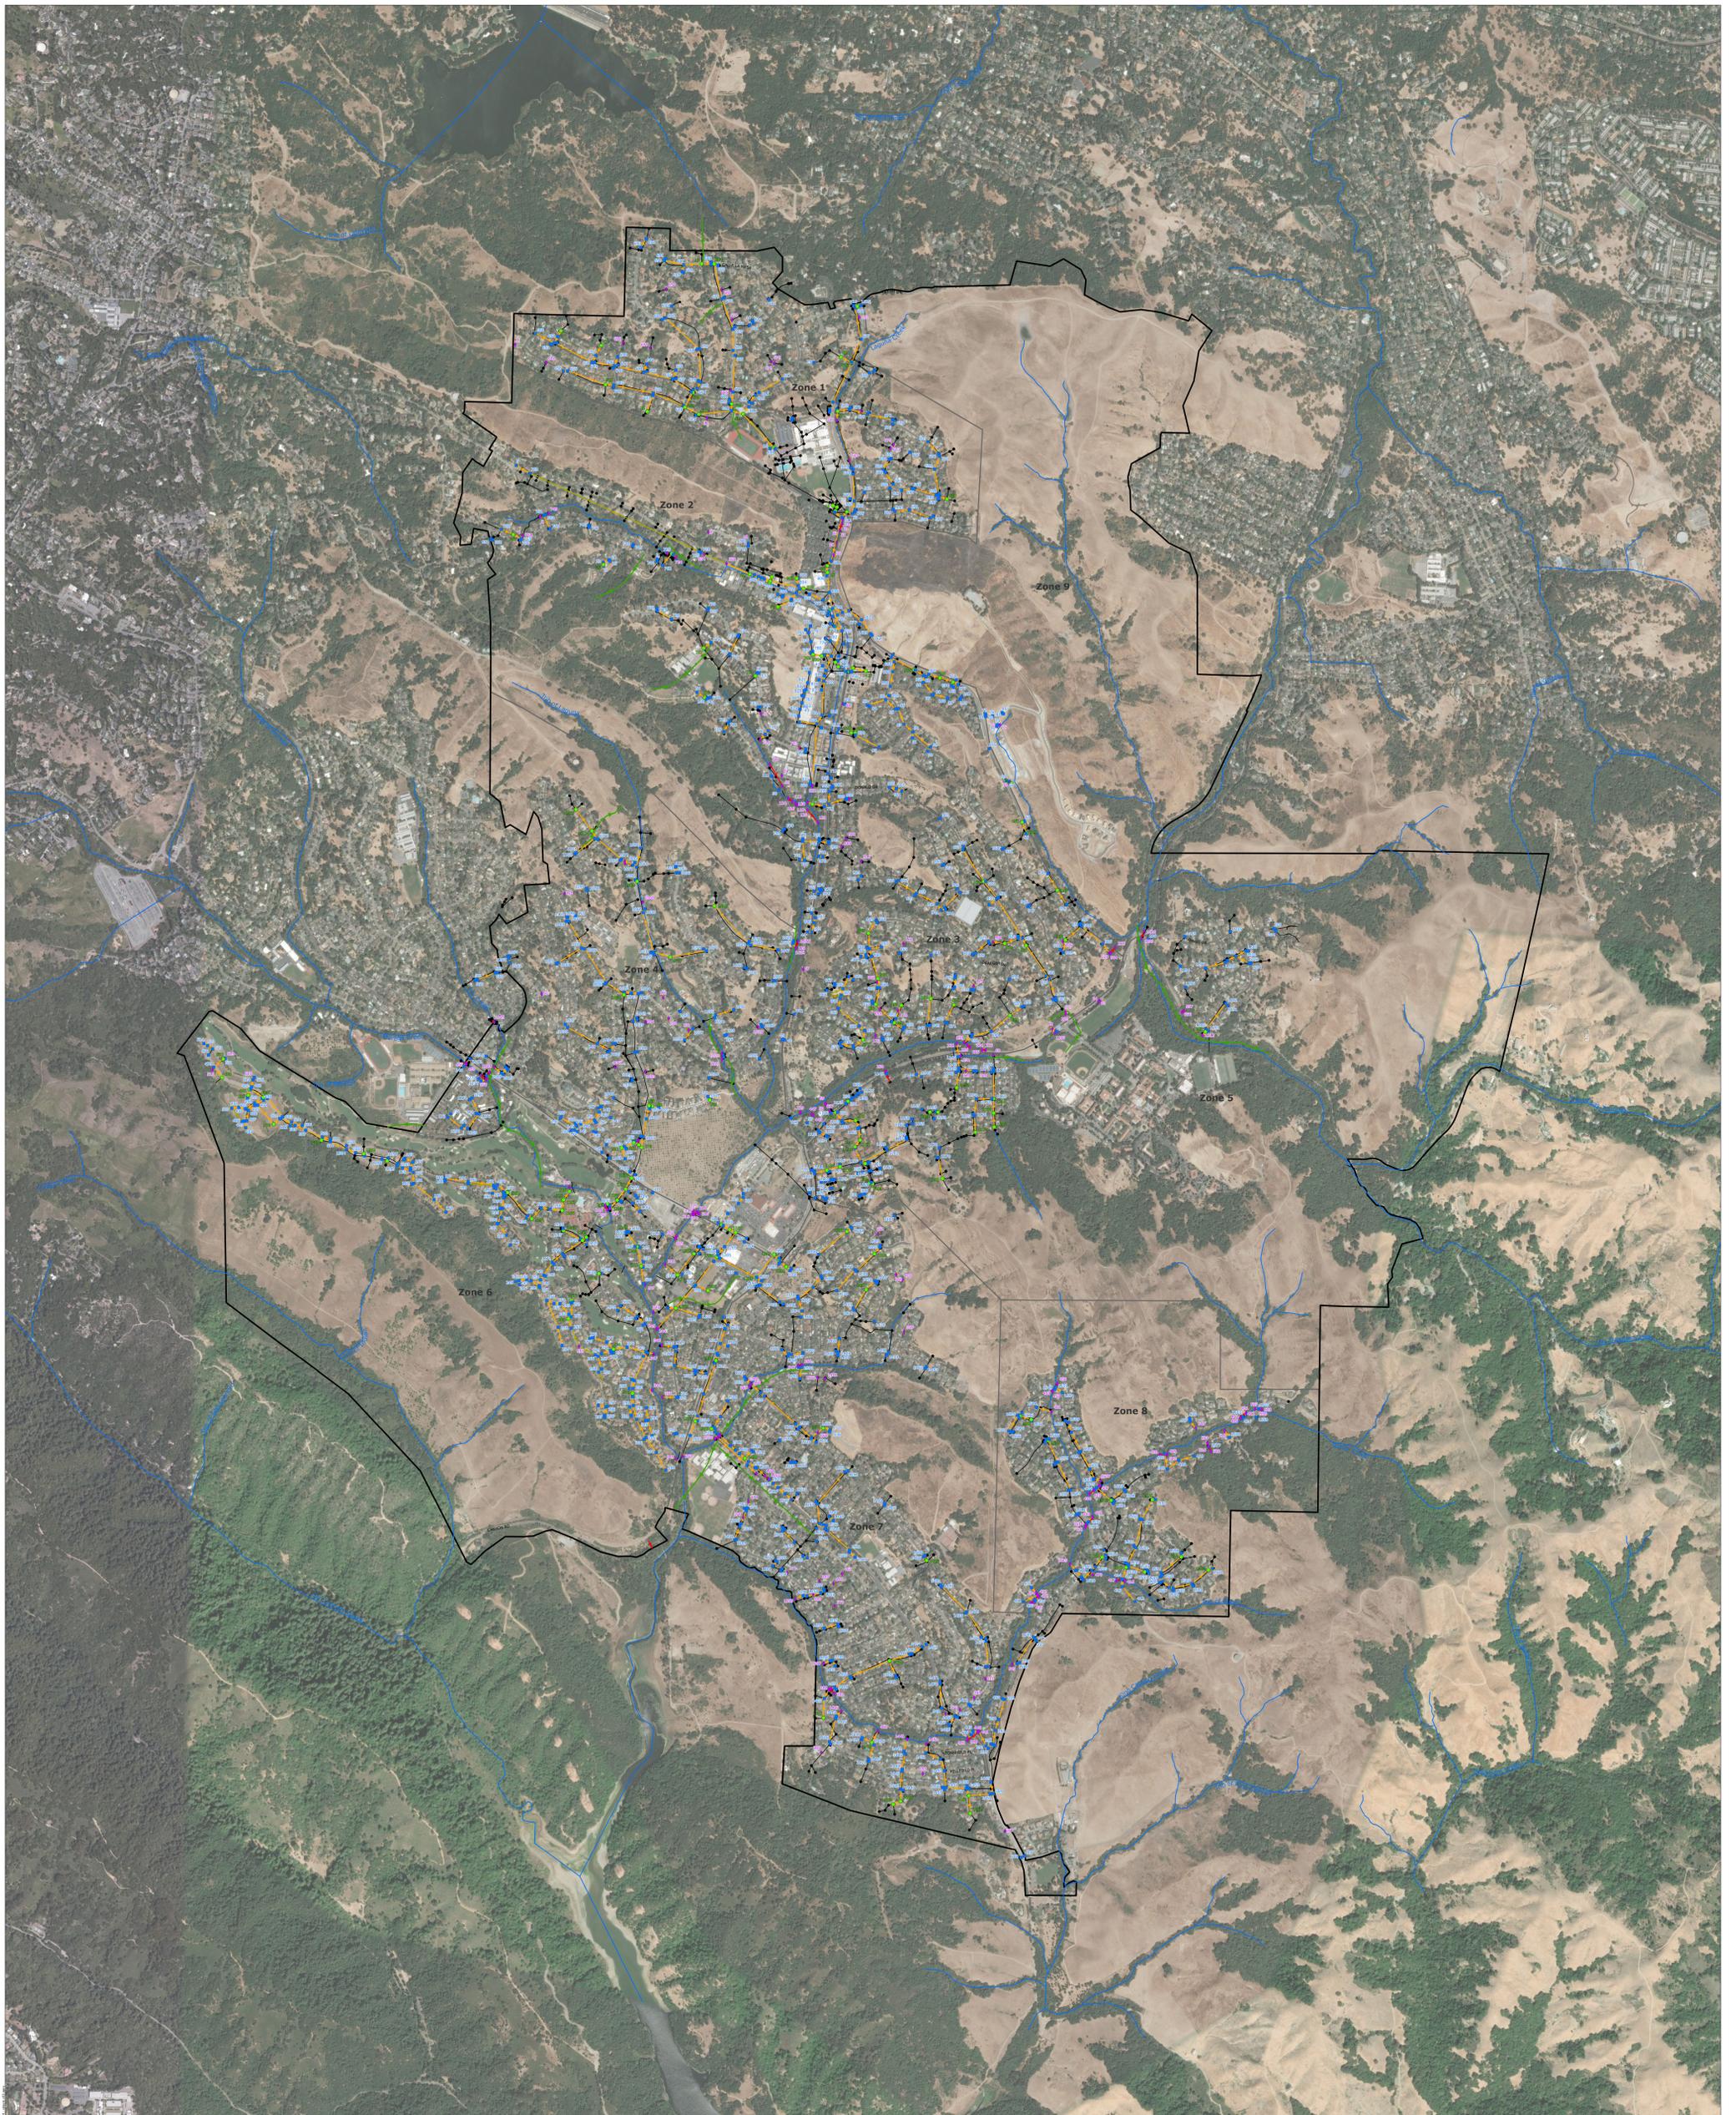
A.1

STORM DRAIN SYSTEM MAP
