Re: Hetfield Project; Draft EIR dated January 14, 2011

I am writing to comment on the Hetfield Estates Subdivision Environmental Impact Report prepared by Mills Associates dated January 14, 2011 ("DEIR"). I wanted to bring to the attention of the Moraga Planning Commission, the Moraga Planning Department, and to Moraga's consultant, Mills Associates, that there are a number of significant issues the DEIR fails to resolve, without which I believe the proposed DEIR should not be approved. Some of my primary comments and concerns are listed below.

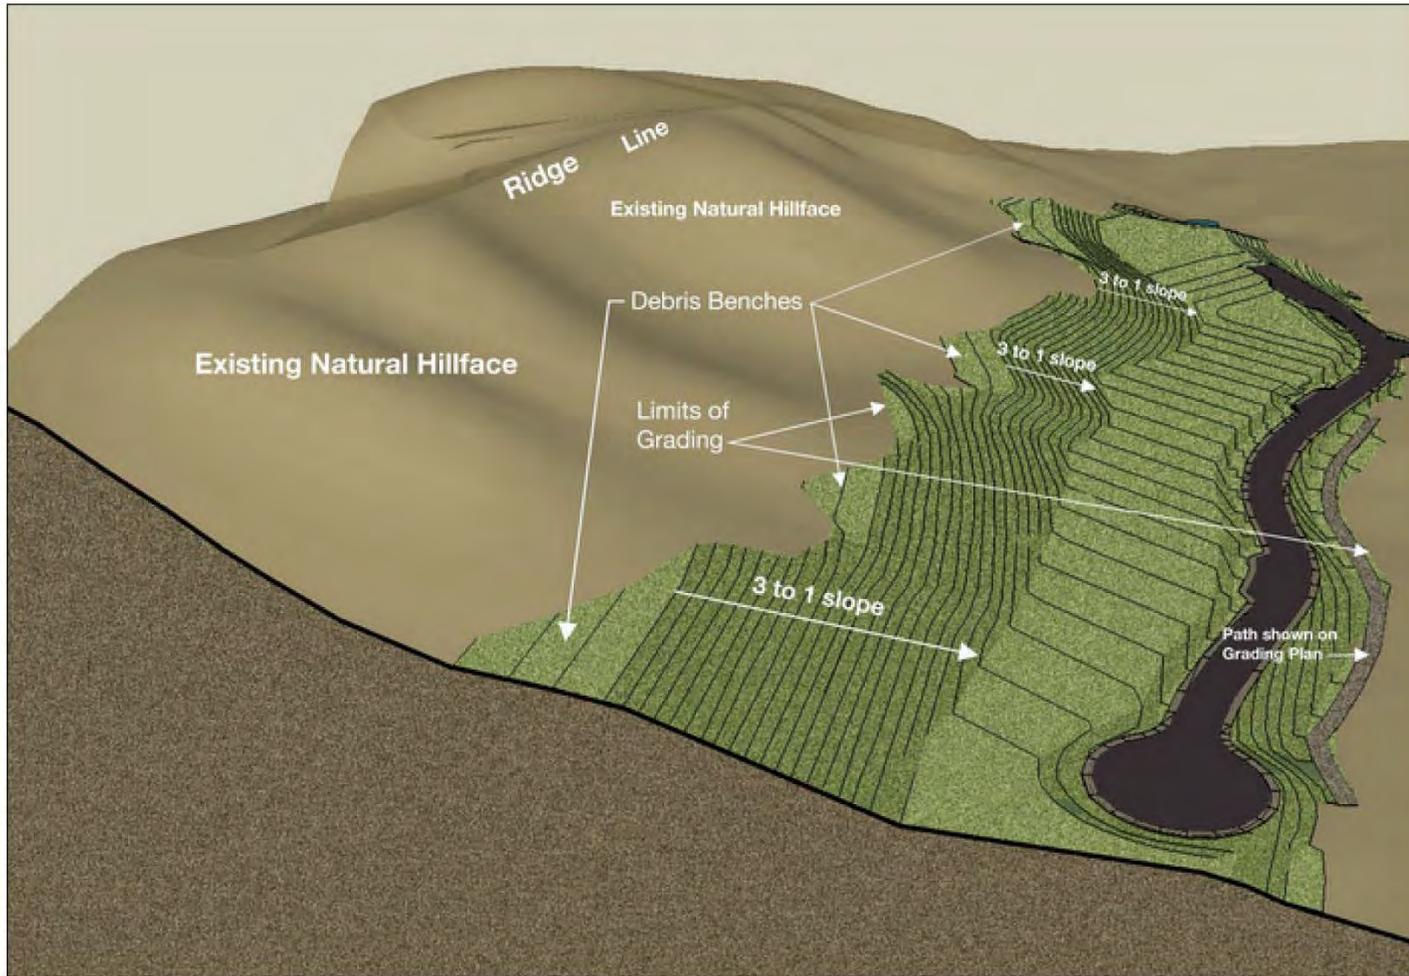
Figure C&R-1 Block Diagram Illustrating Post Grading Conditions as Seen Through Lot 6

Computer generated perspective of contours from grading plan; 2-foot contour interval.
