UPDATED PRELIMINARY  
GEOTECHNICAL REPORT  
INDIAN VALLEY PROJECT  
MORAGA, CALIFORNIA

Project No.  
5900.200.000

Subject: Indian Valley Project  
Moraga, California

## UPDATED PRELIMINARY GEOTECHNICAL REPORT

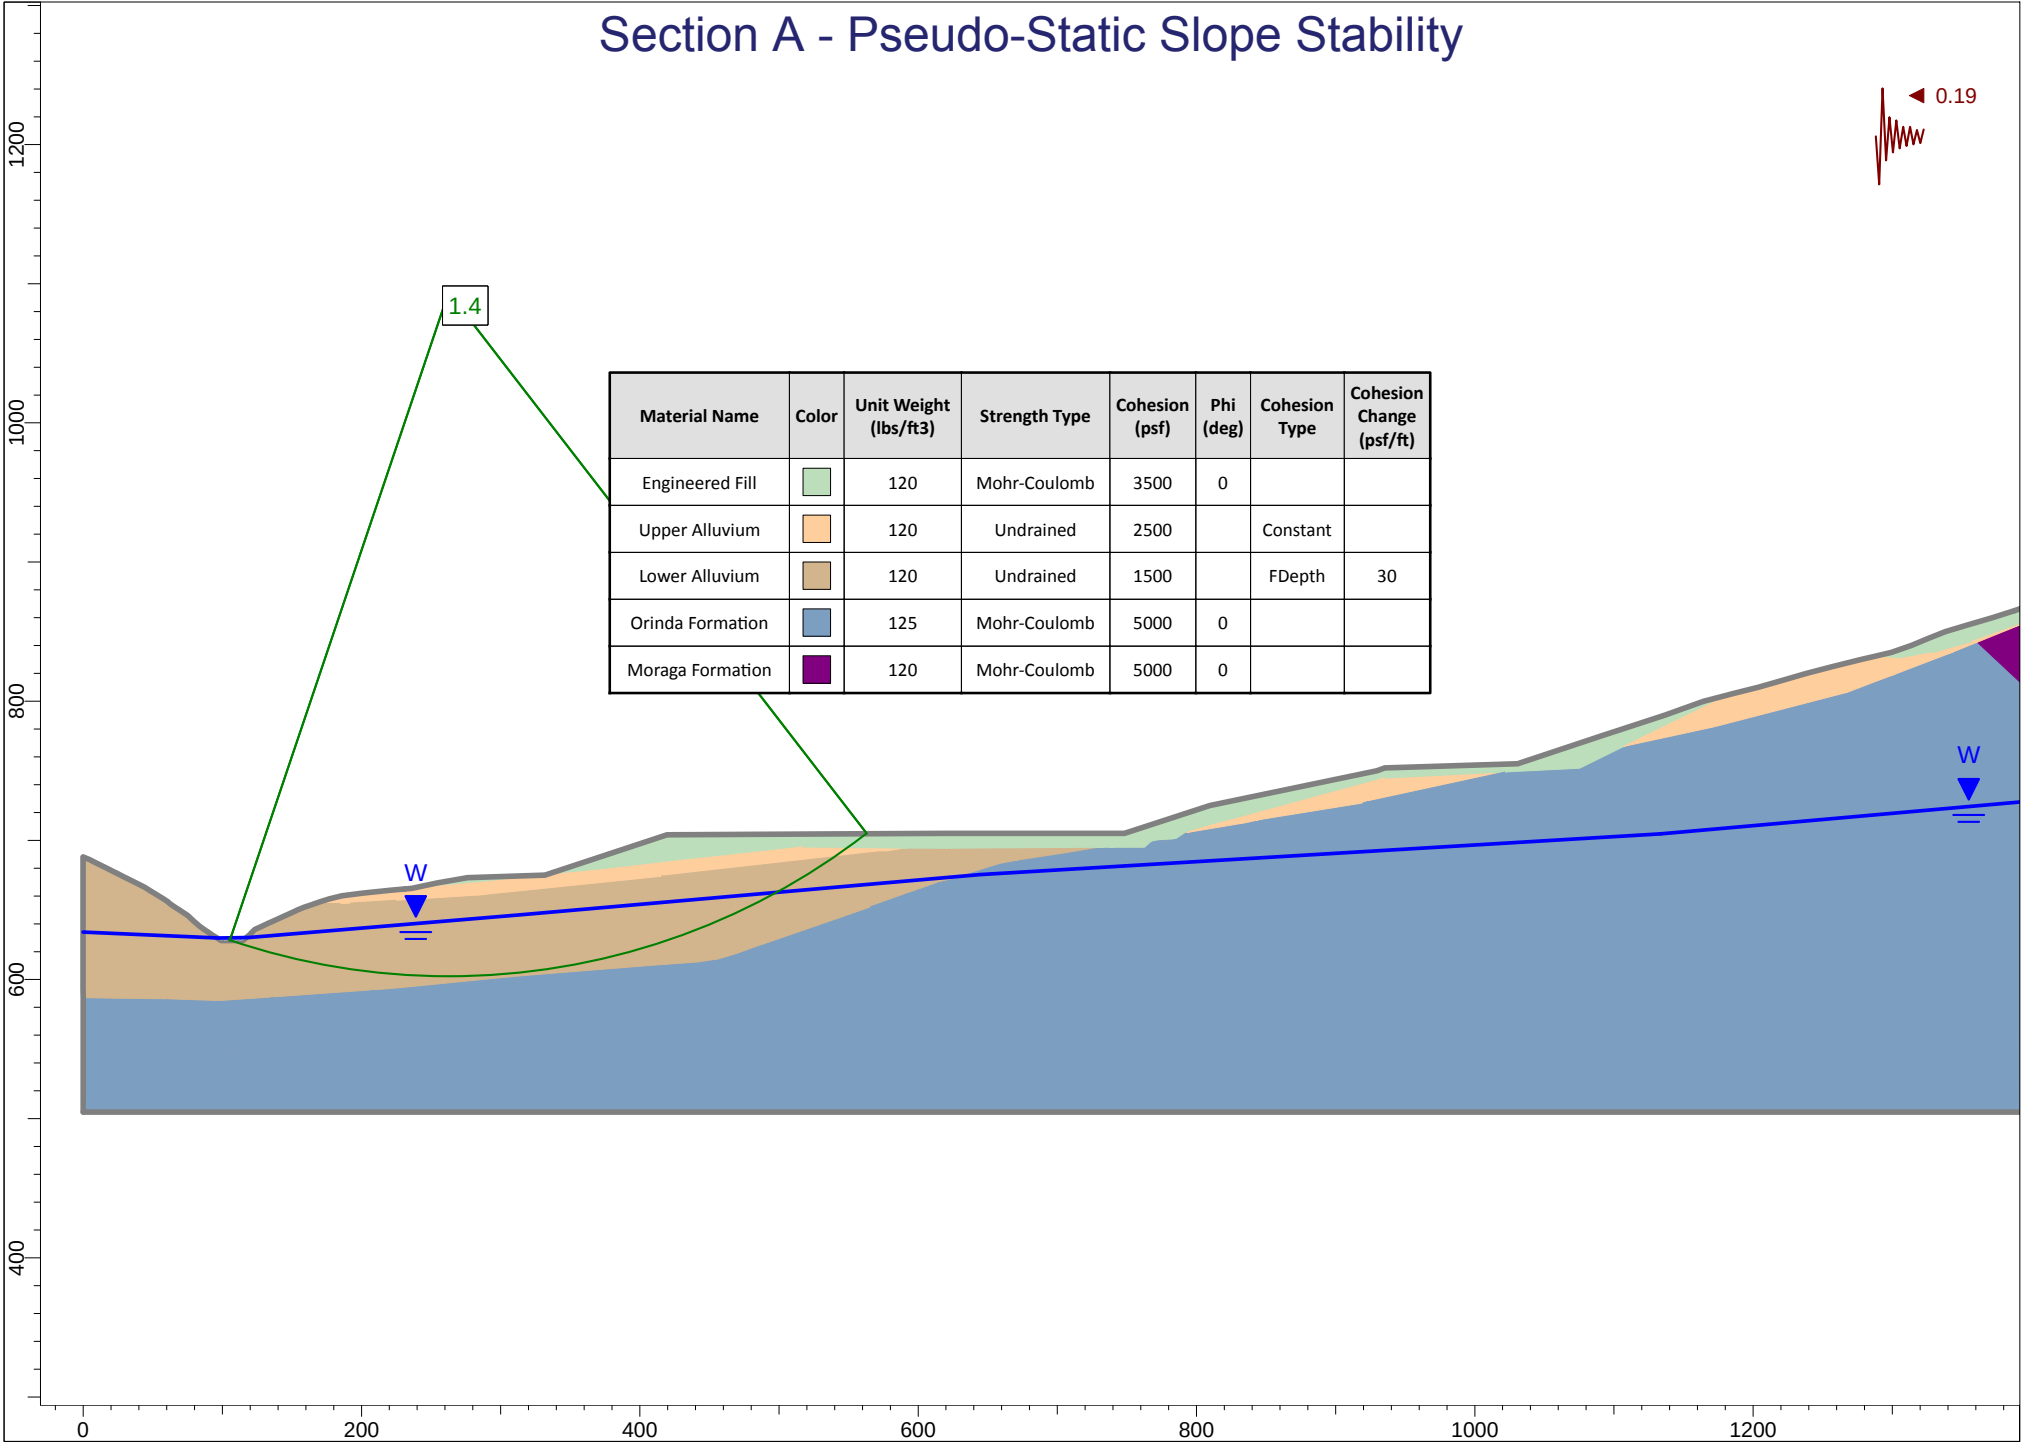
# Section A - Pseudo-Static Slope Stability
