# **Moraga Storm Drain Master Plan**

## **July 2015**

# TECHNICAL MEMORANDUM

## TOWN OF MORAGA STORM DRAINAGE CONDITION ASSESSMENT

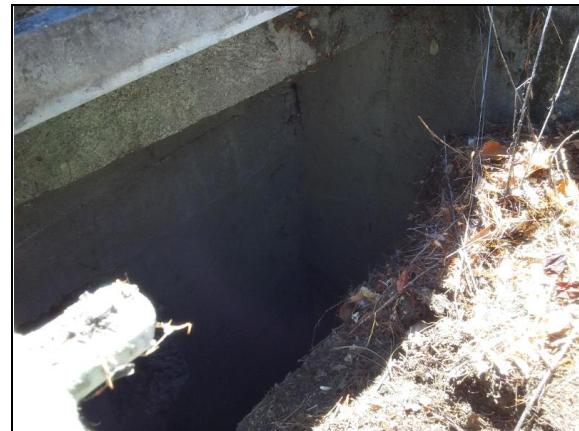
View inside catch basin.

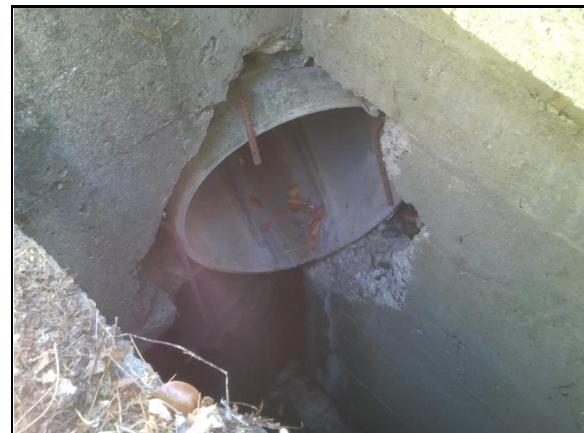
Projecting reinforcing steel and exposed aggregate.

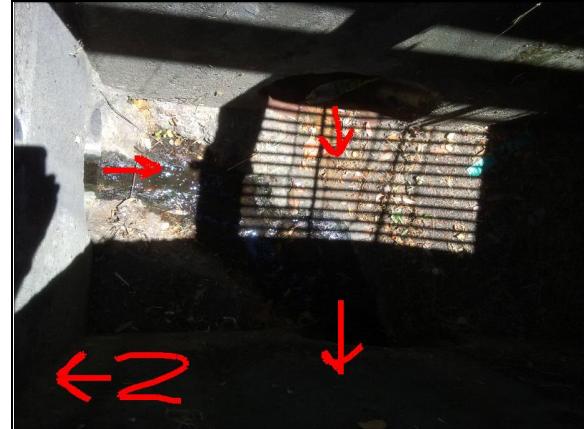
View inside catch basin.

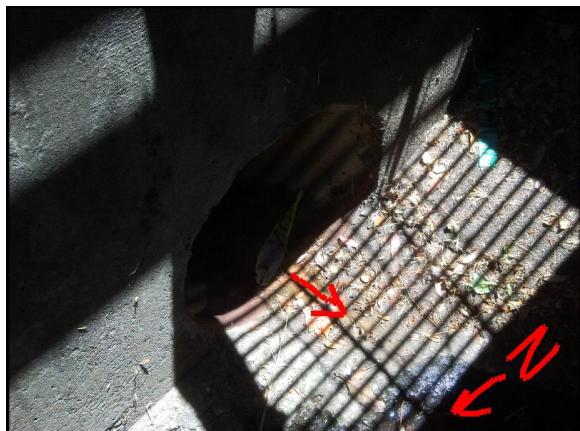
View of east inlet.

East inlet pipe. Changes diameter and material. Upstream portion is a RCP in good condition. Significant to moderate surface corrosion. Pipe runs under residence. Please refer to included videos for visuals.

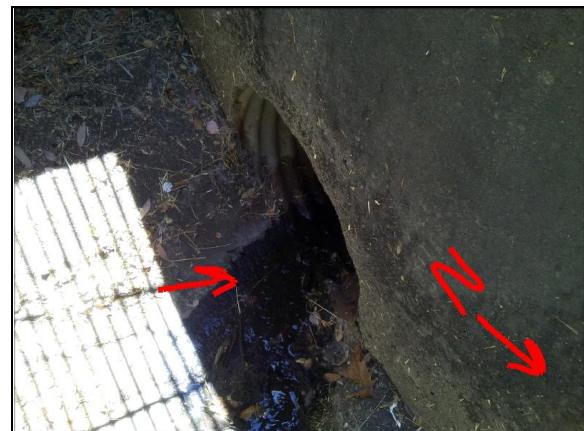
View of outlet.

Outlet pipe. Significant surface corrosion. Pipe runs under roadway. Please refer to included videos for visuals.

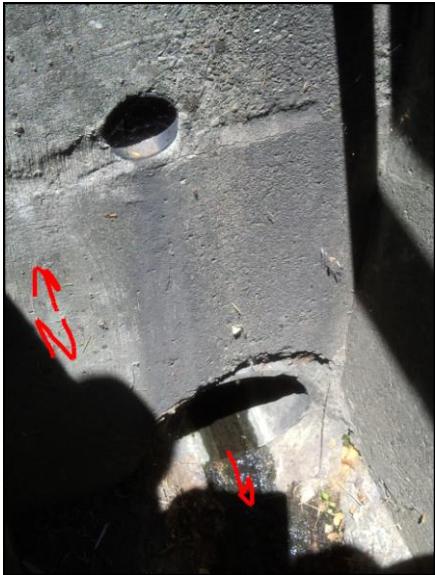
View of north inlet.

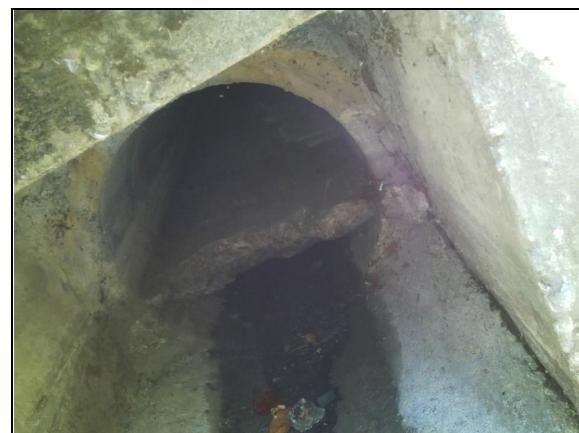
View of outlet. Concrete slab obstructing pipe.

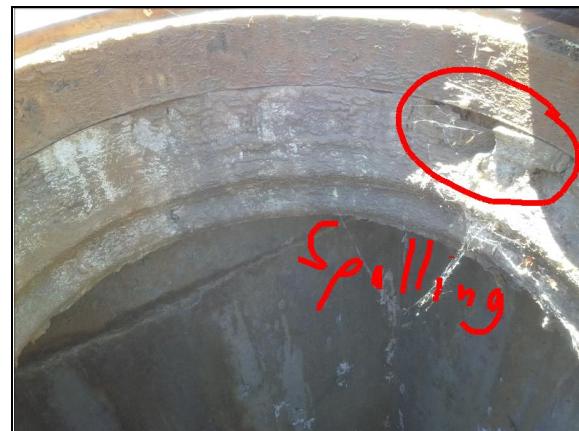
View inside manhole. Spalled concrete on manhole chimney.

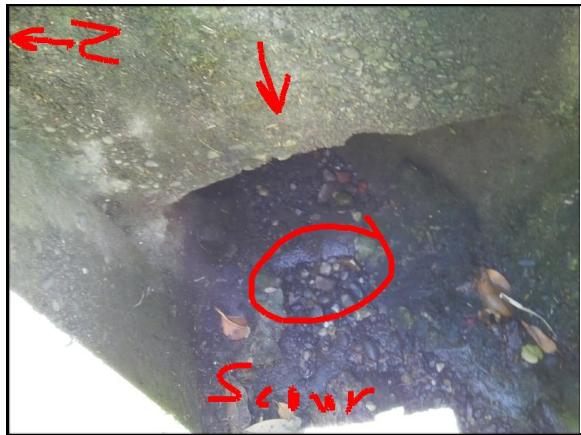
View of inlet. Scouring on structure floor.

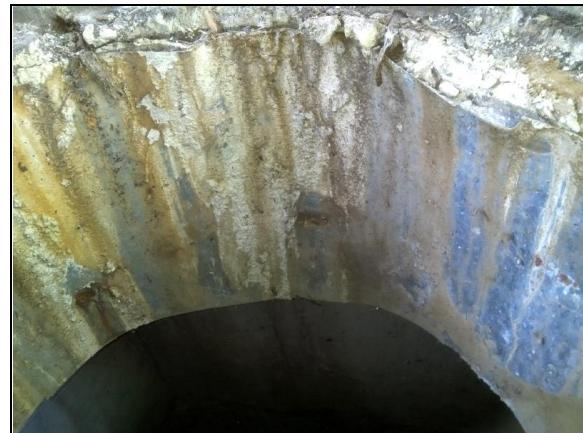
Thin metal lining over chimney, possibly served as a construction form. Concrete degradation at pipe connections.

Delaminating metal lining on manhole chimney.

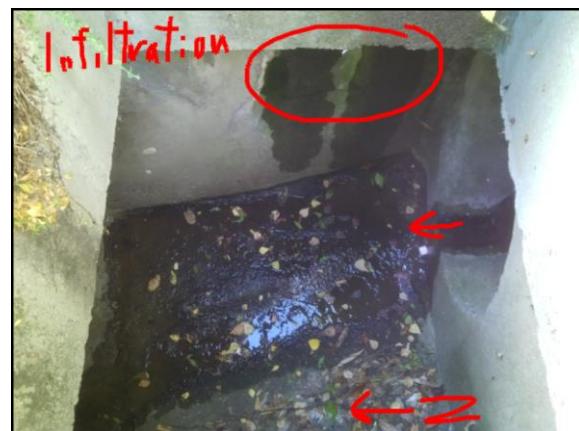
Infiltration stains on catch basin structure walls.

Down view of structure. Water infiltration staining.

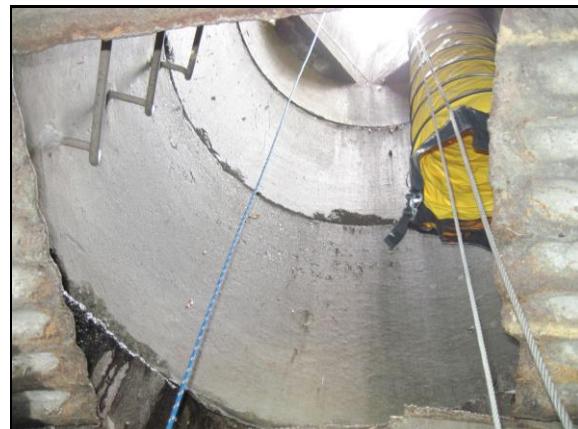
Filter removed in order to access for assessment. Opening cut in crown of CMP (2 ft. x 2 ft.). Weeper infiltration at 14 ft. from grade.

Catch Basin 14' Infiltration

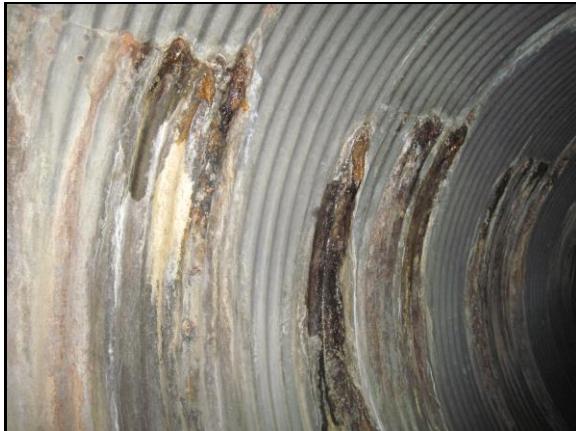
Downstream 10' Infiltration

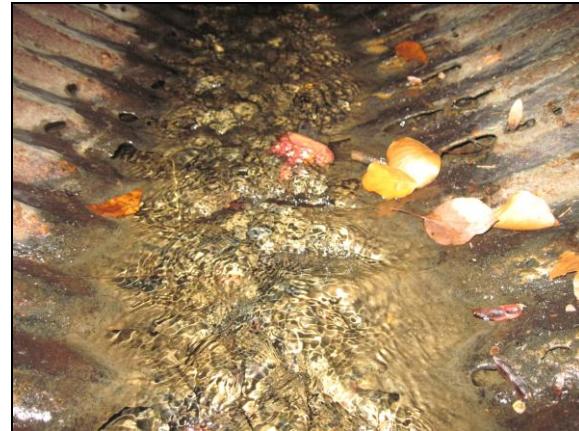
Downstream 13' Holes Void Visible

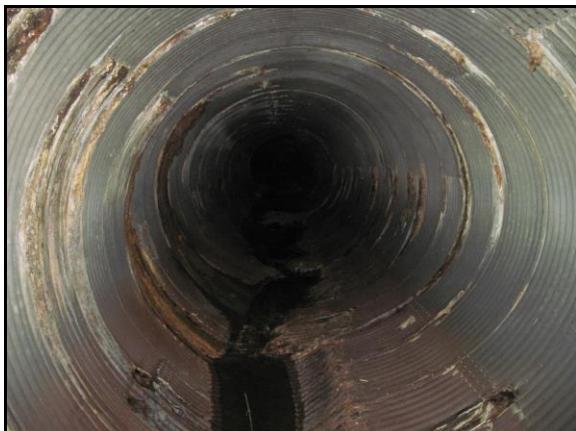
Downstream 20' Deformed (IMG\_2580)

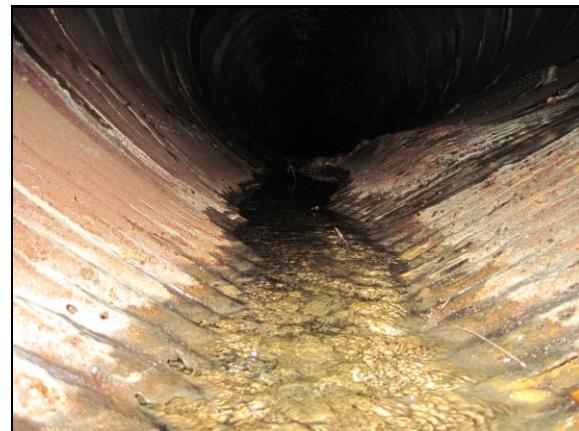
Downstream 20' Deformed (IMG\_2583)

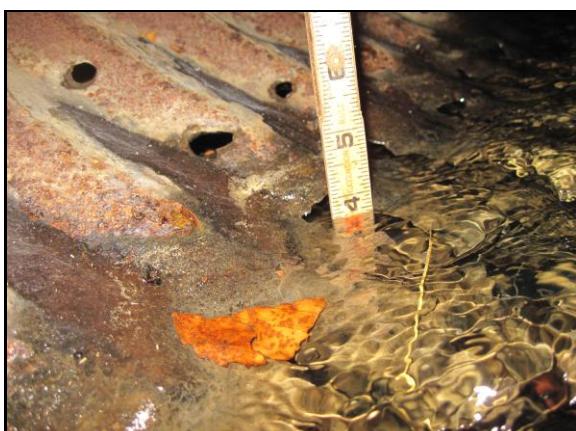
Outlet pipe. Pipe runs under roadway, parking lot, and commercial buildings. Multiple points of infiltration/encrustation. Significant/severe corrosion at invert. Perforations in invert with voids visible. Voids are about 3 in. deep. Pipe buckled/deformed in various places by approx. 10 percent. Portion of pipe invert has been rehabilitated with a concrete overlay.

Downstream 20' Holes Void Visible

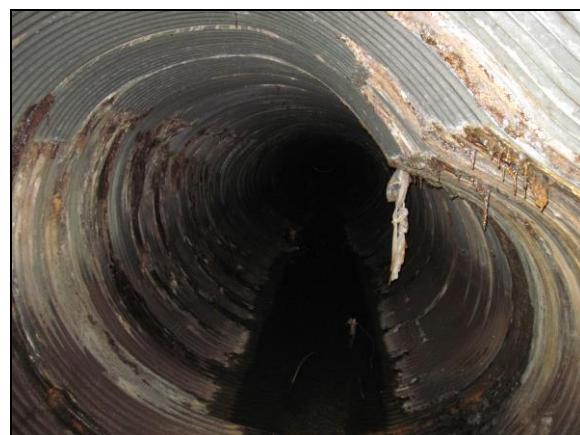
Downstream 207' Deformed (2)

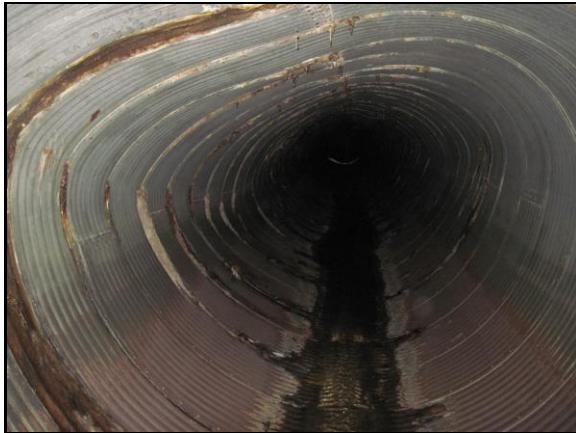
Downstream 270' Deformed (IMG\_2644)

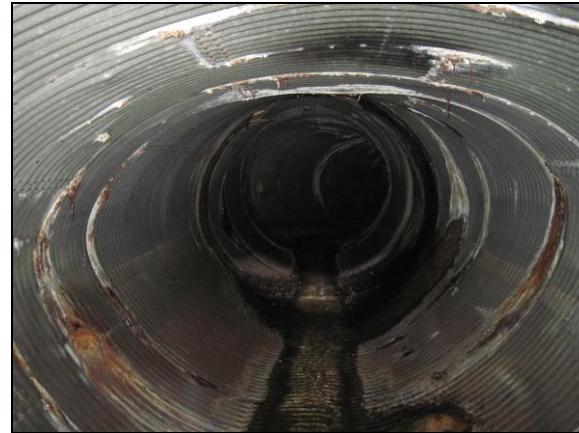
Downstream 337' Deformed

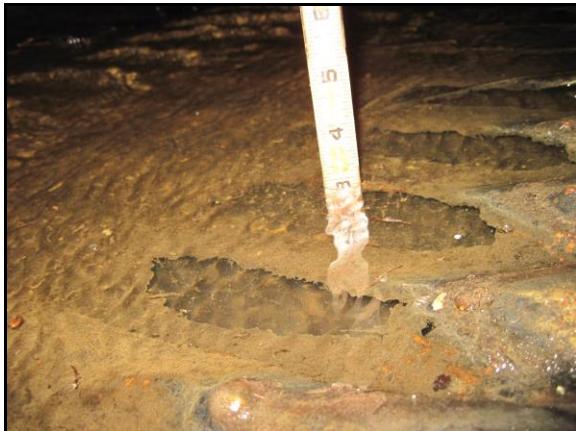
Downstream 411' Hole Void Visible  
(IMG\_2654)

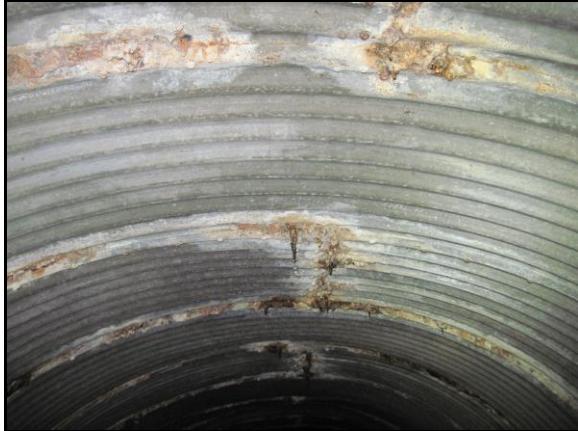
Inlet pipe. Pipe runs under roadway, parking lot, and commercial buildings. Multiple points of infiltration/encrustation. Significant/severe corrosion at invert. Perforations in invert with voids visible. Voids are between 4 in. to 10 in. deep. Hole with void visible on east pipe wall near assessment entry point. Pipe changes from CMP to RCP of same diameter. Connection appears to be of sheet metal and wood boards. RCP is in good condition with some infiltration staining/encrustation. Mortar missing at RCP joints (1 in. gap between pipe segments). Evidence of vandalism/unauthorized access warrants additional safety concerns.

Upstream Infiltration (4)

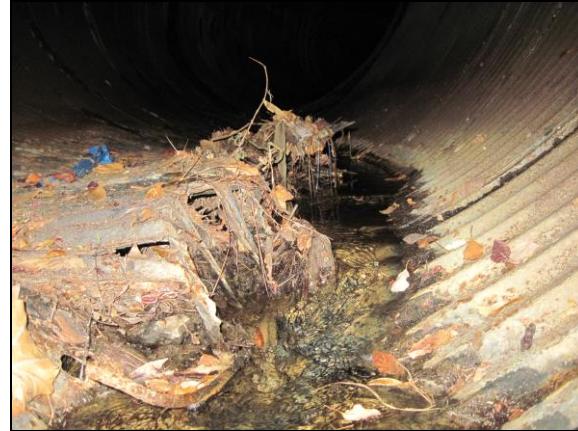
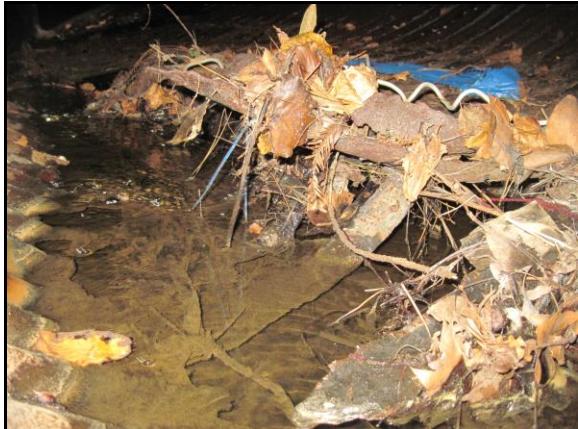
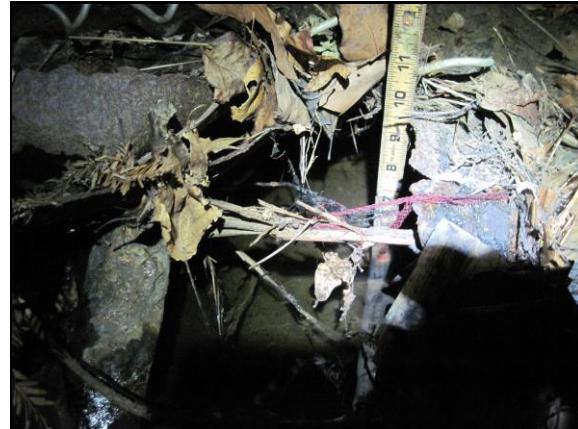
Upstream 8' Broken Pipe (1)

Upstream 8' Broken Pipe (2)

Upstream 8' Broken Pipe (3)

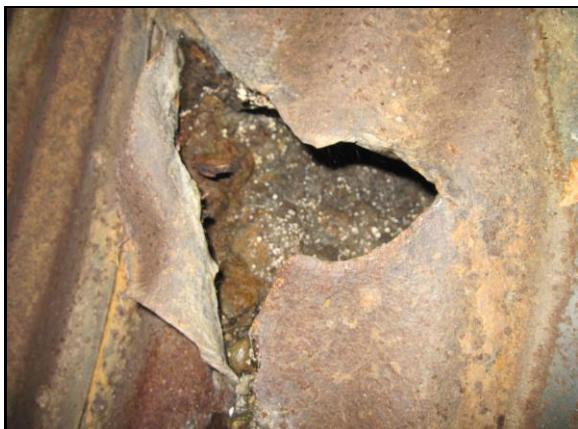
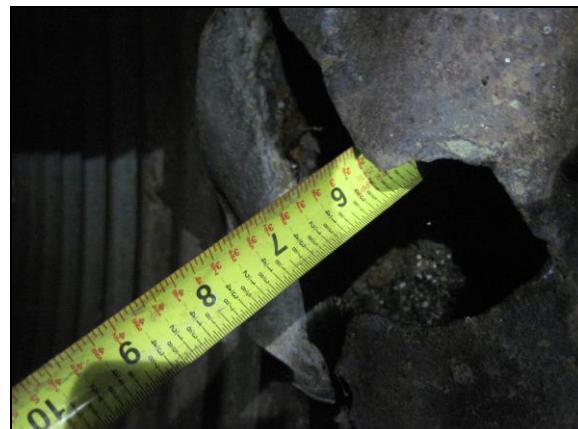
Upstream 8' Hole Void Visible (1)

Upstream 8' Hole Void Visible (2)

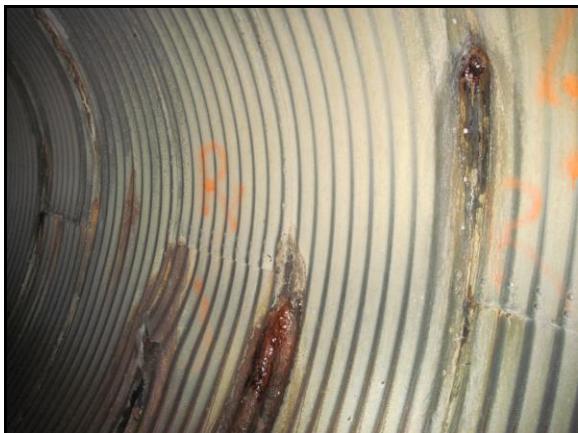
Upstream 15' Holes

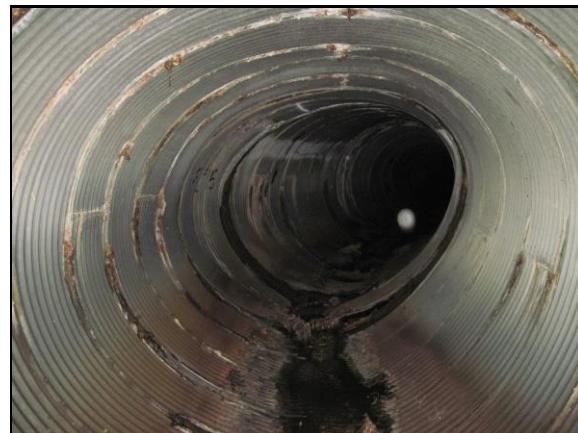
Upstream 18' Deformation

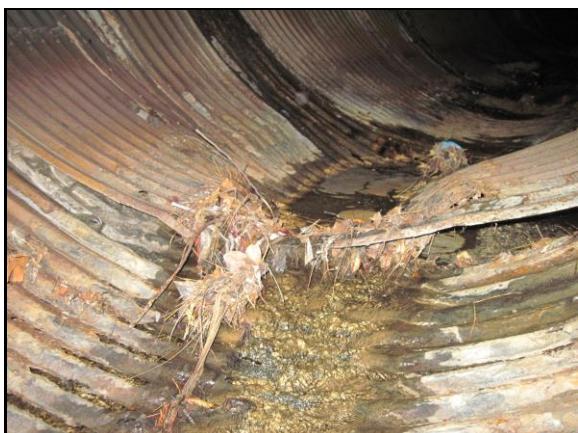
Upstream 21' Open Joint

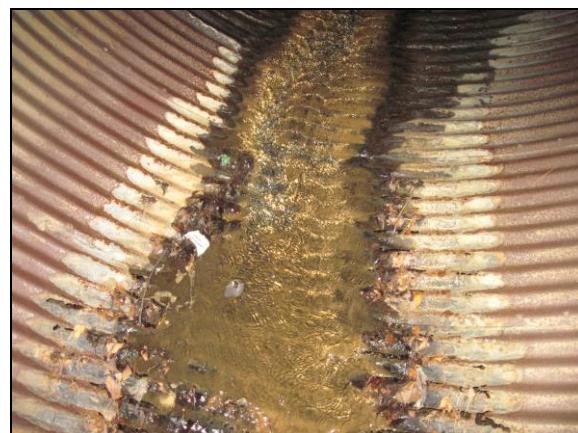
Upstream 44' Hole Void Visible

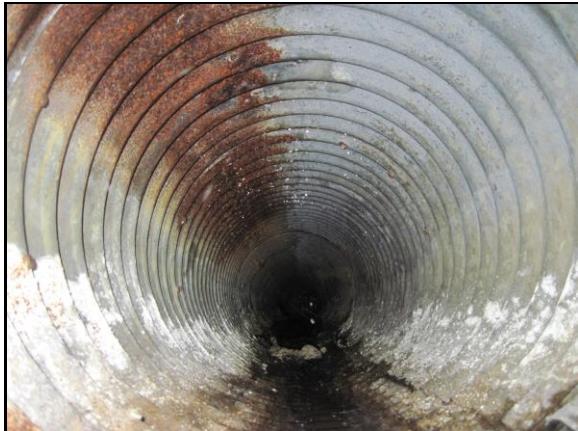
Upstream 44' Staining

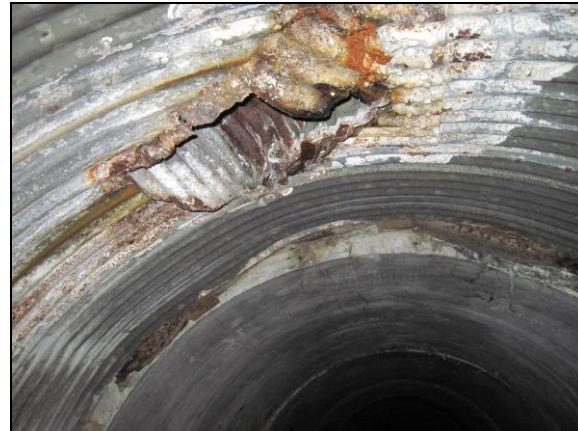
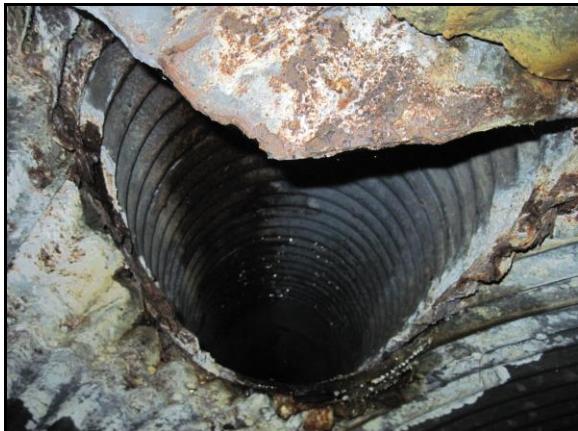
Upstream 45.5' Defective Tap Connection (1)

Upstream 45.5' Defective Tap Connection (4)

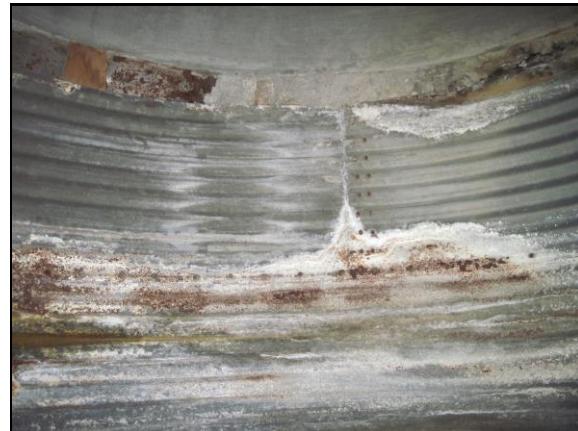
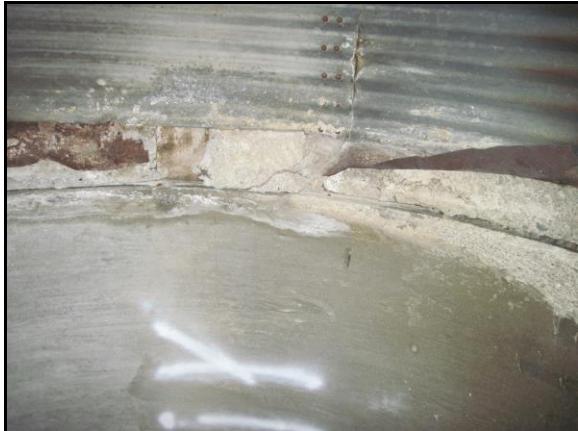
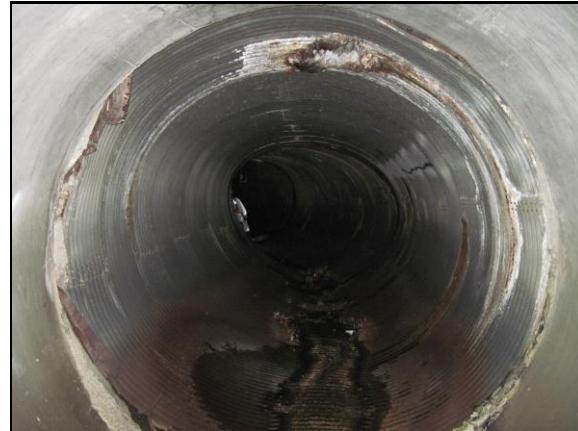
Upstream 46' Defective Pipe Material Change (1)

Upstream 46' Defective Pipe Material Change (2)

Upstream 46' Defective Pipe Material Change (3)

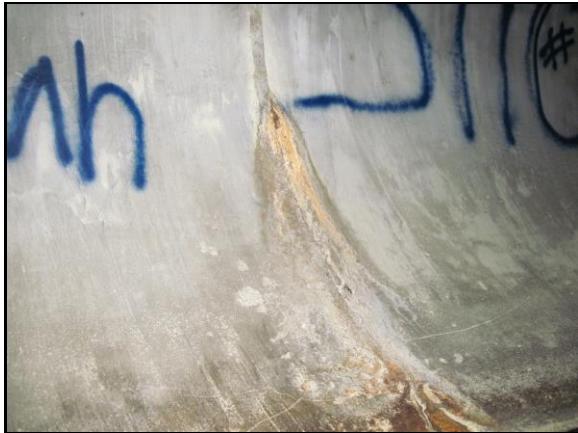
Upstream 73' Longitudinal Cracks, Staining (1)

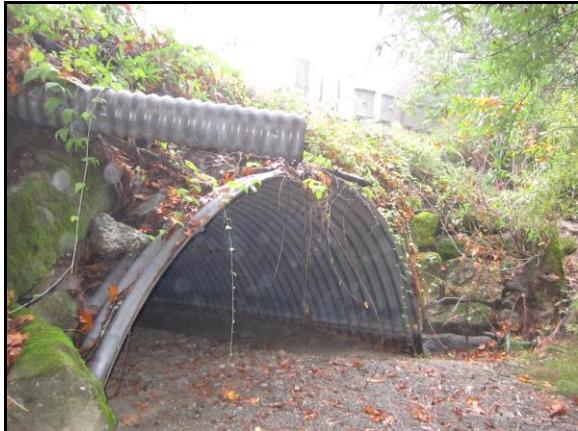
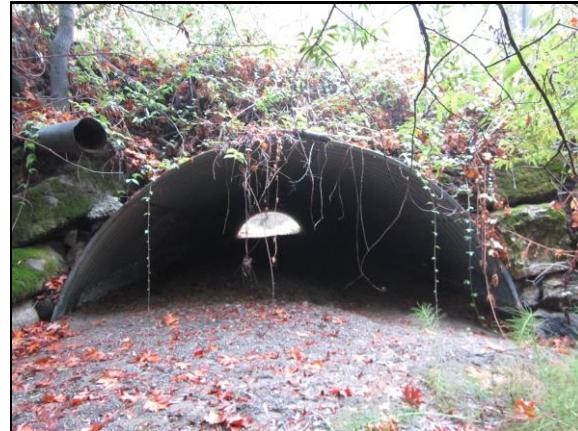
Outlet to culvert. Minor to moderate surface corrosion at base of pipe wall. Nearby CMP outlet.

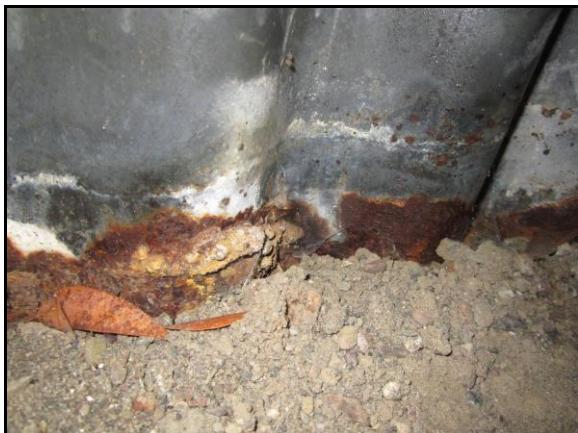
Pipe runs under roadway. Accessed from outlet and proceeded towards inlet. Minor to moderate surface corrosion at base of pipe wall.

Corrosion on pipe wall.

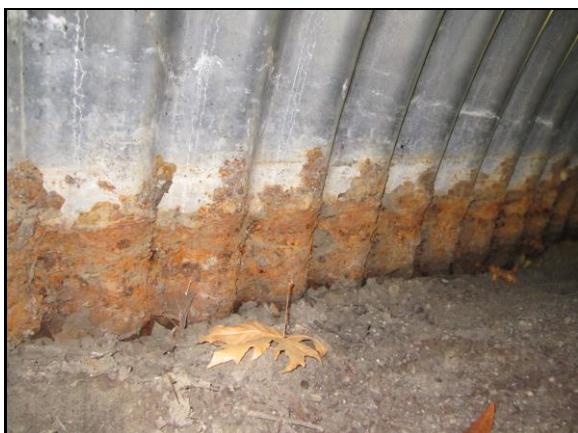
Corrosion on pipe wall

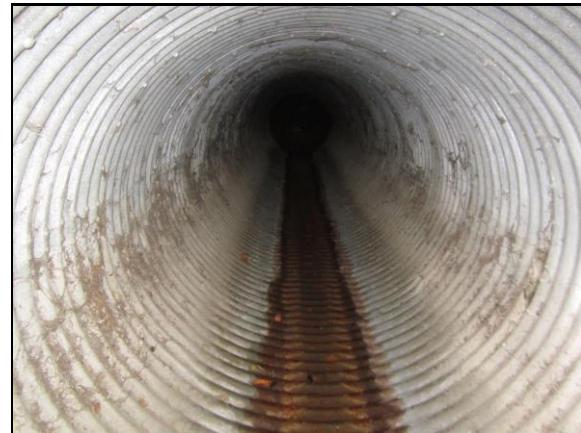
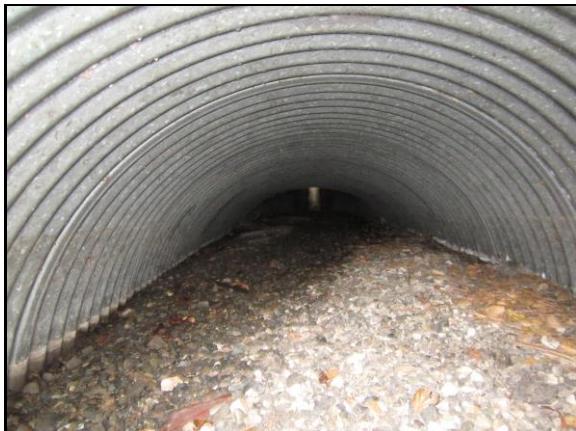
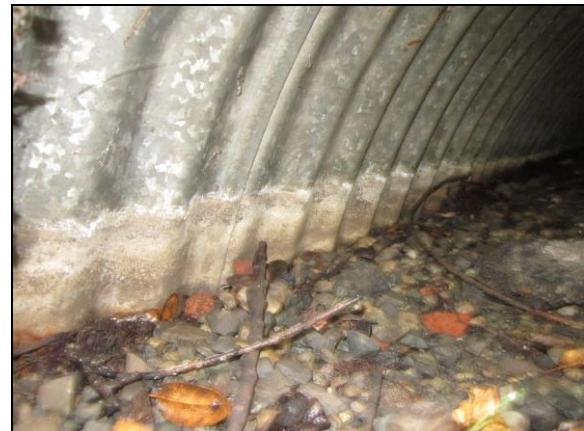
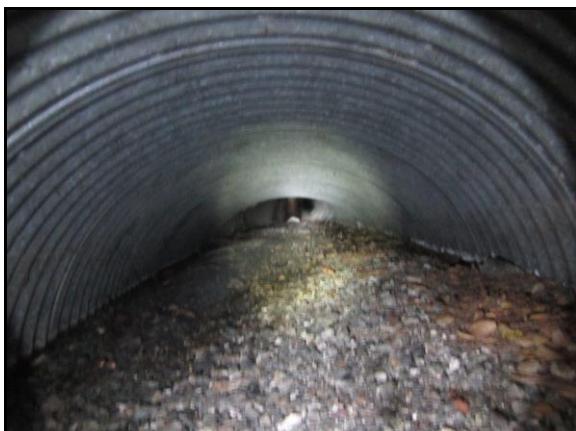
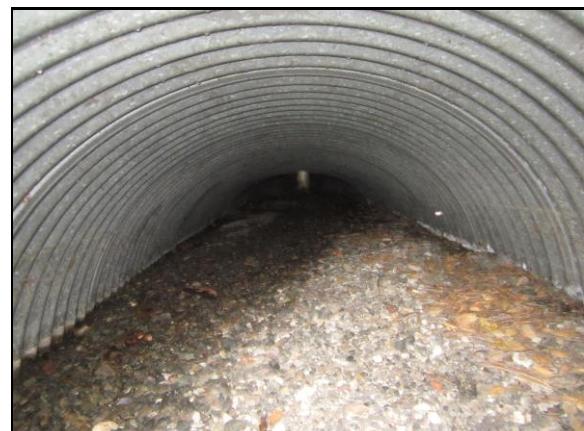
**Culvert Z5\_LINK\_S20**

Pipe appears to slope down, then bend into a flat horizontal section. This slope change could be the reason for the buildup of sediment at the outlet. Outlet is 48 in. while inlet is 50 in. indicating possible pipe deformation.

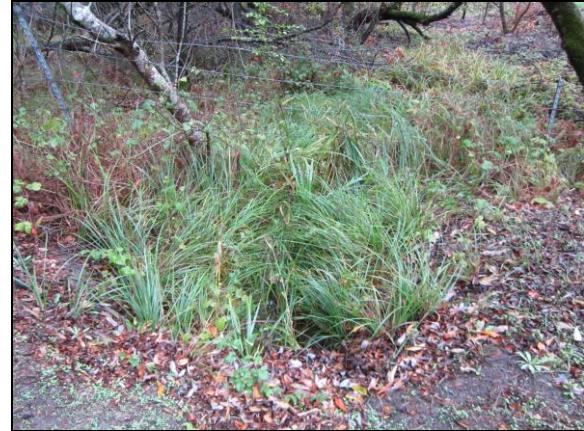
### ***Culvert Z6\_NODE\_S21\_N1***

Outlet to culvert. Significant/severe corrosion with lower half of pipe missing. Significant scouring of pipe bedding.

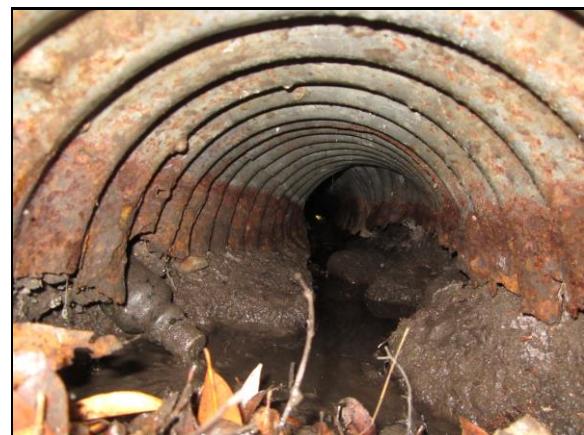
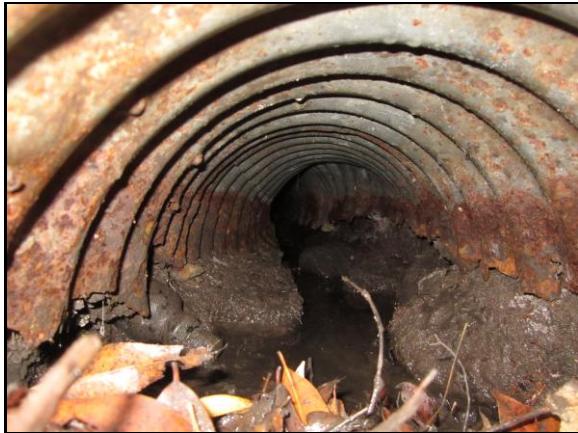
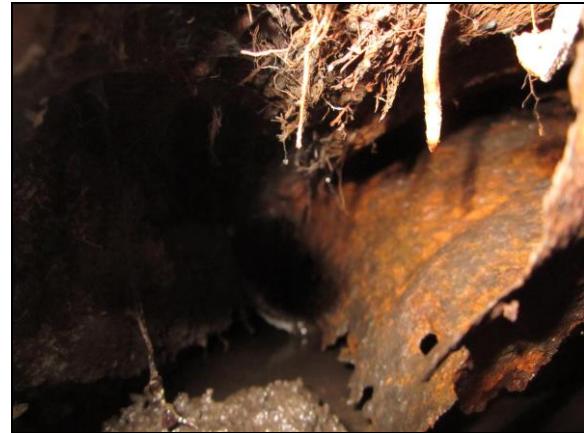
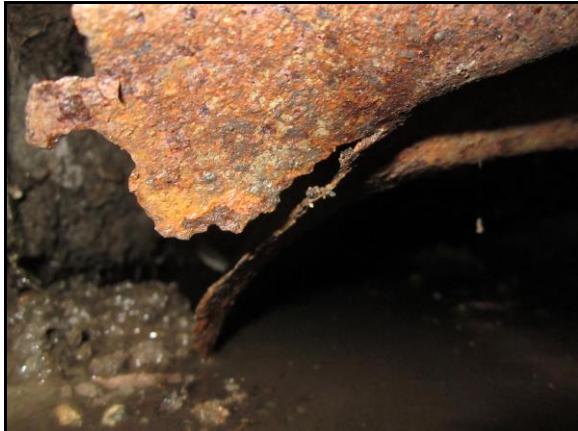
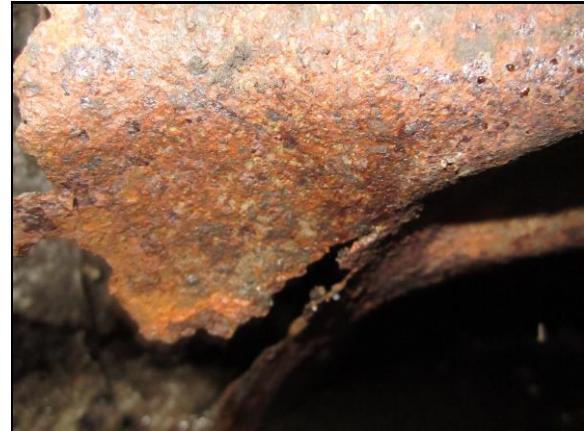
**SDFA 21 - 423 Canyon Rd**
**Culvert Z6\_LINK\_S21**

Pipe runs under roadway. Significant/severe corrosion with lower half of pipe missing. Significant scouring of pipe bedding.

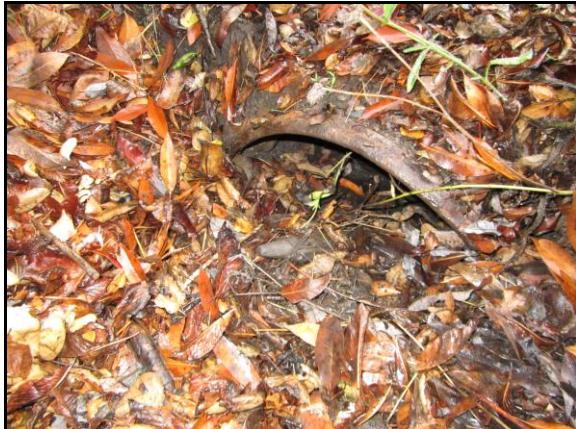
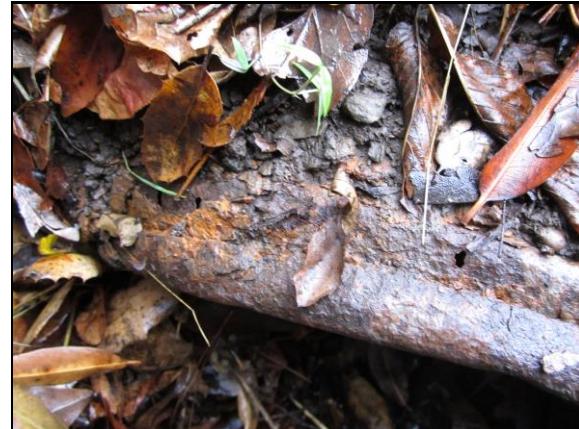
### Culvert Z6\_NODE\_S21\_N2

Inlet to culvert. Significant/severe corrosion with lower half of pipe missing. Significant scouring of pipe bedding.

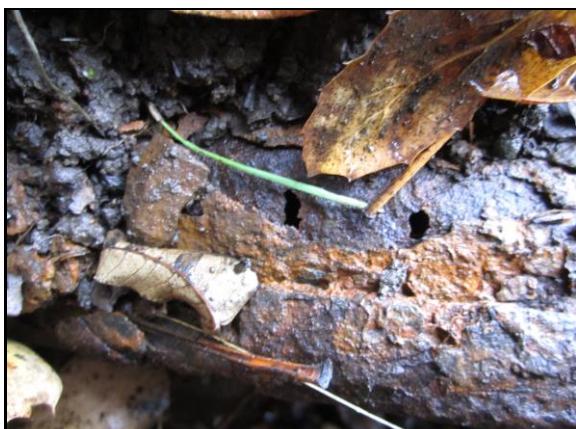
Minor perforations in pipe crown at inlet.

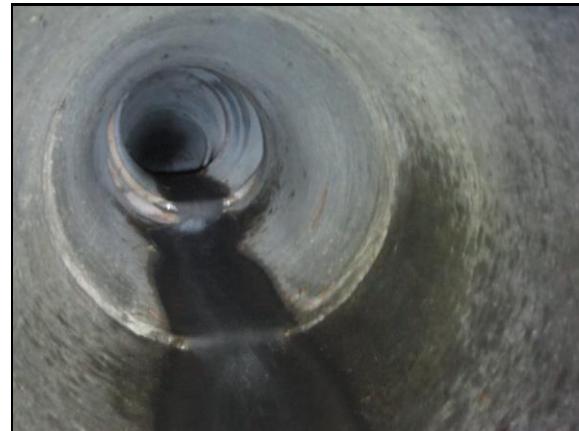
Offset joint inside nearby 16-in. RCP outlet.

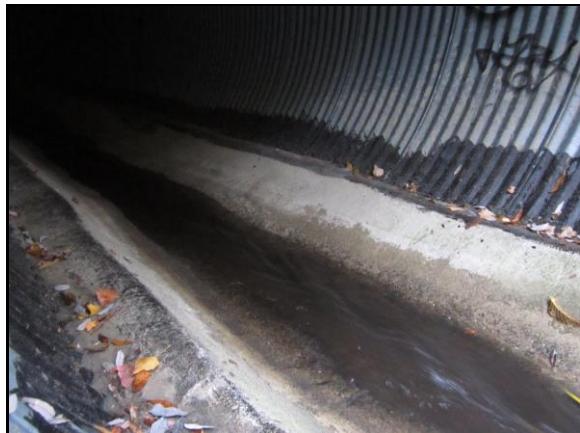
View of invert at outlet.

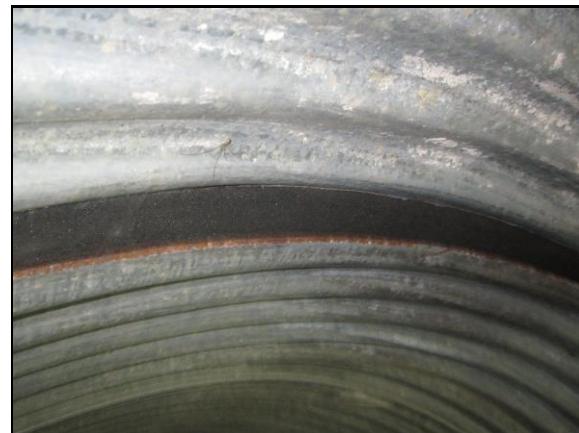
Joint seal.

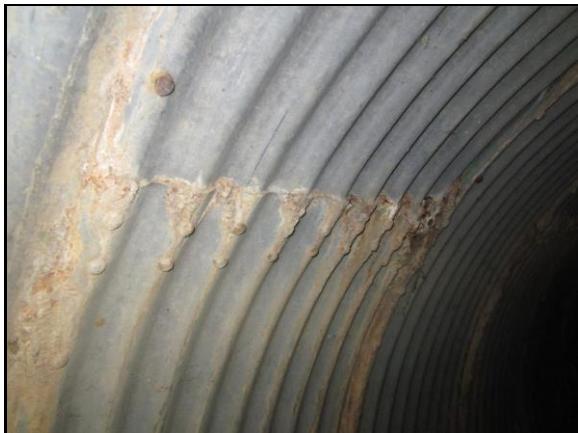
Pipe runs under roadway. The pipe is in overall good condition. There is some infiltration staining/encrustation. There is one hole in the pipe wall near the bend, but there is another layer of metal material behind the hole. The invert has a concrete formed channel. There is a coating on the upstream portion of the pipe. There is some minor surface corrosion near the concrete invert.

View of encrustation on pipe wall.

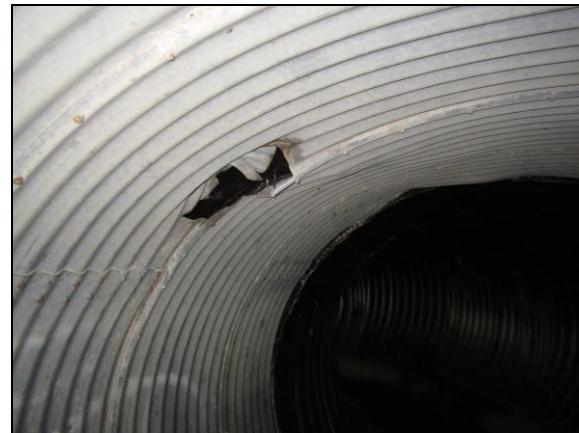
Hole in pipe wall.

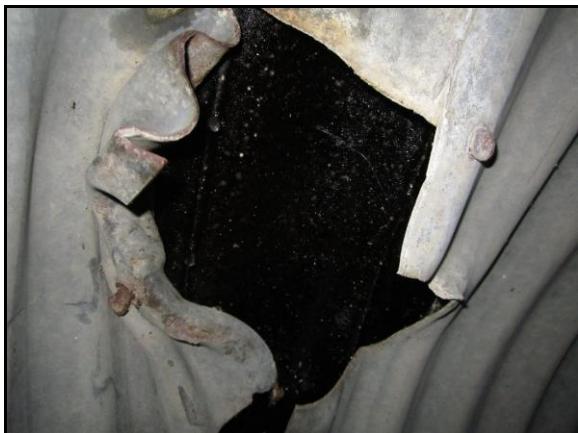
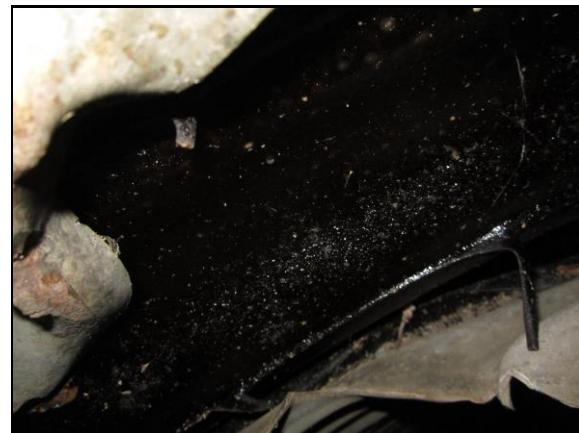
View inside hole in pipe wall. Appears to be another layer of metal material within the hole.

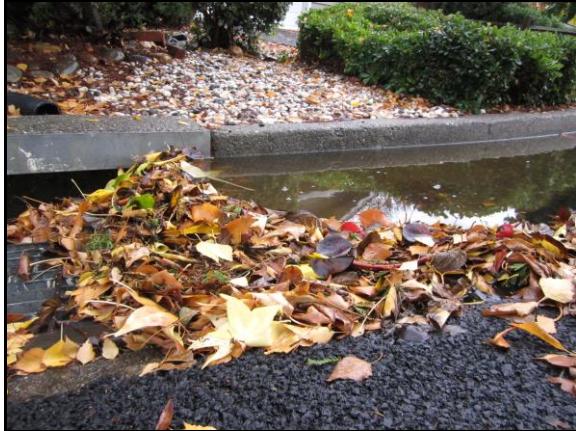
Debris buildup and ponding.

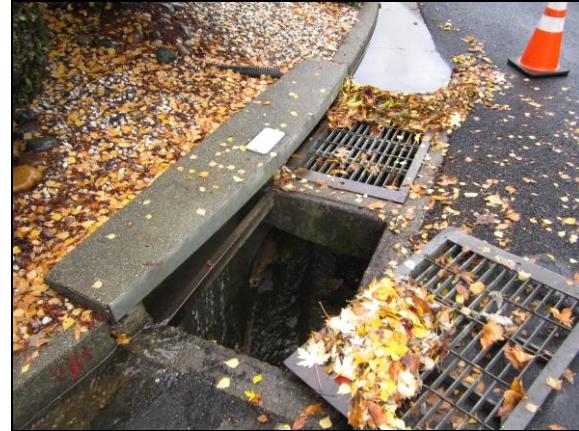
View of catch basin.

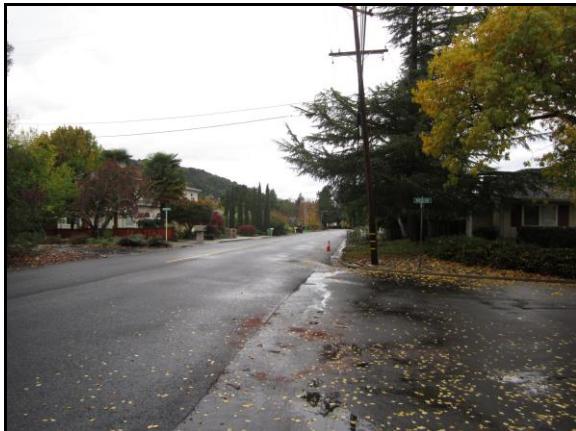
Location view.

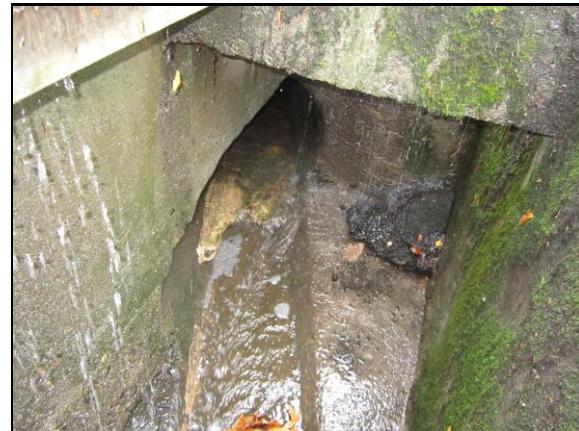
View of inlet pipe.

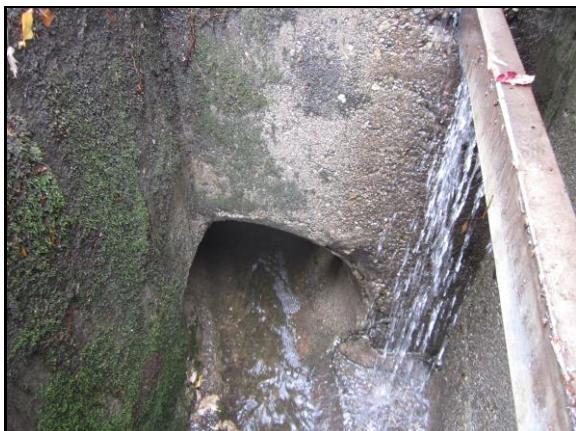
View of outlet pipe.

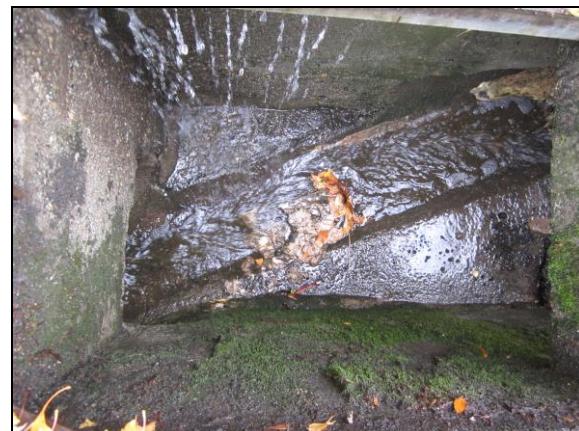
View inside catch basin.

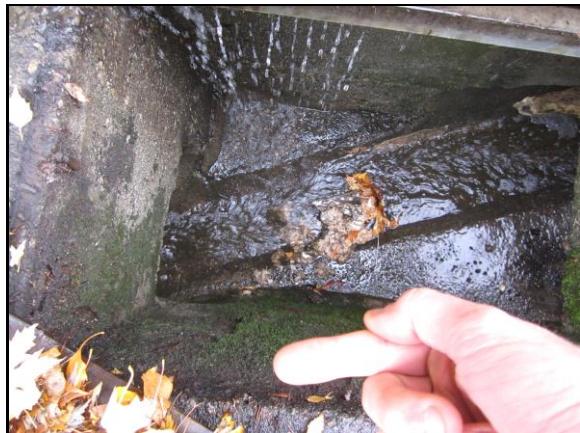
Direction of flow.

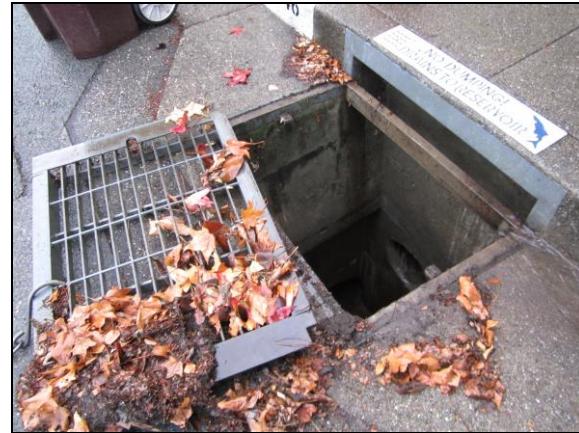
View of catch basin.

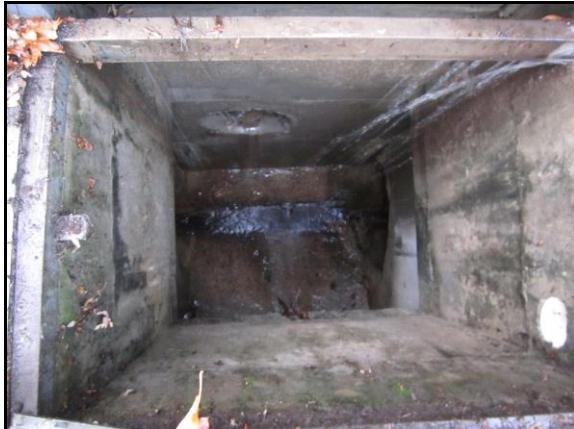
View inside catch basin.

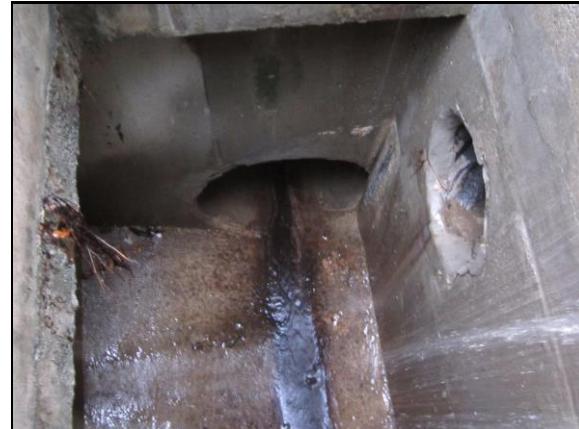
View of 36-in. RCP outlet and 16-in. CMP inlet.

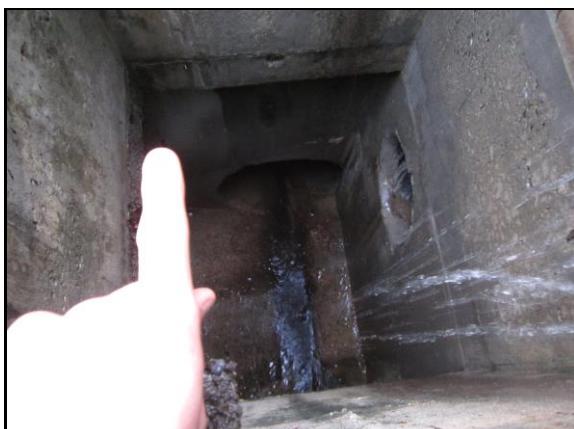
Direction of flow.

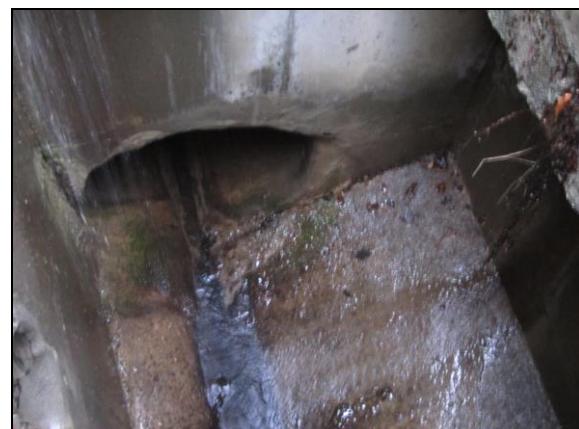
View of 36-in. RCP inlet.

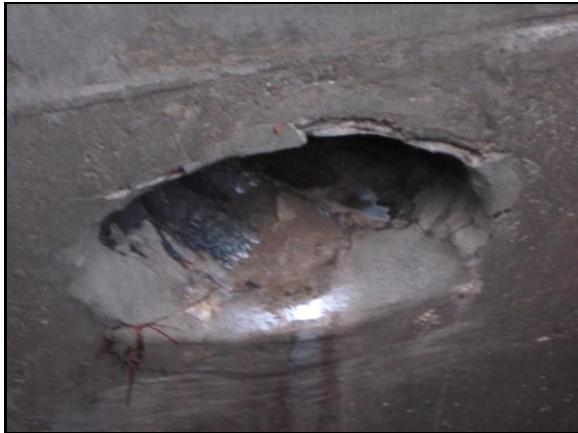
View of 16-in. CMP inlet.

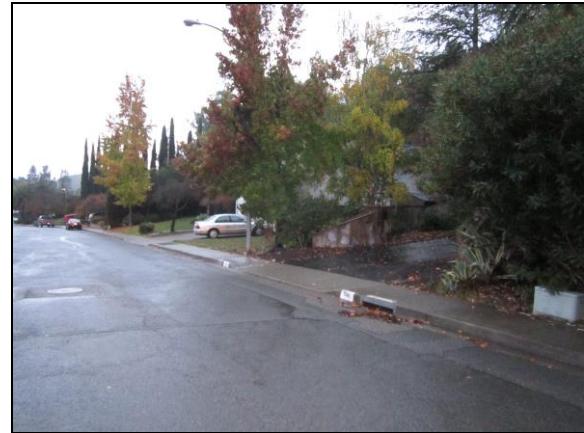
Location view.

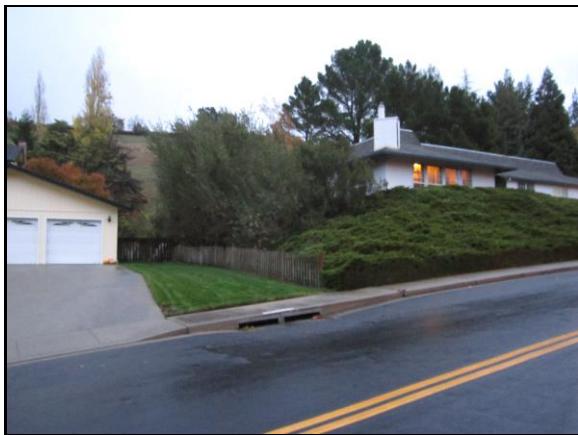
Unable to evaluate due to bolted catch basin grate.

Location view.

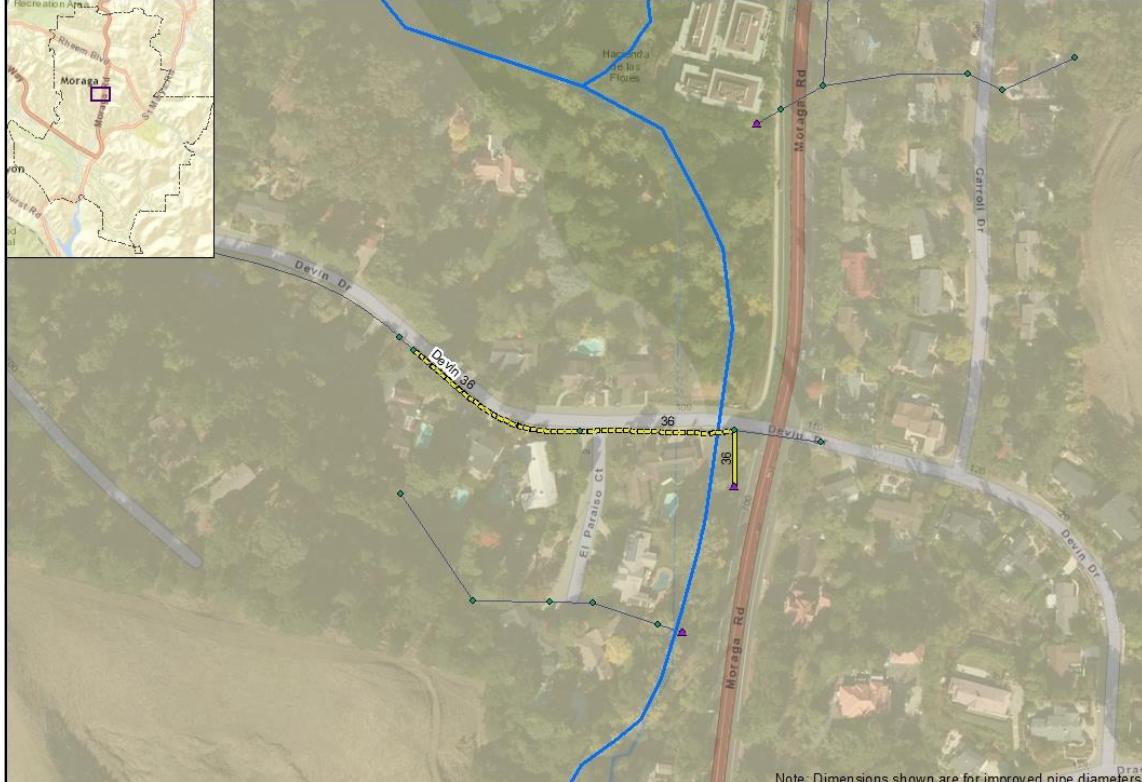
<b>A. Project ID: C04</b>	<b>B. Project Name: Devin</b>																
<b>C. Project Location: Devin Dr. near intersection with Moraga Rd.</b>																	
<b>D. Priority: Moderate (Capacity)</b>																	
<b>E. Project Description:</b> Overflows caused by undersized pipes occur on Devin Dr. Project includes replacing two pipes under private property on Devin Dr. and one in the public right-of-way on Moraga Rd.																	
<table border="1"> <thead> <tr> <th>Ex. Diameter (in)</th><th>Imp. Diameter (in)</th><th>Equivalent Parallel (in)</th><th>Length (ft)</th></tr> </thead> <tbody> <tr> <td>24</td><td>36</td><td>30</td><td>249</td></tr> <tr> <td>24</td><td>36</td><td>30</td><td>311</td></tr> <tr> <td>24</td><td>36</td><td>30</td><td>90</td></tr> </tbody> </table>	Ex. Diameter (in)	Imp. Diameter (in)	Equivalent Parallel (in)	Length (ft)	24	36	30	249	24	36	30	311	24	36	30	90	
Ex. Diameter (in)	Imp. Diameter (in)	Equivalent Parallel (in)	Length (ft)

24	36	30	249														
24	36	30	311														
24	36	30	90														
<b>F. Project Cost.....</b>	<b>\$351,000</b>																
<b>G. Design Contingency.....</b>	<b>\$105,300</b>																
<b>H. Total Preliminary CIP Cost.....</b>	<b>\$456,300</b>
