# **Moraga Storm Drain Master Plan**

## **July 2015**

# TECHNICAL MEMORANDUM

## TOWN OF MORAGA STORM DRAINAGE CONDITION ASSESSMENT

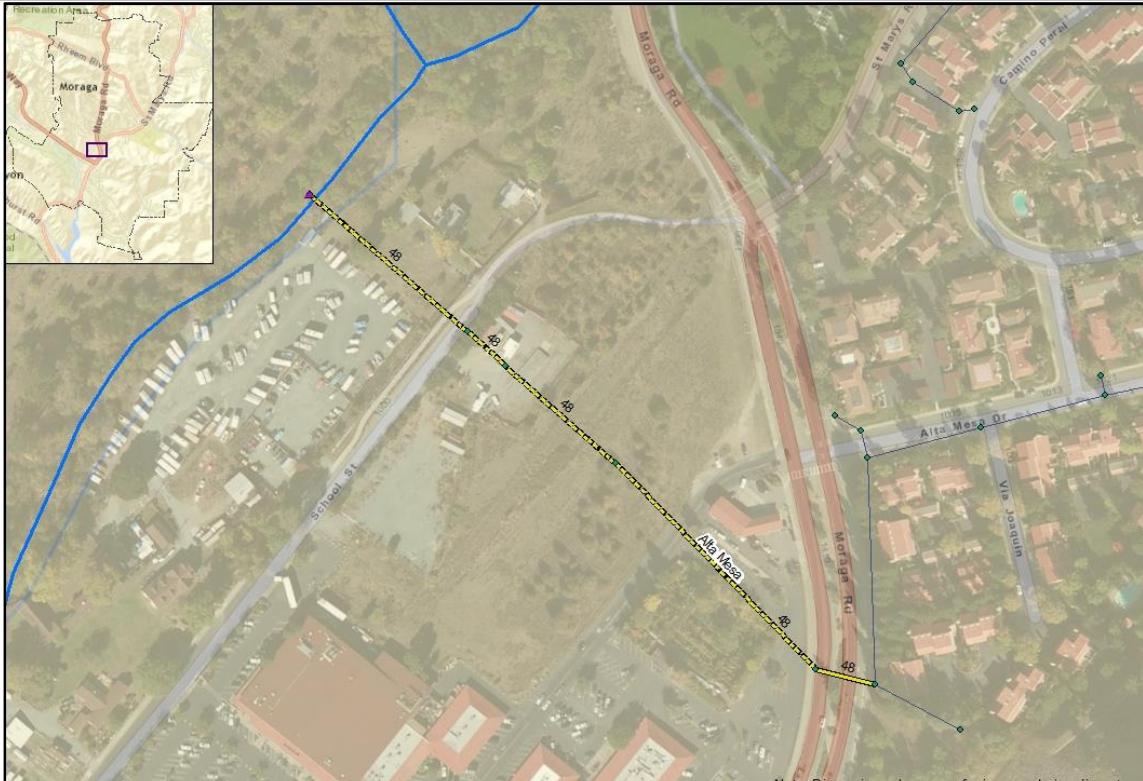
<b>A. Project ID: C06</b>	<b>B. Project Name: Alta Mesa</b>																								
<b>C. Project Location: On Moraga Rd. South of Corner with Alta Mesa</b>																									
<b>D. Priority: Moderate (Capacity)</b>																									
<b>E. Project Description:</b> Significant storm drain overflows adjacent to Moraga Rd. occur where two steep pipes join into one relatively flat, undersized pipe. Project includes replacing one pipe under Moraga Rd. and four pipes that run under private property.																									
<table border="1"> <thead> <tr> <th>Ex. Diameter (in)</th><th>Imp. Diameter (in)</th><th>Equivalent Parallel (in)</th><th>Length (ft)</th></tr> </thead> <tbody> <tr><td>36</td><td>48</td><td>30</td><td>337</td></tr> <tr><td>36</td><td>48</td><td>30</td><td>81</td></tr> <tr><td>36</td><td>48</td><td>30</td><td>237</td></tr> <tr><td>36</td><td>48</td><td>30</td><td>462</td></tr> <tr><td>36</td><td>48</td><td>30</td><td>99</td></tr> </tbody> </table>		Ex. Diameter (in)	Imp. Diameter (in)	Equivalent Parallel (in)	Length (ft)	36	48	30	337	36	48	30	81	36	48	30	237	36	48	30	462	36	48	30	99

Ex. Diameter (in)	Imp. Diameter (in)	Equivalent Parallel (in)	Length (ft)																						
36	48	30	337																						
36	48	30	81																						
36	48	30	237																						
36	48	30	462																						
36	48	30	99																						
<b>F. Project Cost.....</b> <b>\$833,800</b>																									
<b>G. Design Contingency.....</b> <b>\$250,100</b>																									
<b>H. Total Preliminary CIP Cost.....</b> <b>\$1,083,900</b>
